StEER
STRUCTURAL
EXTREME EVENTS
RECONNAISSANCE

M 6.4 and M 7.1 Ridgecrest, CA Earthquakes PRELIMINARY VIRTUAL RECONNAISSANCE REPORT (PVRR)

Released: July 8, 2019 | **NHERI DesignSafe Project ID:** PRJ-2444

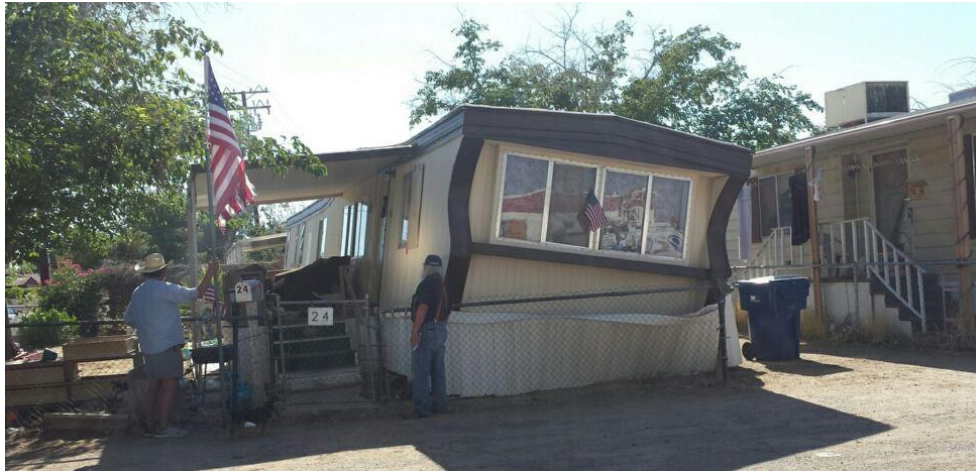
Damaged mobile home in Ridgecrest, CA during the M 6.4 earthquake. Photo by [Darla A. Baker / The Californian](#).

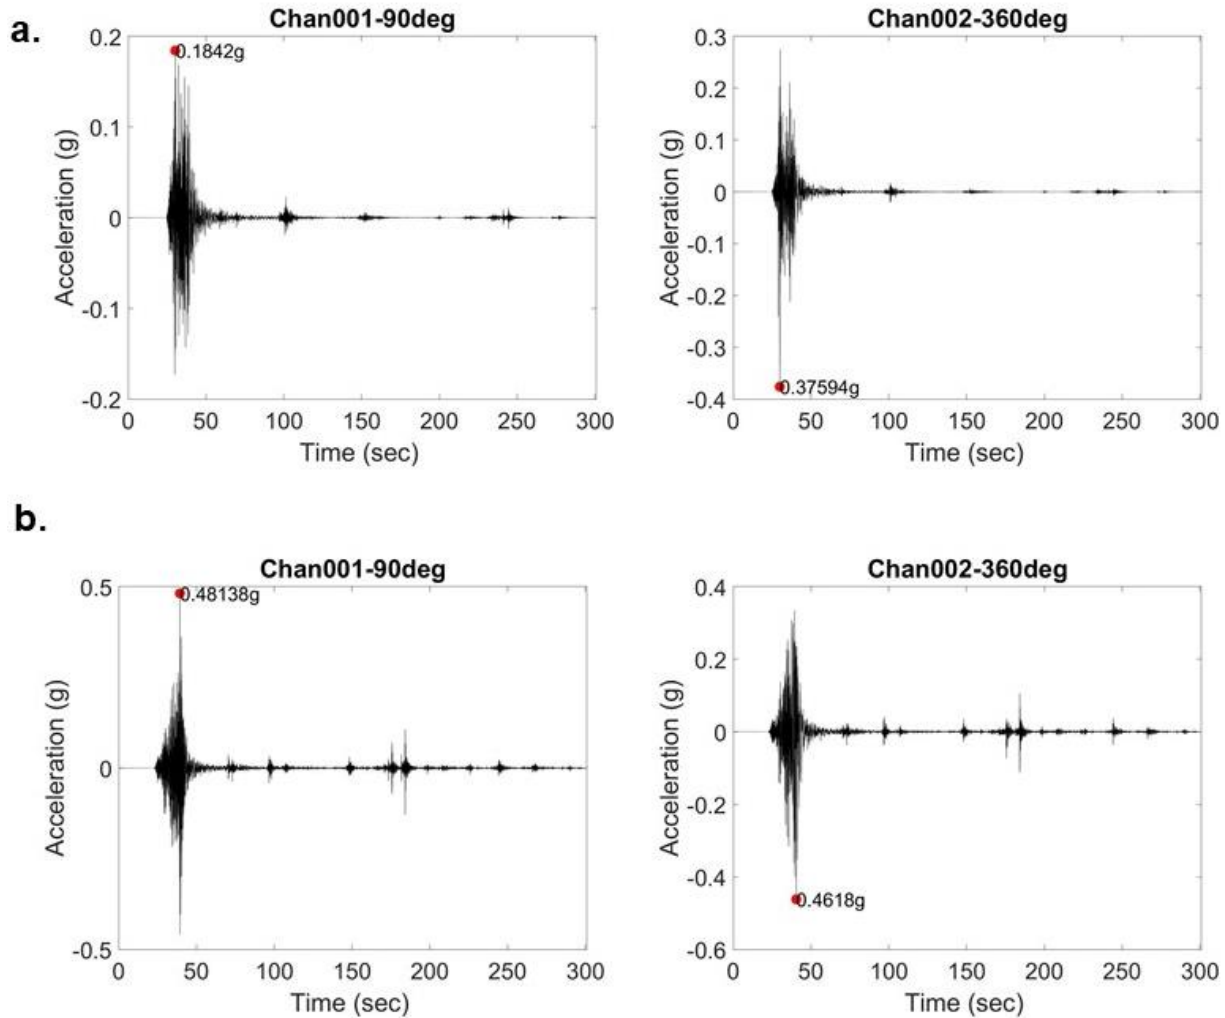
Figure 3. Acceleration time histories recorded at the Christmas Canyon China lake (CCC) station from (a) M 6.4 event and (b) M 7.1 event

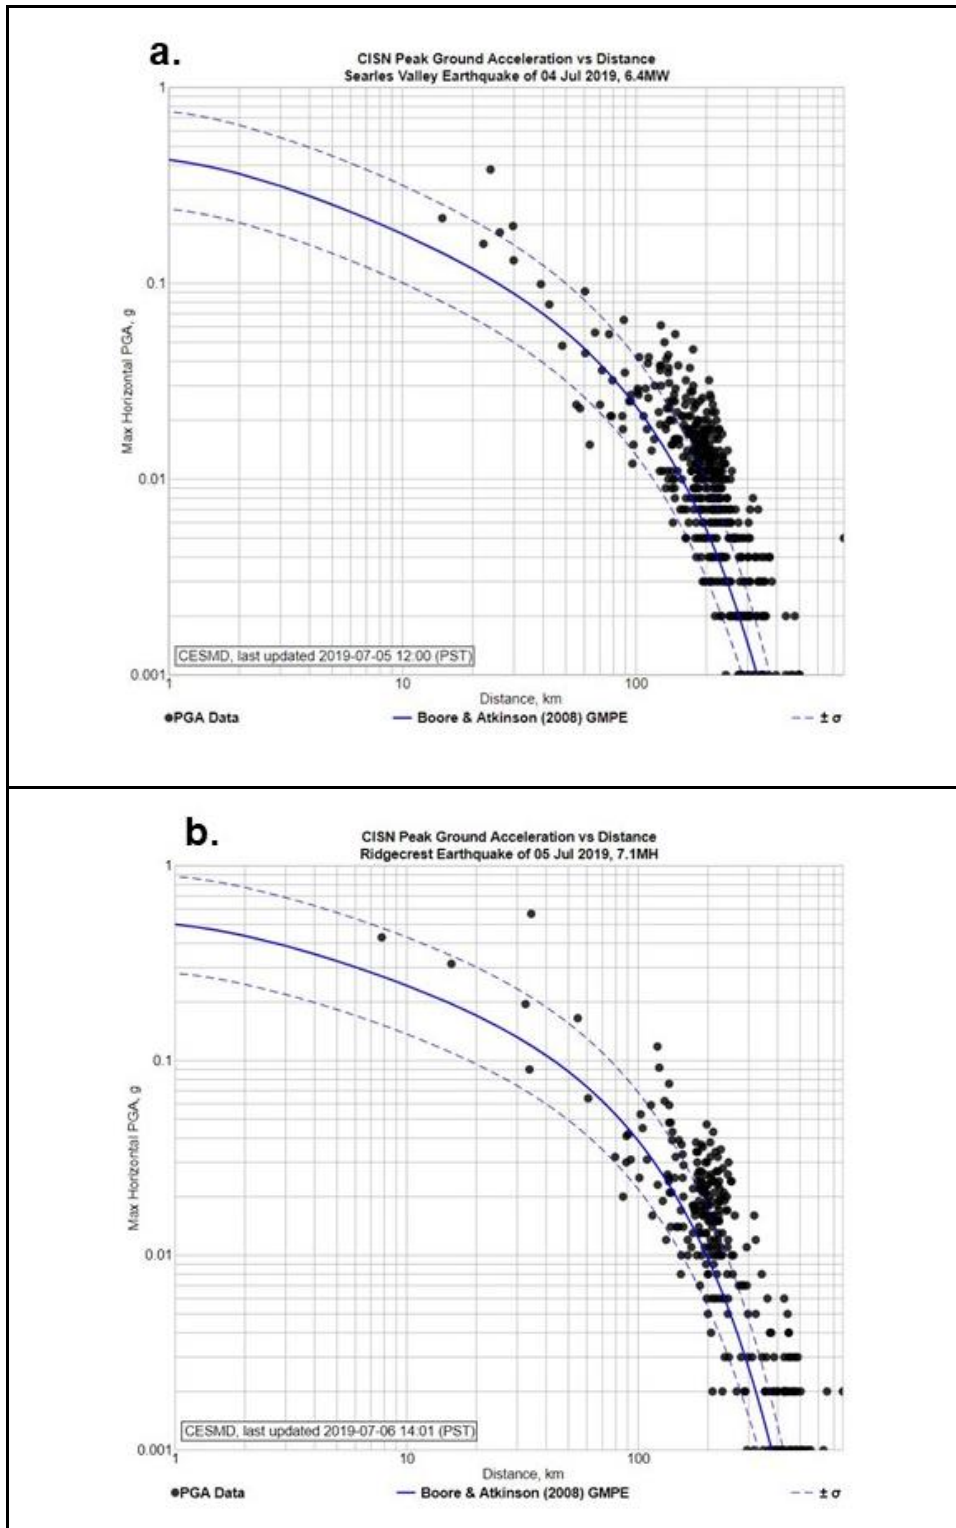
Figure 4. Maximum horizontal ground motion versus distance compared with Boore & Atkinson (2008) Ground Motion Prediction Equation (GMPE) for (a) M 6.4 event and (b) M 7.1 event where distance is fault distance if available, otherwise epicentral distance²

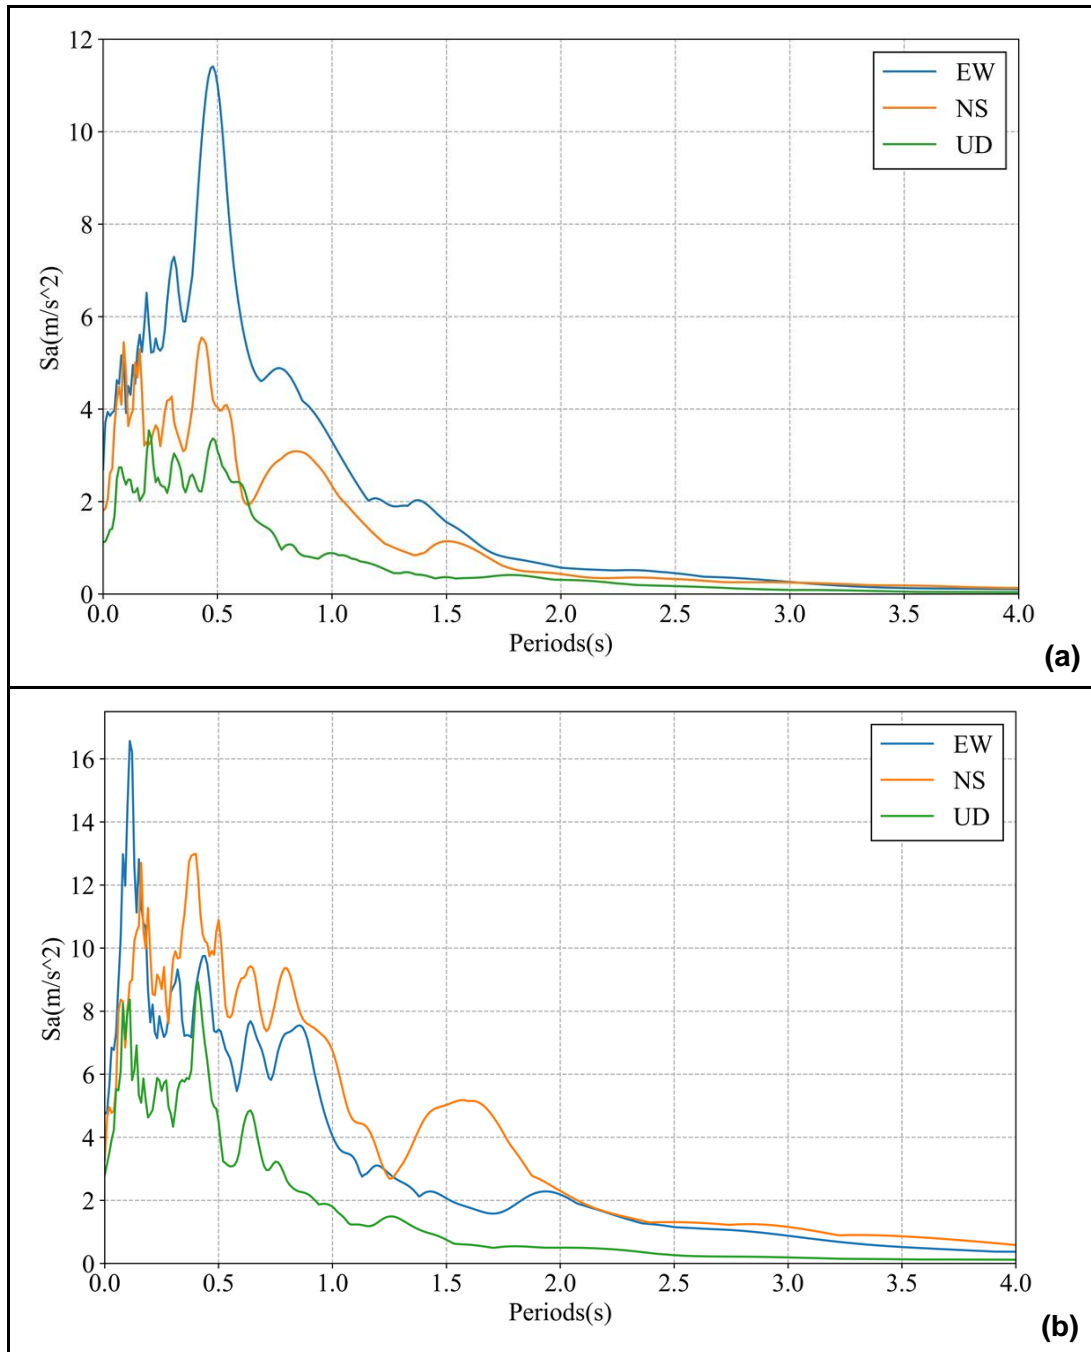
Response spectra (5% damped) of the two horizontal components and the vertical component of the ground motion with the largest PGA, at the Christmas Canyon China Lake station (code CCC), are shown in Figure 5. The highest spectral acceleration for this station is computed to be 1.17g at about 0.48 sec period for the M 6.4 event, Figure 5(a). For the M 7.1 event, Figure 5(b), the maximum spectral acceleration was computed as 1.69g at about 0.11 sec period. Long period effect was observed in the response spectra of the mainshock.

Figure 5. 5% damped response spectra at the CCC station for the (a) M 6.4 event and (b) M 7.1 event (Source: X. Lu, Tsinghua University & also similar to that reported in the CESMD database³)

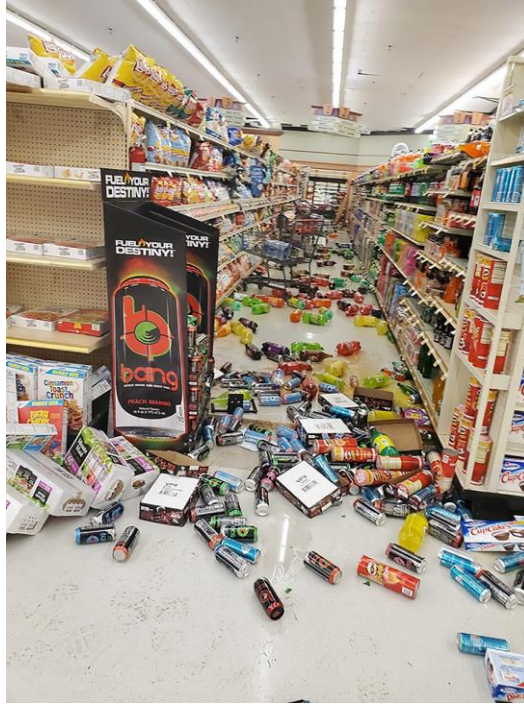
Figure 11. Items knocked from the shelves inside State Bros. Markets in Ridgecrest, California after the M 6.4 event (Source: CNN, 2019)

During the two earthquakes, many unsecured objects fell from shelves (Figures 11 to 13). Inside convenience stores aisles were flooded with broken liquor bottles and food items that had fallen off the shelves. There was also light to moderate non-structural component damage, such as collapse of suspended ceilings tiles/grids, concrete, glass and masonry facades, etc. (Figures 14 and 15). As with residential construction covered in the next section, several commercial masonry structures experienced various degrees of damage, Figure 16.

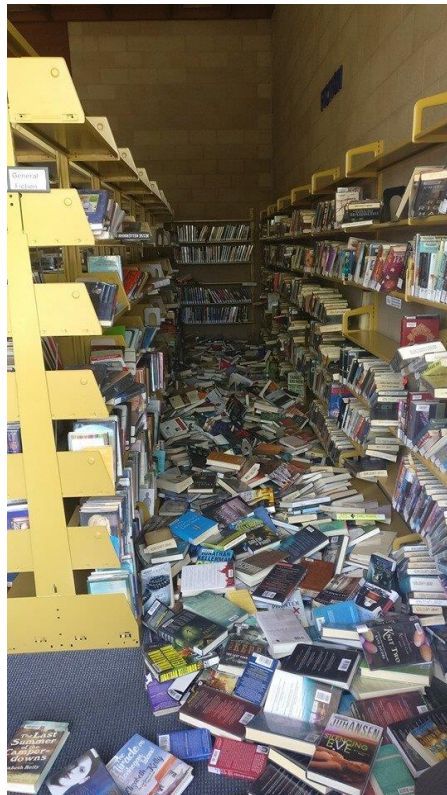
Figure 12. Books cover the floor at a Kern County Library in Ridgecrest after the 6.4 magnitude event (Credit: Richard Wagner, Source: KTLA, 2019)

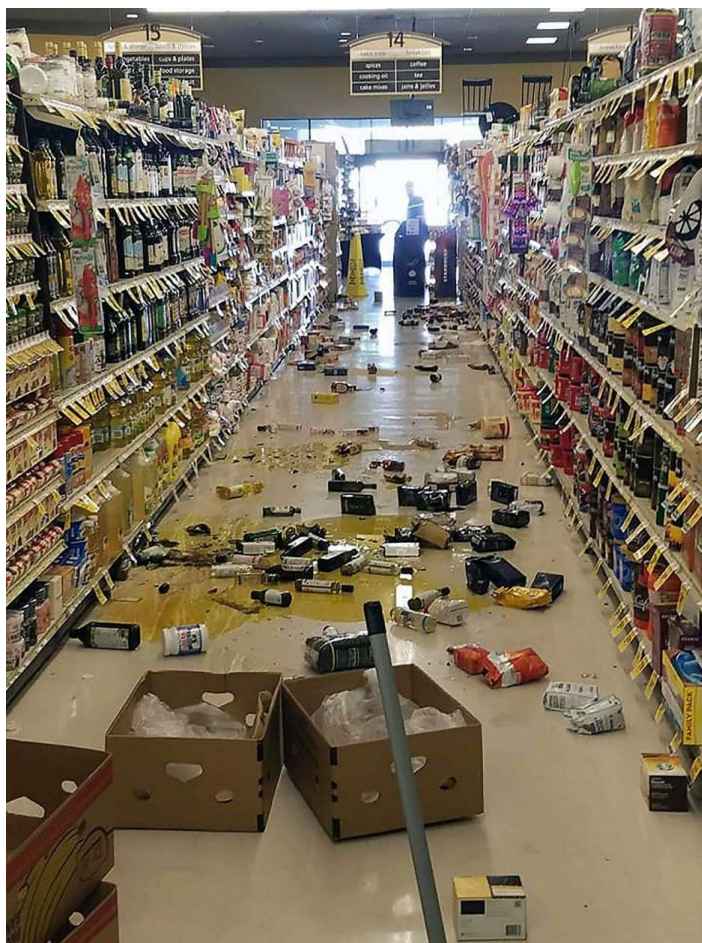
Figure 13. Broken bottles and other goods in a store in Lake Isabella after the magnitude 6.4 earthquake¹⁸

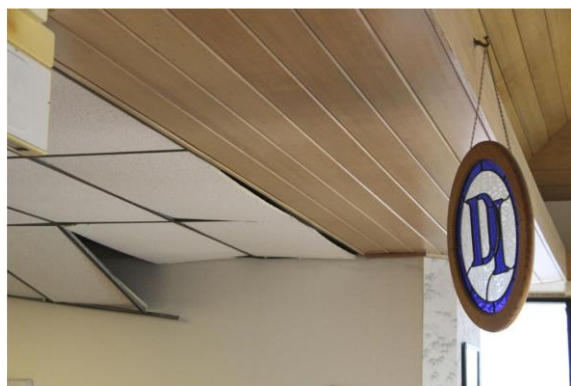
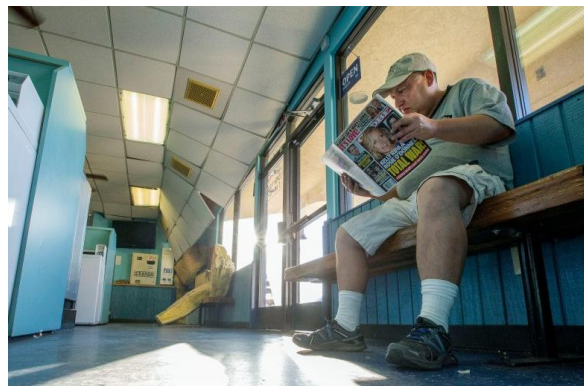
Figure 14. (a) The Daily Independent Newspaper office ceiling damaged during the M 6.4 event (Jessica Watson, AP); (b) Suspended ceiling partial failure at a laundromat in Ridgecrest after the M 6.4 event (Photo by Terry Pierson, The Press-Enterprise/SCNG)

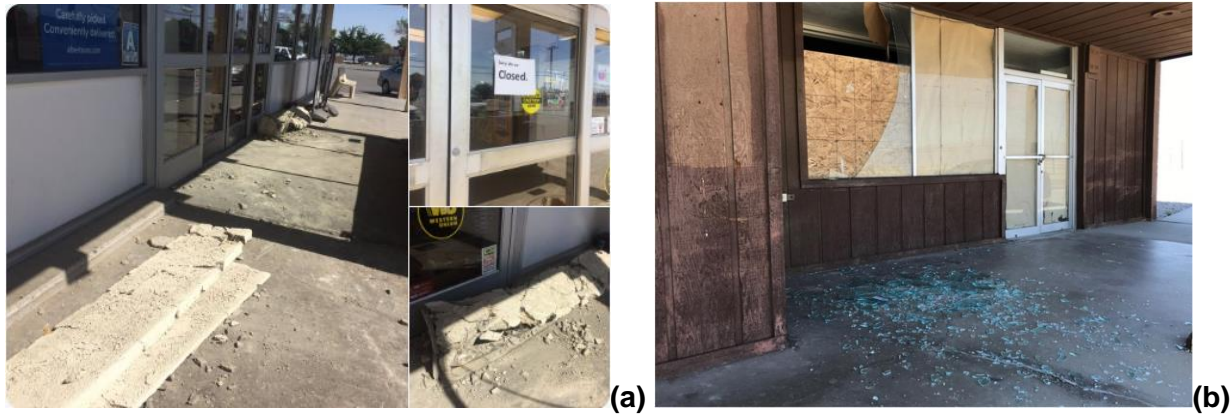
Figure 15. (a) Fallen concrete panels at a building in North Ridgecrest (Source: [Karen Hua via Twitter](#)); (b) Glass facade damage in retail building due to M 6.4 event (Source: AP)

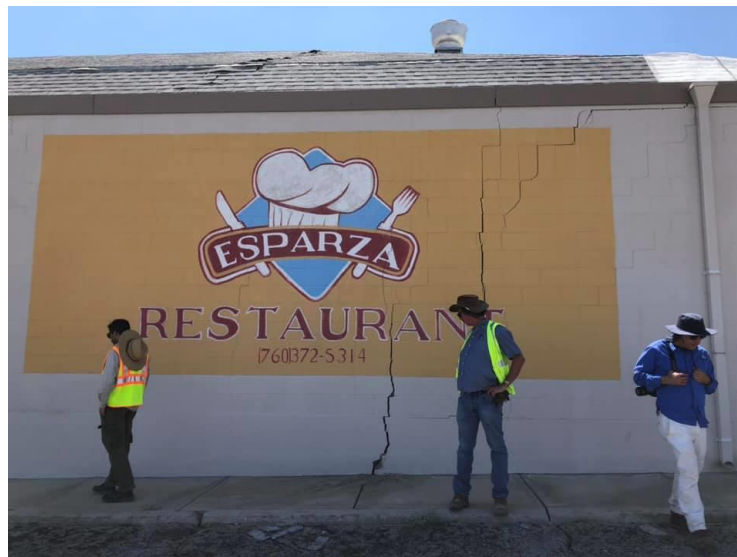
Figure 16. Cracks in masonry walls in Trona following the M 7.1 event (Photo by Christine Goulet, SCEC)

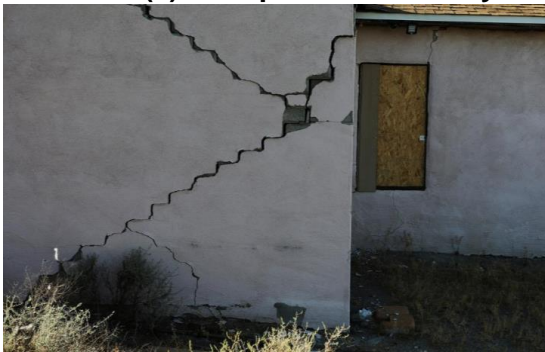
(b) Cracks in exterior walls

Figure 18. Damage to masonry structures (Sources: (a) Reuters, 2019; (b) Yahoo, 2019, and (c) [themegaagency](#), Instagram, 2019)

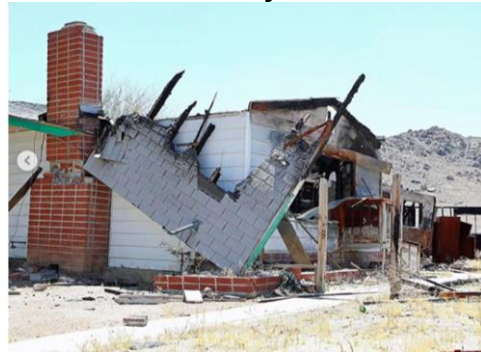
(c) Fire damage after M 7.1 event

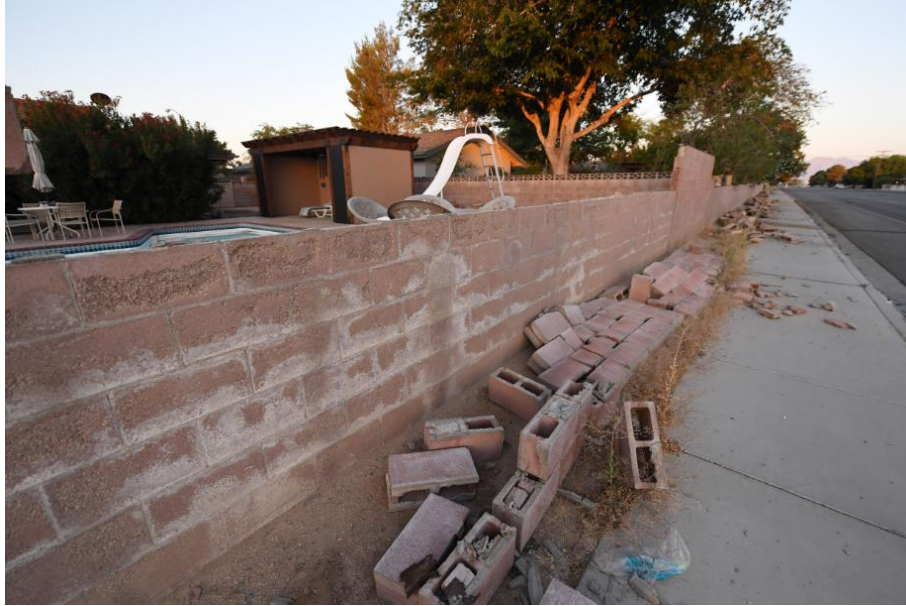
Figure 19. A cinderblock wall partially destroyed in Ridgecrest following the magnitude 7.1 Earthquake (CNN, 2019)

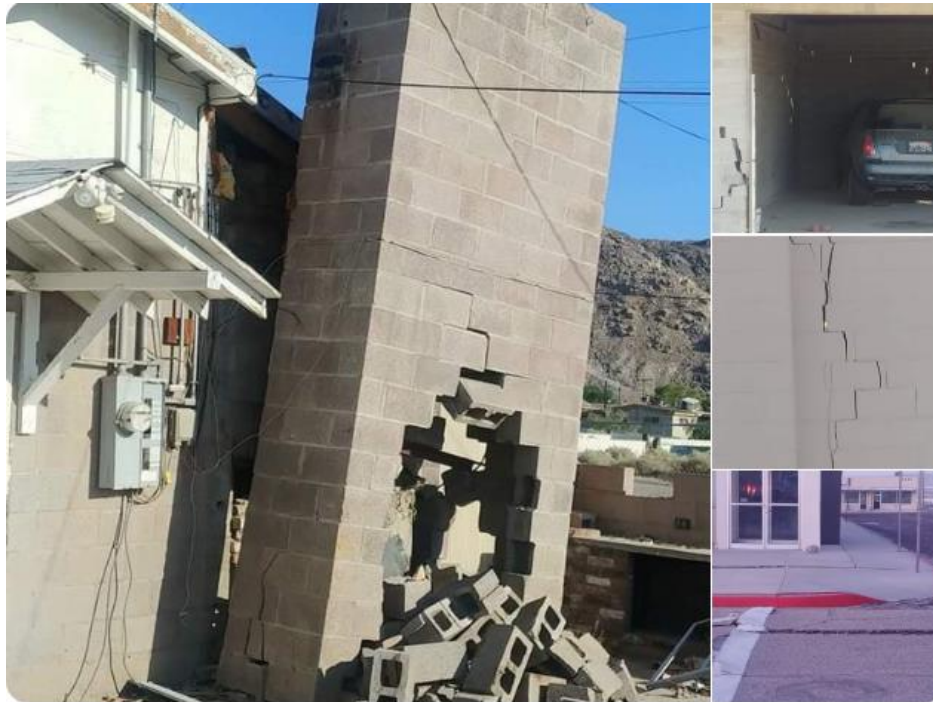
Figure 20. Damage to a masonry house in Trona after the M 7.1 earthquake (Source: [Eytan Wallace](#) via Twitter)

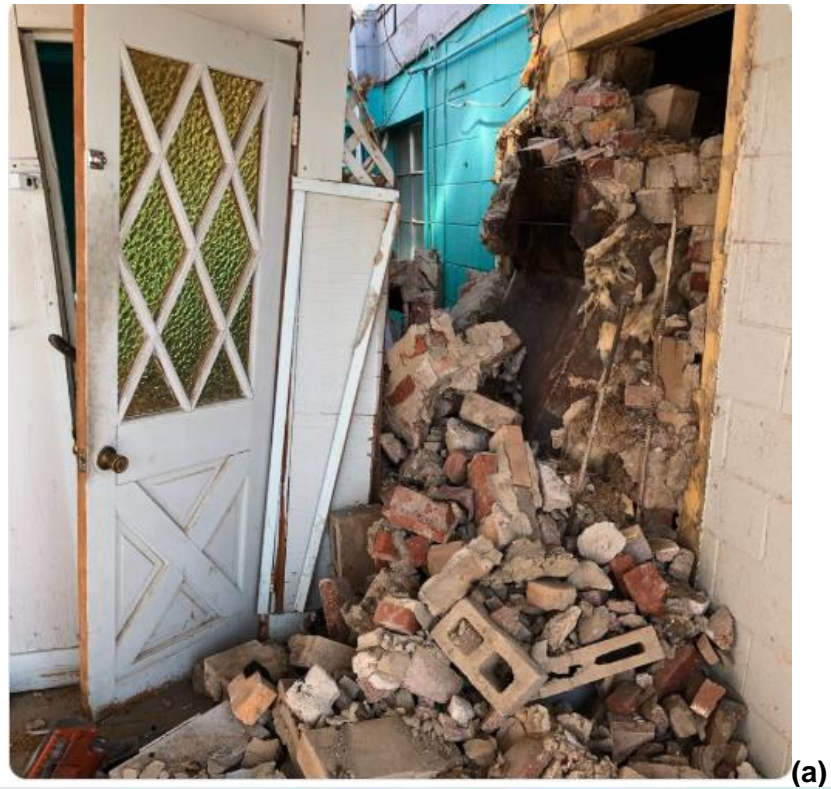
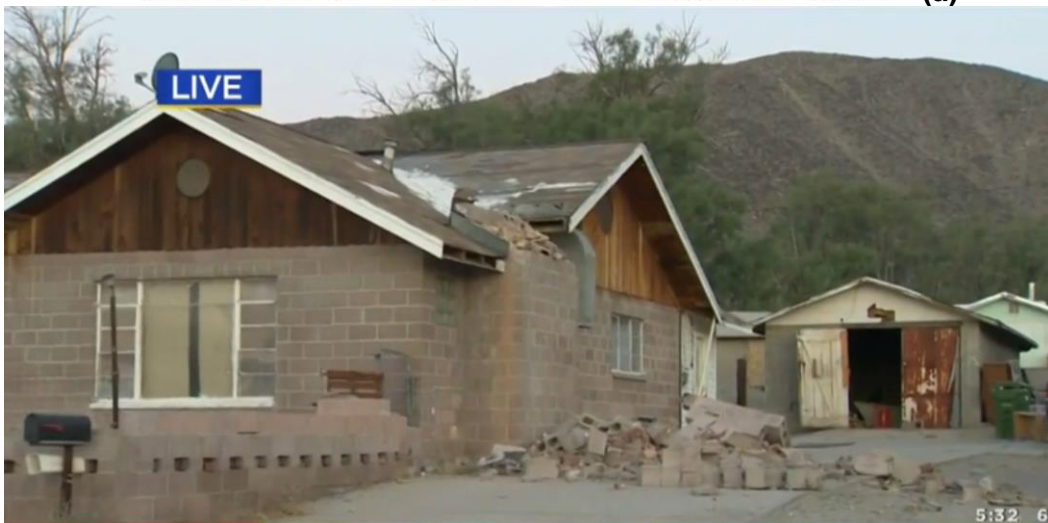
Figure 21. Damage to a masonry houses in Trona after the M 7.1 earthquake (Sources:a) [Rob Mcmillan](#) via Twitter, b) CBS Los Angeles)

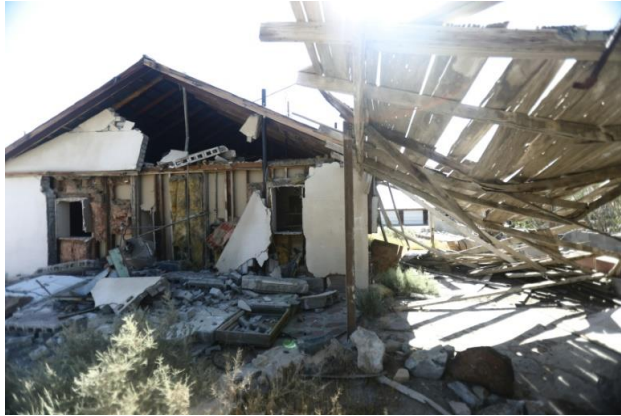
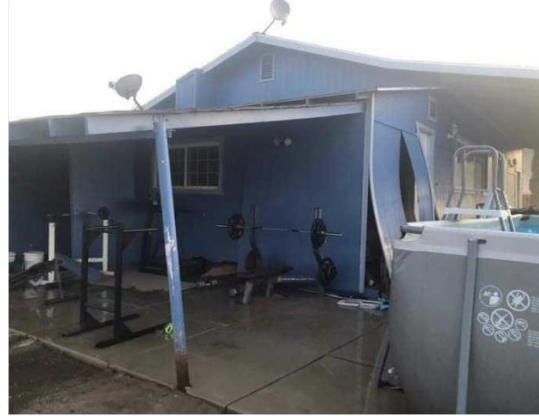
Figure 22. (a) Damaged house in Trona after the M 7.1 event (credit: Mario Tama, AFP); (b) Damaged walls of a home in Trona (Source: @23ABCNews via Twitter)

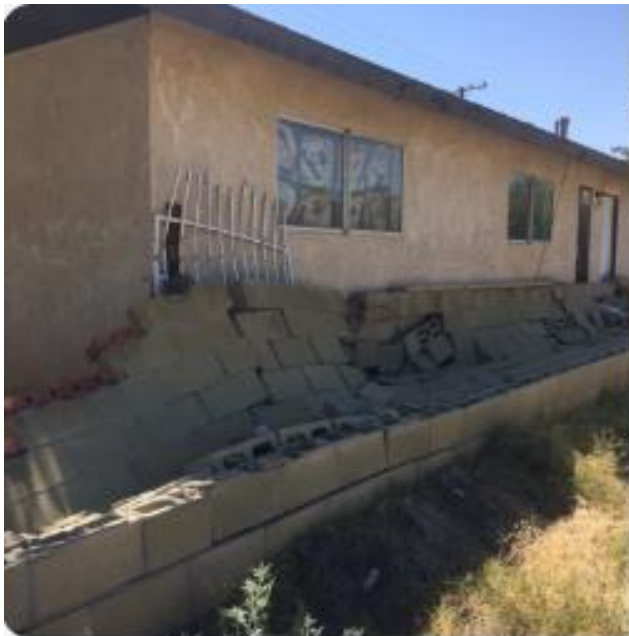
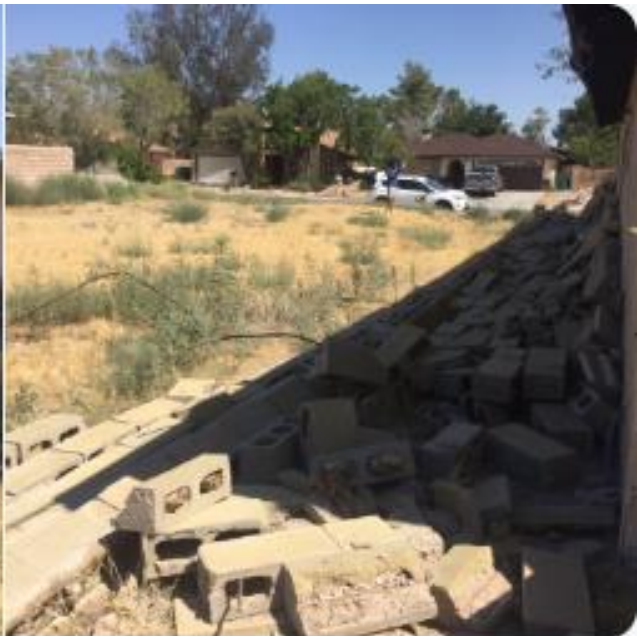
Figure 23. Collapsed cinder block walls of a masonry house (Source: [Karen Hua](#) via Twitter)

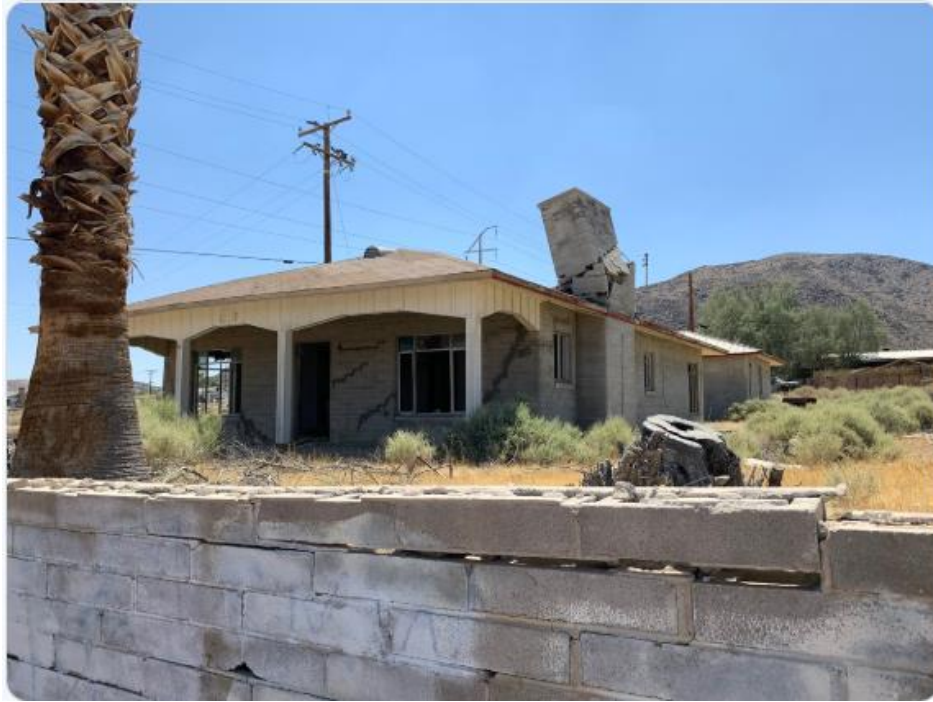
Figure 24. Broken masonry chimney and damaged masonry walls (Source: [Ken O'Doll](#) via Twitter)

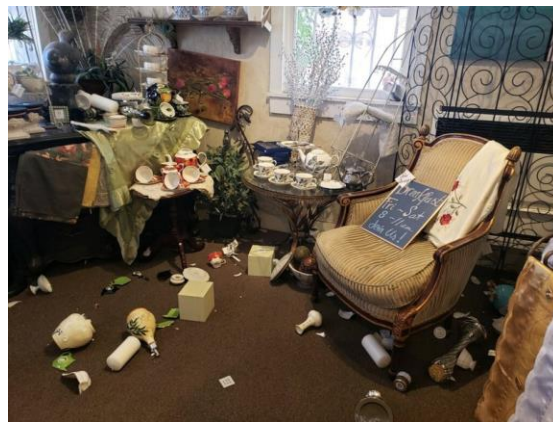
Figure 25. Contents damage in a cafeteria due to the M 6.4 event (AP News, 2019)

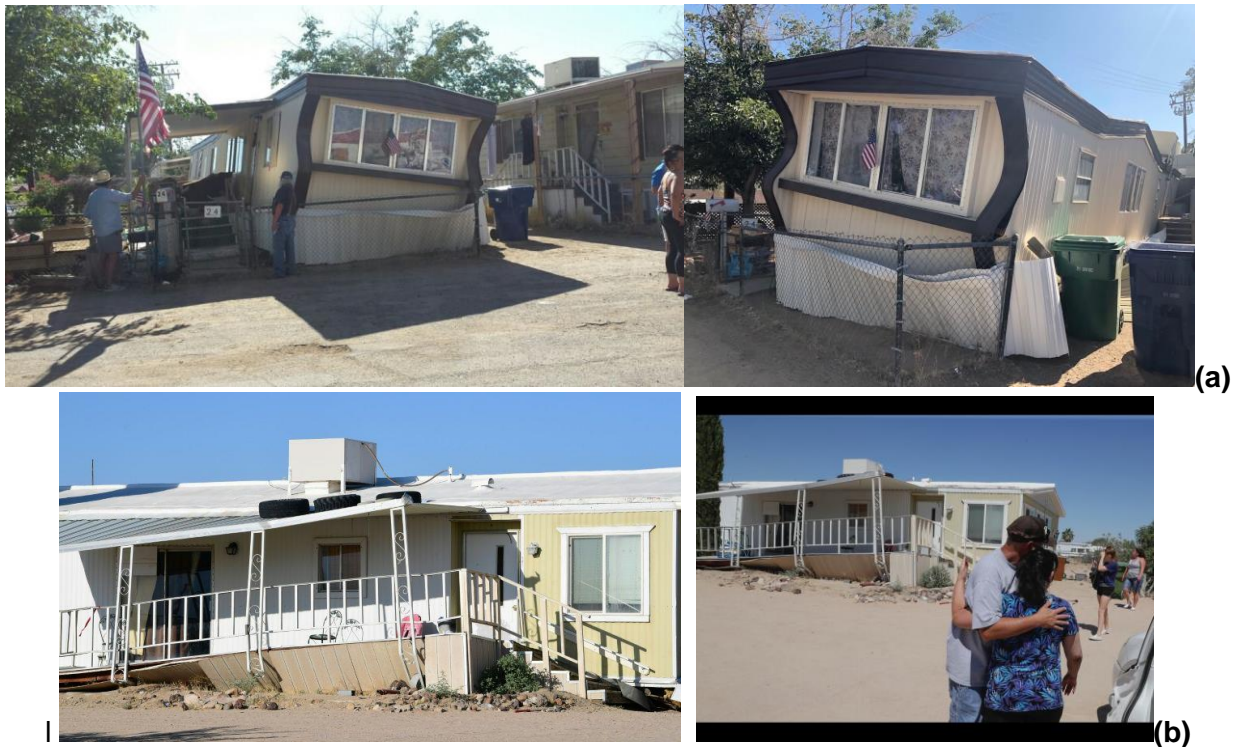
At least two mobile homes were damaged during the M 6.4 event. One is at Trousdale Estates at 210 W. Ward Ave. in Ridgecrest where a woman and her child were inside the building when the earthquake occurred but were unharmed, Figure 26(a). The mobile home appears to have been displaced off its supports, resulting in damage to the skirt surrounding the trailer chassis. Another mobile home also appears to have fallen off its supports resulting in damage to the metal columns supporting the roof over the porch, Figure 26(b). Out of 193 mobile homes in three mobile home parks north of Ridgecrest, eight mobile homes collapsed; none of which were tied down or had seismic braces (Keith Porter from the field.) It appears that most of these collapses were due to the M 7.1 event. According to Jonathan Stewart from the field: there are damaged structures in Trona, in many cases this is from the effects of ground failure. Following the M 7.1 event, Trona seems to be largely abandoned, due to loss of water (it is served by the water pipes ruptured by

Figure 26. Damage to mobile homes in Ridgecrest area due to the M 6.4 event (a) Source: Bakersfield News, 2019; (b) Source: Yahoo News, 2019

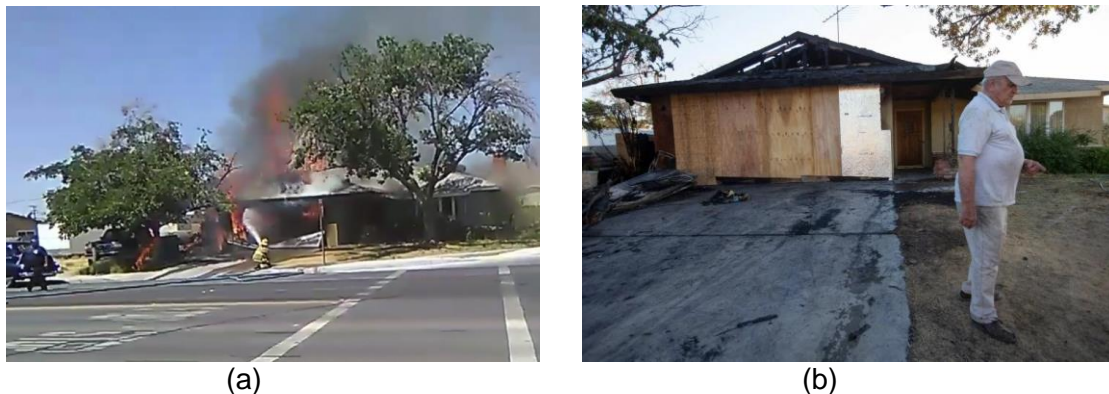
The M 6.4 earthquake caused two structural fires, a brush fire, and a few vegetation fires. This section will focus on the fires caused in structures. The structural fires occurred in Ridgecrest, CA and in Bakersfield, CA and were reported by the Kern County Fire Department. It is unknown at the time as to the cause of the fires, but multiple gas leaks were also reported after the earthquake. Figure 28(a) shows an active fire in Ridgecrest and Figure 28(b) shows the post-fire

Figure 28. Fire following M 6.4 event in Ridgecrest (a) active fire conditions (ABC, 2019), and (b) post-fire condition (Source: San Bernardino Sun, 2019)

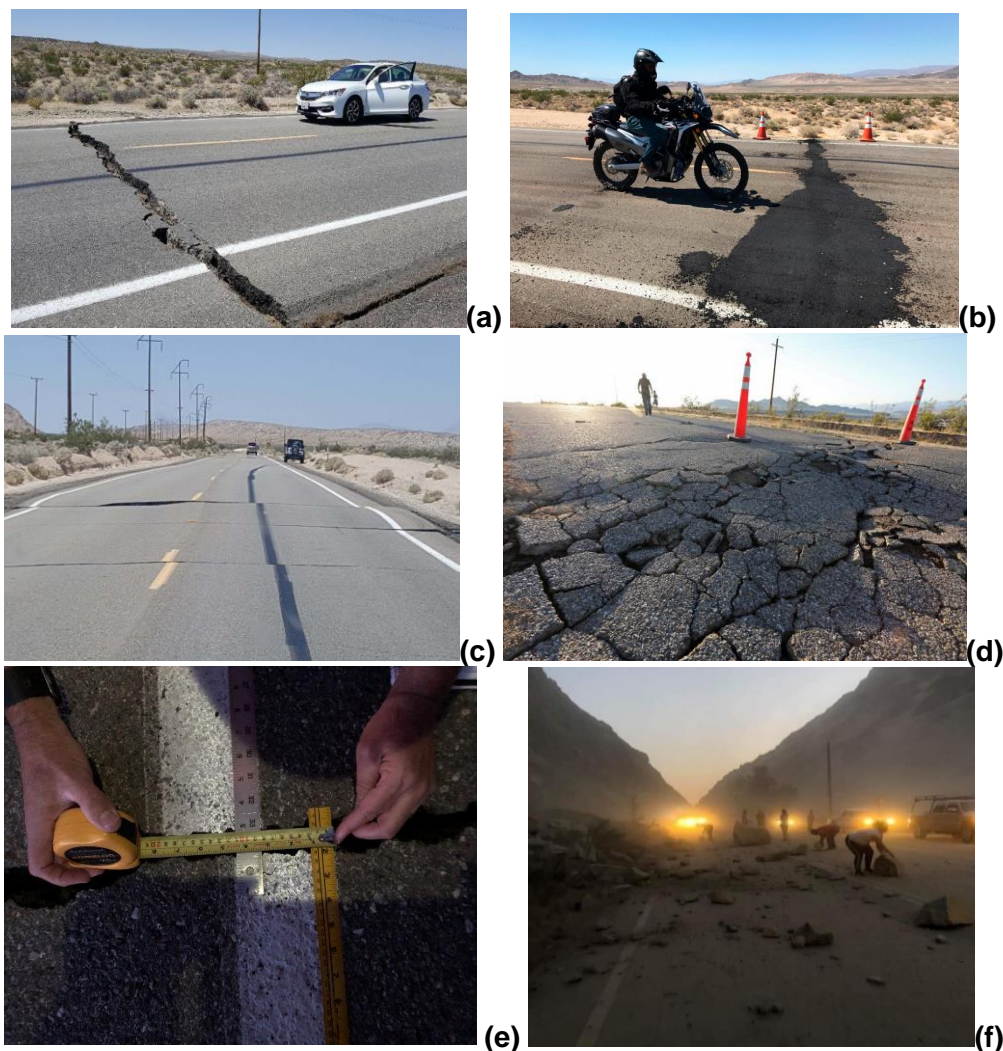
A large crack has formed in a highway near Ridgecrest following the earthquake event on July 4, 2019. The road damage included a 12-inch (305 mm) crack across Highway 178, about two miles west of Trona Road. Moreover, several cracks formed on the SR 178 between Trona and Ridgecrest after the M 7.1 event. The roads have been closed for repairs and were quickly repaired by Caltrans crews (KTLA, 2019, Figures 31 to 33). After the M 6.4 event, highways in San Bernardino County remained open. However, after the M 7.1 event, the SR 178 between Trona and Ridgecrest was closed for repairs. No damage to bridges and airports was reported.

Figure 31. Damage reported in Highway 178 (a) Large crack formed near Trona²⁰ (b) a motorcyclist rides over a temporarily repaired part of the damaged highway in Ridgecrest one day after the earthquake, demonstrating the rapid response of repair crews; (c) damage reported in Ridgecrest during the M 6.4 event²¹; (d) surface cracks near Ridgecrest following the M 6.4 event²² (AP Photo/David McNew) (e) Crack length near Ridgecrest after the July 4th event²³; (f) rockslides cause closure of the highway from the M 7.1 event on Friday night; announced clear Saturday at 1 AM by Kern Country²⁴

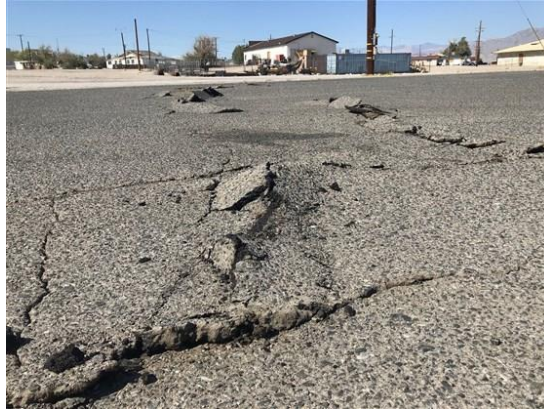
Figure 32. A road in Trona slightly damaged during M 6.4 event (AP Photo/M. Hartman²⁵)

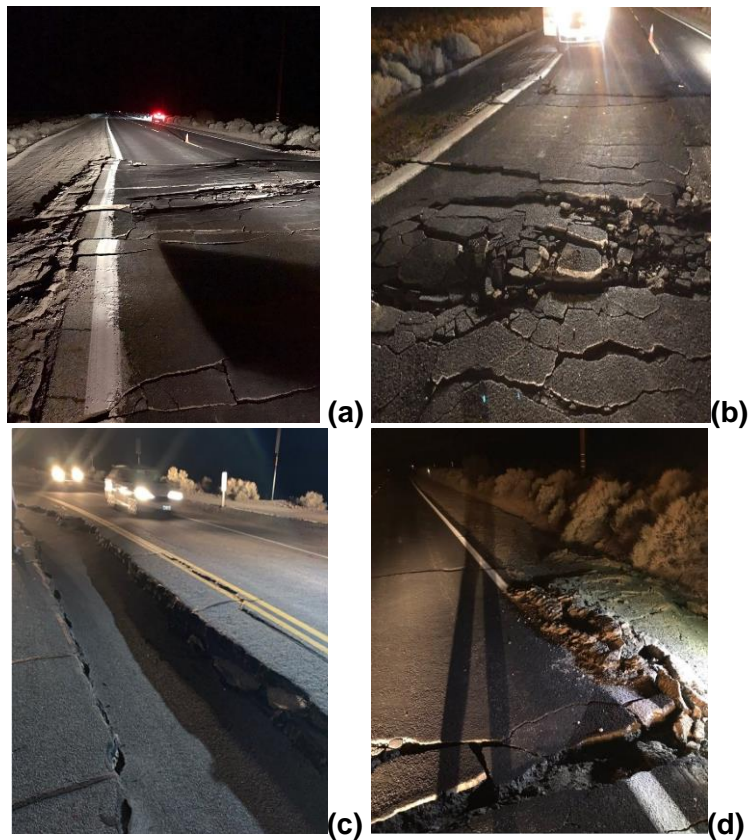
Figure 33. (a) Several cracks on the SR 178 WS between Trona and Ridgecrest after the M 7.1 event. The road was closed for repairs; (b) Details of the cracks²⁶; (c) Other picture of the cracks²⁷; (d) Rockfall cleared on SR 178 between Trona and Ridgecrest but route still closed for temporary repair²⁸

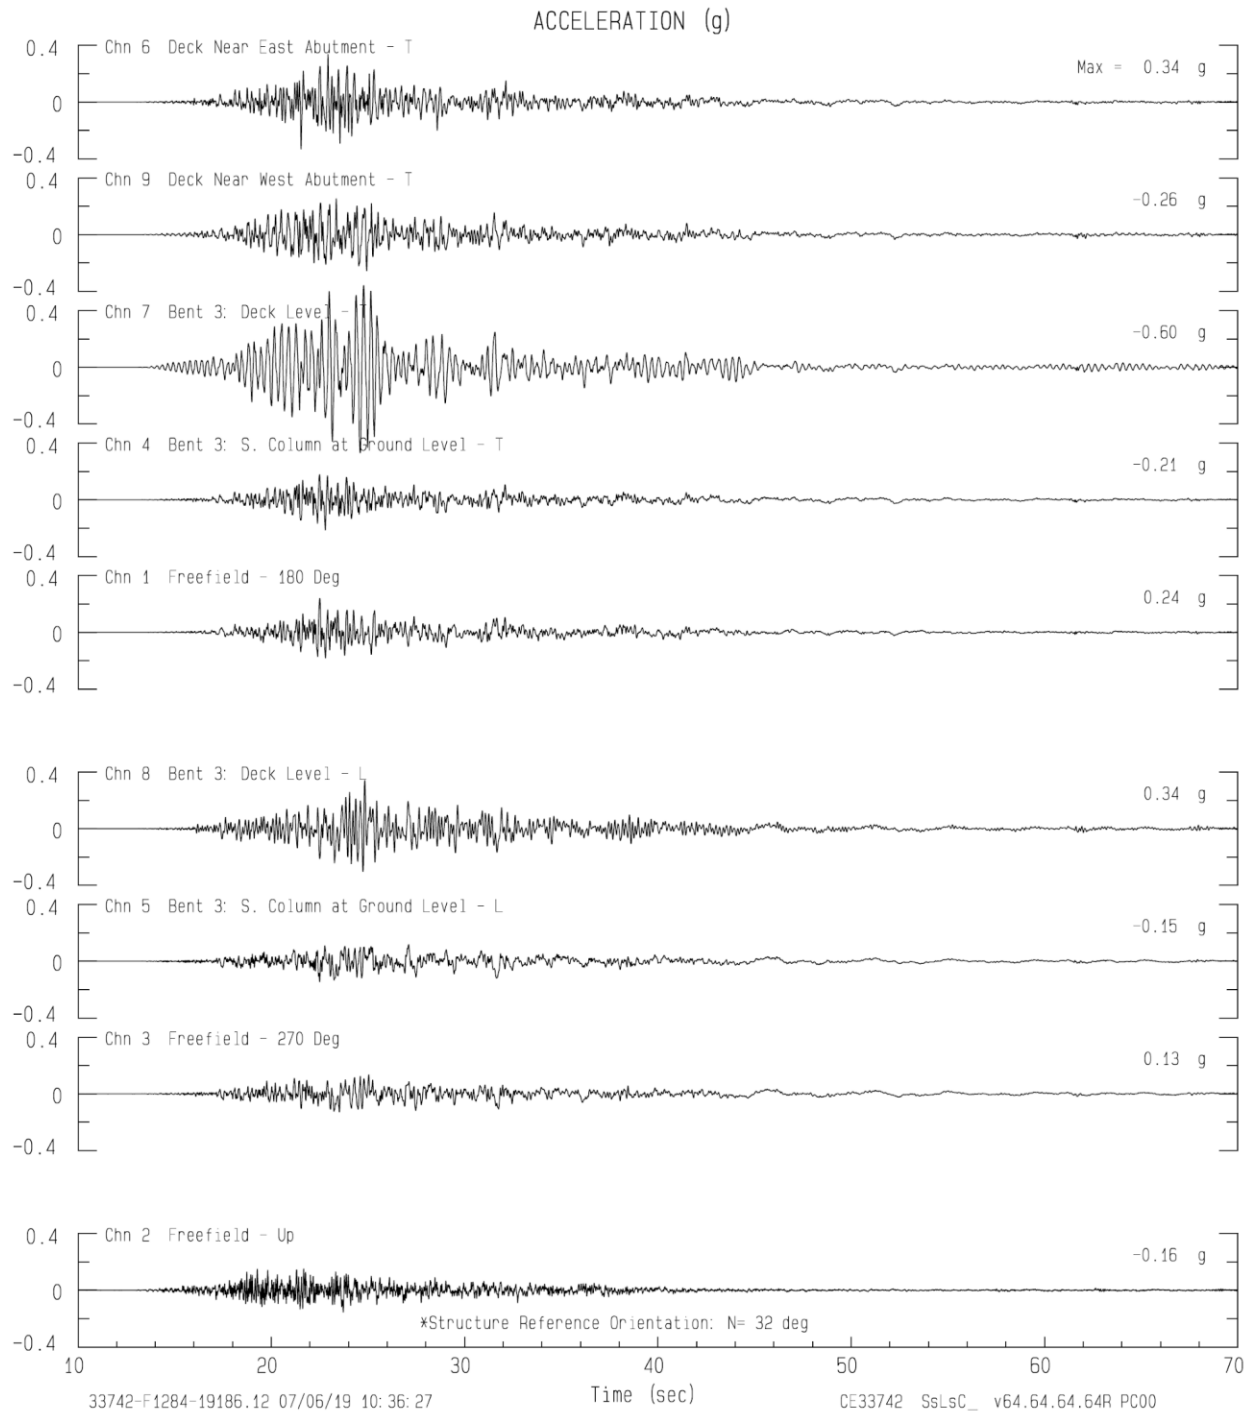
Figure 35. Measured accelerations of Bridge No. 50-340 of Brown Road during M 7.1 event (for Channel numbers, refer to Figure 34(b))

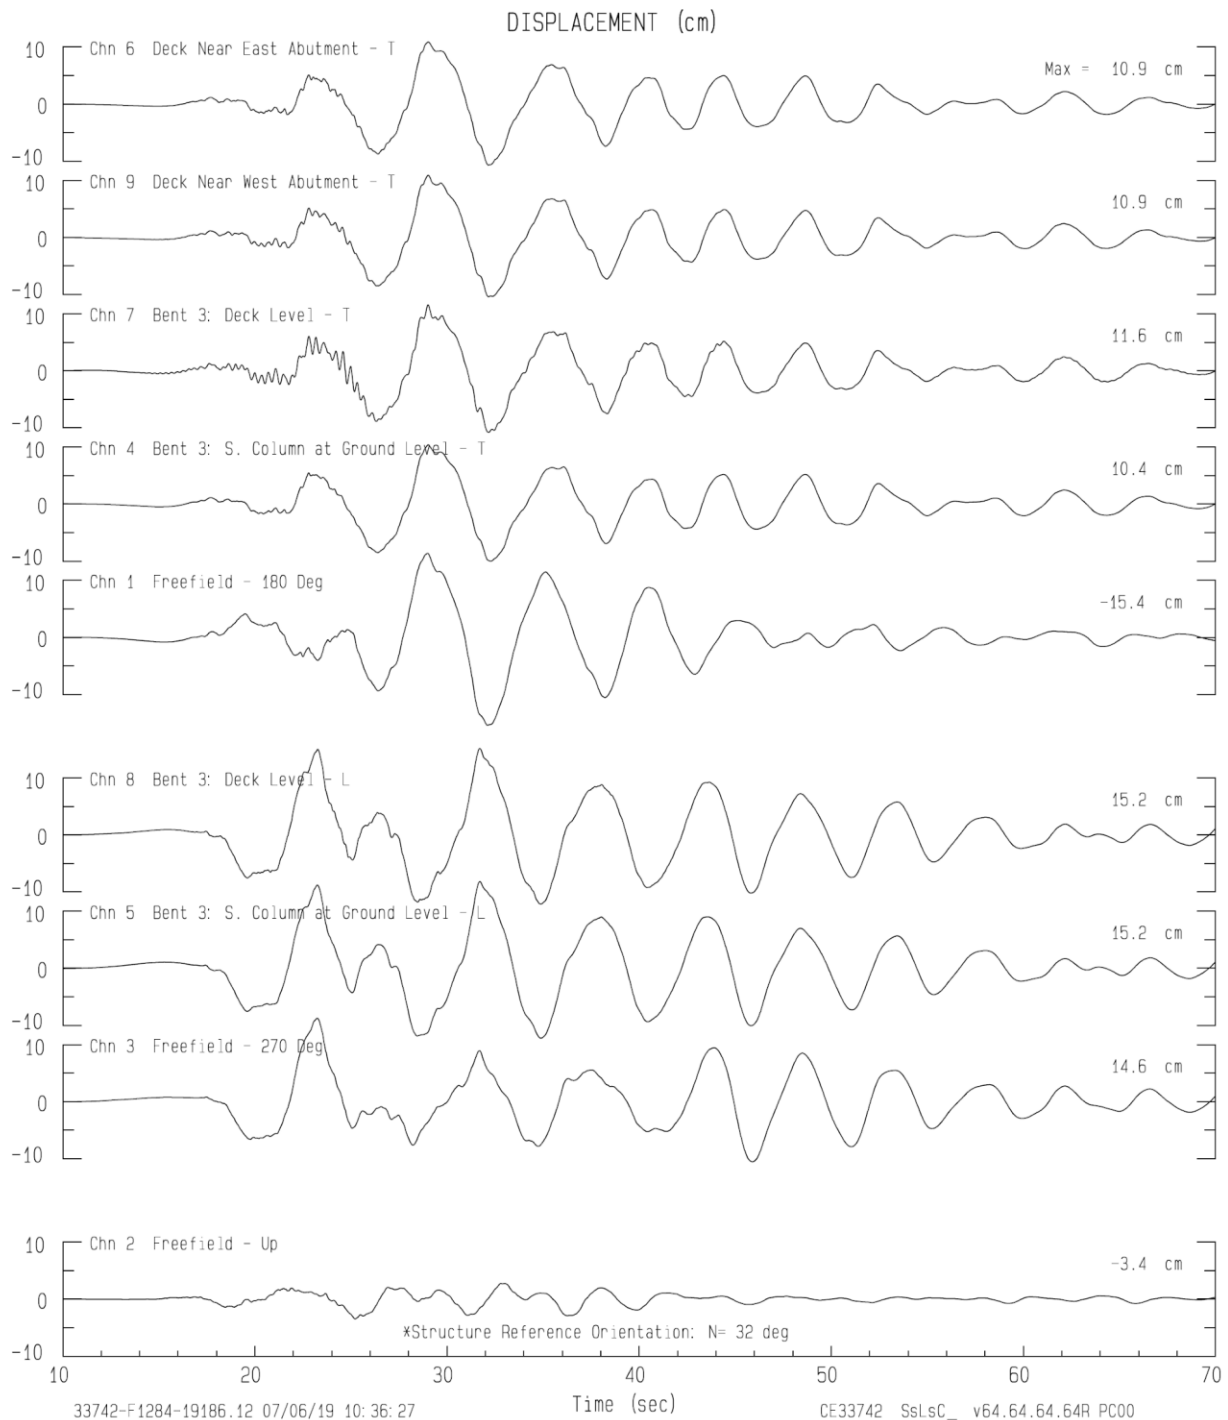
Figure 36. Computed displacement from measured accelerations of Bridge No. 50-340 of Brown Road during M 7.1 event (for Channel numbers, refer to Figure 34(b))

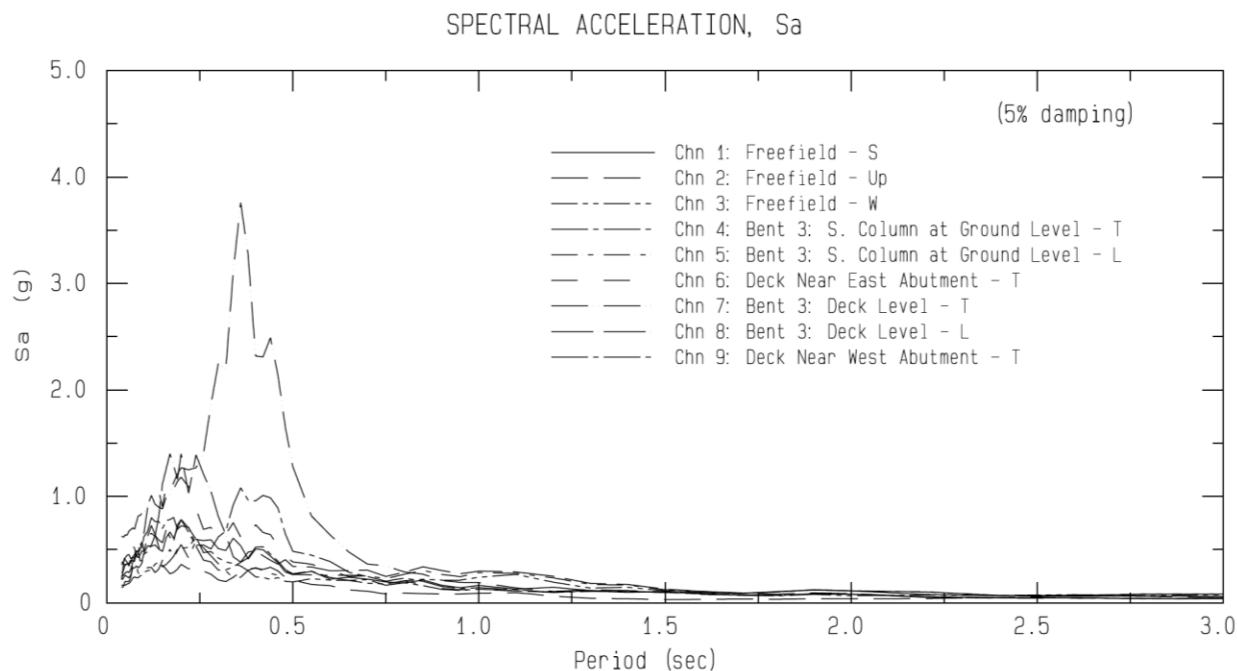
Figure 37. Computed 5% damped spectral accelerations from measured accelerations of Bridge No. 50-340 of Brown Road during M 7.1 event (for Channel numbers, refer to Figure 34(b))

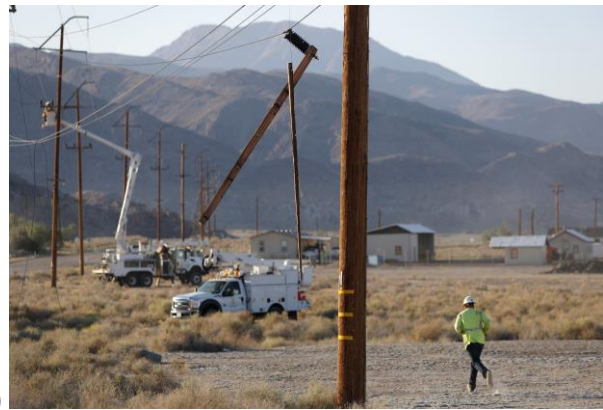
Figure 38. (a) A utility pole in Trona was damaged during the earthquake³²; (b) Workers repair damaged utility lines in Trona, CA (AP Photo/Mario Tama | Getty Images³³

Power was knocked out in Trona, Figure 38, a small town closest to the epicenter, located about 25 miles north of Ridgecrest. In addition, residents reported water main breaks and gas line breaks³⁰. It was reported that 2,000 customers in Kern County and another 3,000 in San Bernardino and Inyo lost power after the M 7.1 event. Service had been restored quickly³¹. Some water pipes were damaged during the M 6.4 event. Refer to Figures 39 and 40.

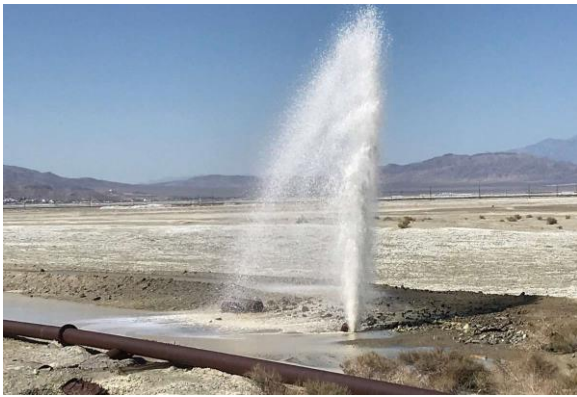
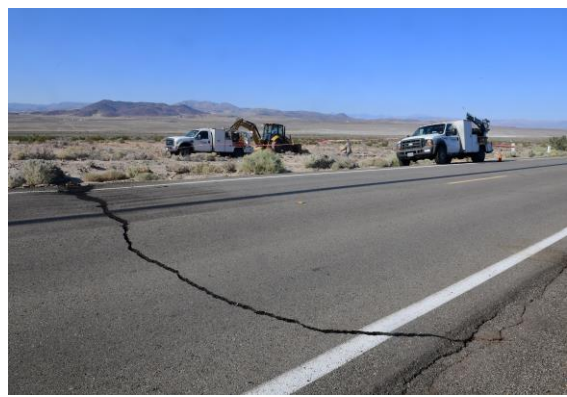
Figure 39. (a) Water spews from pipes in Trona damaged by the M 6.4 event (AP Photo/Matt Hartman³⁴; (b) A crack on Highway 178 seen during fixing a broken water line south of Trona (Source: AP Photo/F.J. BROWN | AFP/GETTY IMAGES³⁵
