StEER
STRUCTURAL
EXTREME EVENTS
RECONNAISSANCE

M 6.4 and M 7.1 Ridgecrest, CA Earthquakes PRELIMINARY VIRTUAL RECONNAISSANCE REPORT (PVRR)

Released: July 8, 2019 | **NHERI DesignSafe Project ID:** PRJ-2444

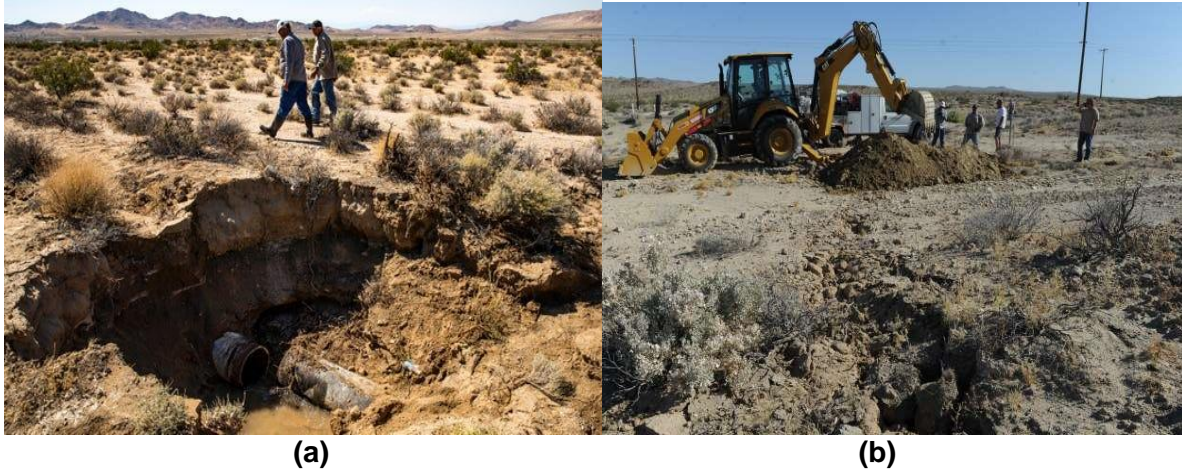
Figure 40. (a) Exploded water pipe reported during the M 6.4 event, consequently forming a crater near Ridgecrest (Source: AP Photo/Etienne Laurent, EPA-EFE³⁶; (b) Crews dealing with a water main that ruptured during the earthquake³⁷

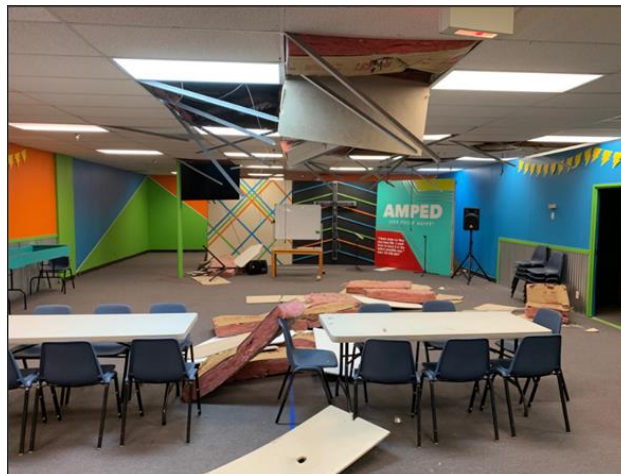
This event caused significant damage to non-structural elements such as infill walls, partition walls (usually built of masonry), ceilings and veneers and various types of building contents. In addition to the equipment damage shown with photographs in previous sections, there was damage to suspended ceilings, Figure 41.

Figure 41. Suspended ceiling damage at Baptist Church in Ridgecrest³⁸

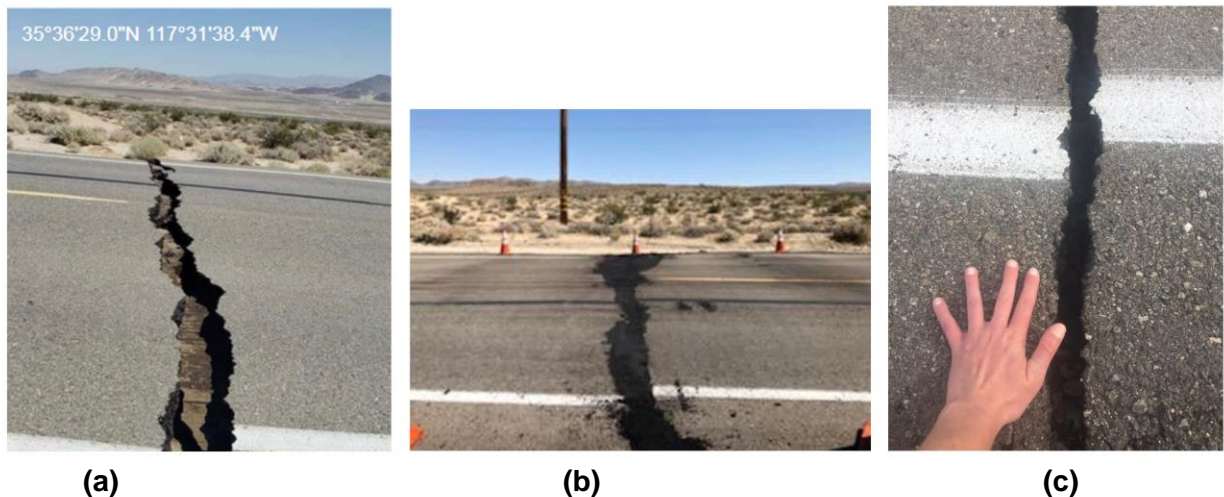
The M 6.4 earthquake caused geotechnical damage in the form of surface fault rupture, ground separation, and ground fissures. An approximately 12" (305 mm) wide crack was formed across Trona Road about 2.5 miles South of State Route 178 (see VERT report included in Appendix B). Another large crack was formed across State Route 178 about 2 miles West of Trona Road. Several other cracks along State Route 178 were reported by the Caltrans District 8 Twitter page; according to the same source these cracks were repaired by the Caltrans District 9 Maintenance crews within an hour after the event. According to the [USnews](#), California Highway Patrol announced that overpasses and underpasses were not damaged and these cracks were primarily in the county roads.

Figure 42. Geotechnical damage following M6.4 Ridgecrest (a) 12"(305 mm) wide crack across Trona road³⁹, (b) Caltrans District 9 Maintenance crews make repairs to cracks along SR 178 near Trona (Source: Caltrans District 8 Twitter page⁴⁰), and (c) ground separation and offset (photo by Emily Guerin⁴¹). All images reported in the VERT report, Appendix B.

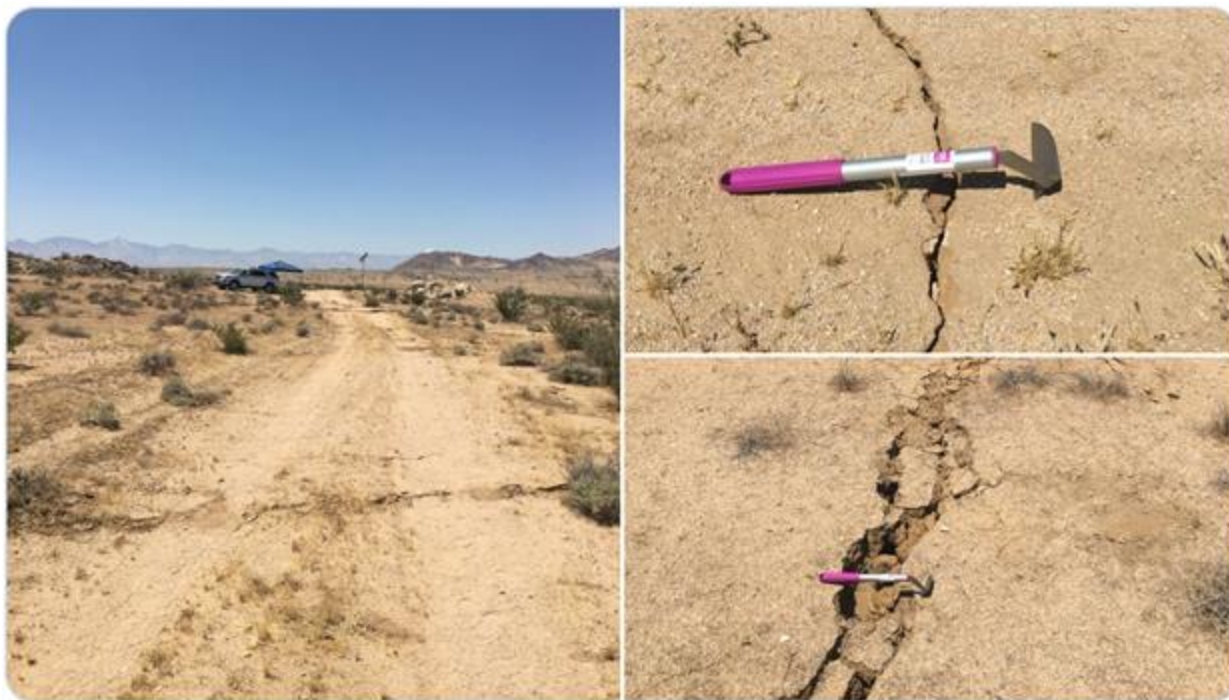
Figure 43. 100 ft (30.48 m) wide zone of parallel ruptures showing left lateral (LL) and some dilation along the Ridgecrest surface rupture reported by Danielle Verdugo Madugo⁴²

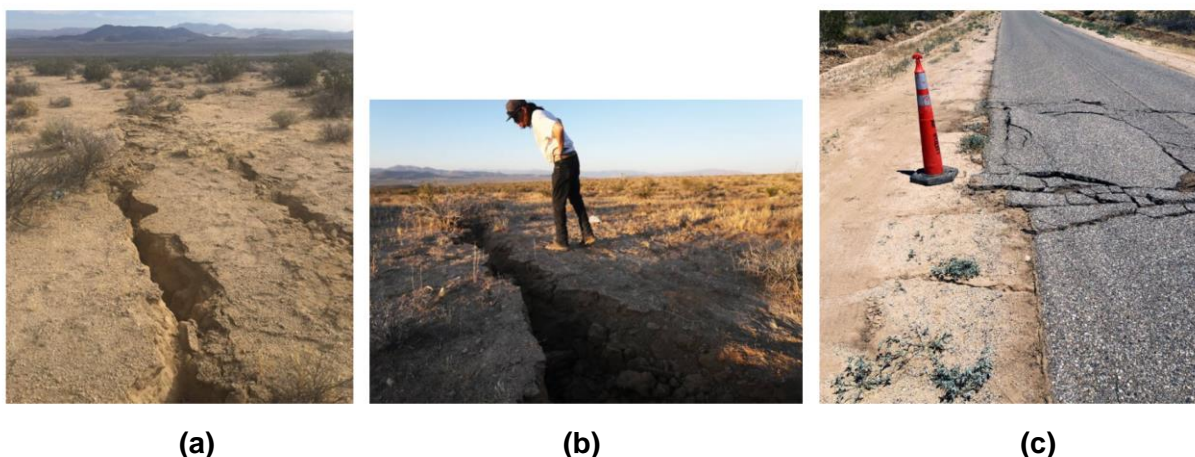
Figure 44. Surface Fault Rupture following M 6.4 Ridgecrest earthquake (a) Off the road rupture (reported by Emily Guerin⁴³), (b) Ground crack near Ridgecrest⁴⁴, (c) fault rupture across Randsburg Wash Road to the south of State Route 178, measured offset of approximately 1.5 feet (457 mm) (Source: Brian Olson Twitter page⁴⁵). All images reported in the VERT report, Appendix B.

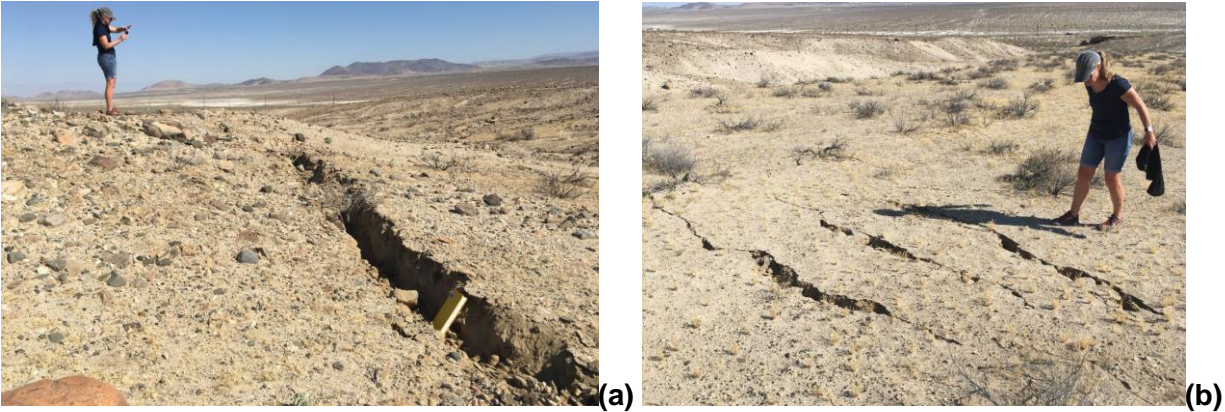
Figure 45. (a) Lateral displacement of about 100 cm; and (b) Wide distributed shears⁴⁶

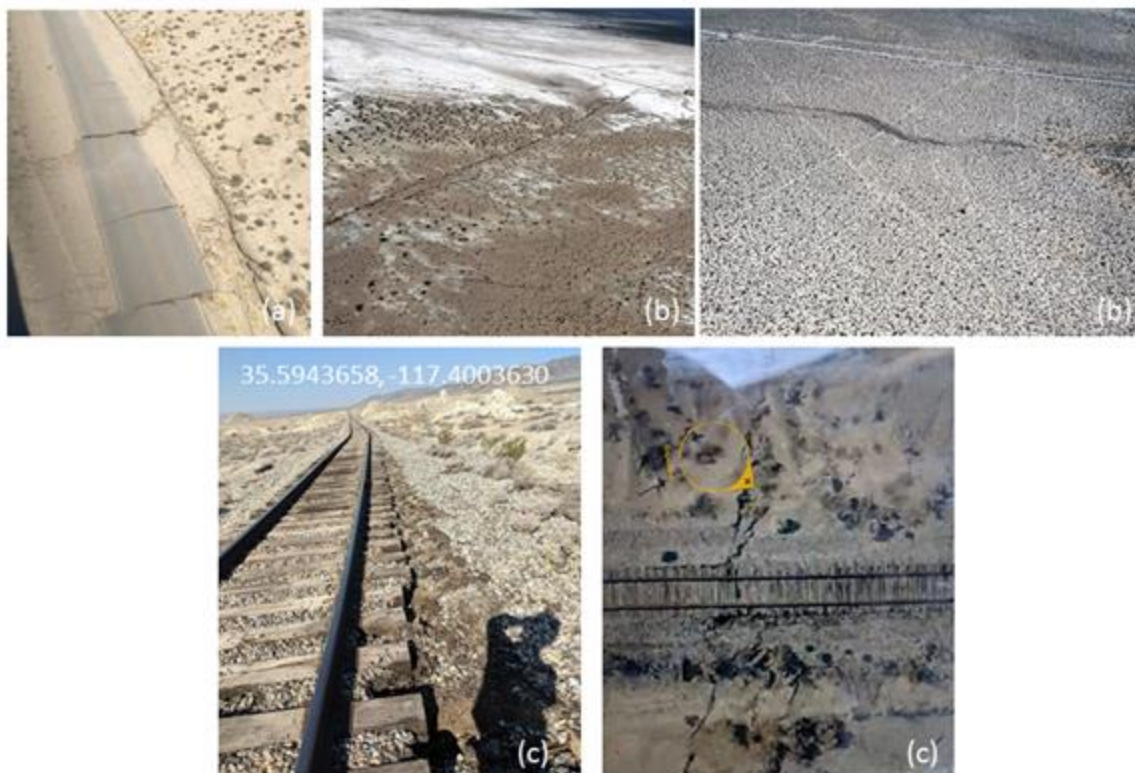
The M 7.1 earthquake caused geotechnical damage in the form of surface fault rupture (e.g. offset, ground fissures etc.), rockfalls, and liquefaction-induced failures (e.g. lateral spreading). A North-West trending fault rupture measured up to 6 feet (1.83 m) of right-lateral offset on the China Lake NWS base⁴⁷. A right-lateral offset of about 6.5 feet (1.98 m) and a vertical offset of about 3 feet (0.91 m) were reported⁴⁸. A surface rupture across State Route 178 caused a right-lateral offset, likely related to the North-West trending conjugate fault⁴⁹, photo taken from the VERT report, Appendix B. Fault rupture also bended railroad tracks and caused damage to the nearby road; a 3-feet (0.91 m) right lateral offset was reported⁵⁰.

Figure 46. (a) Aerial view of the faulted road on the China Lake NWAS base, about 6.5 feet (1.83 m) right lateral (RL) and 3 feet (0.91 m) vertical offset⁵¹, (b) North-West trending fault rupture measuring 6 feet (1.83 m) of right-lateral offset on the China Lake NWAS base⁵², and (c) Bent railroad track due to the fault rupture , close to 3 feet (0.91 m) of RL offset⁵³

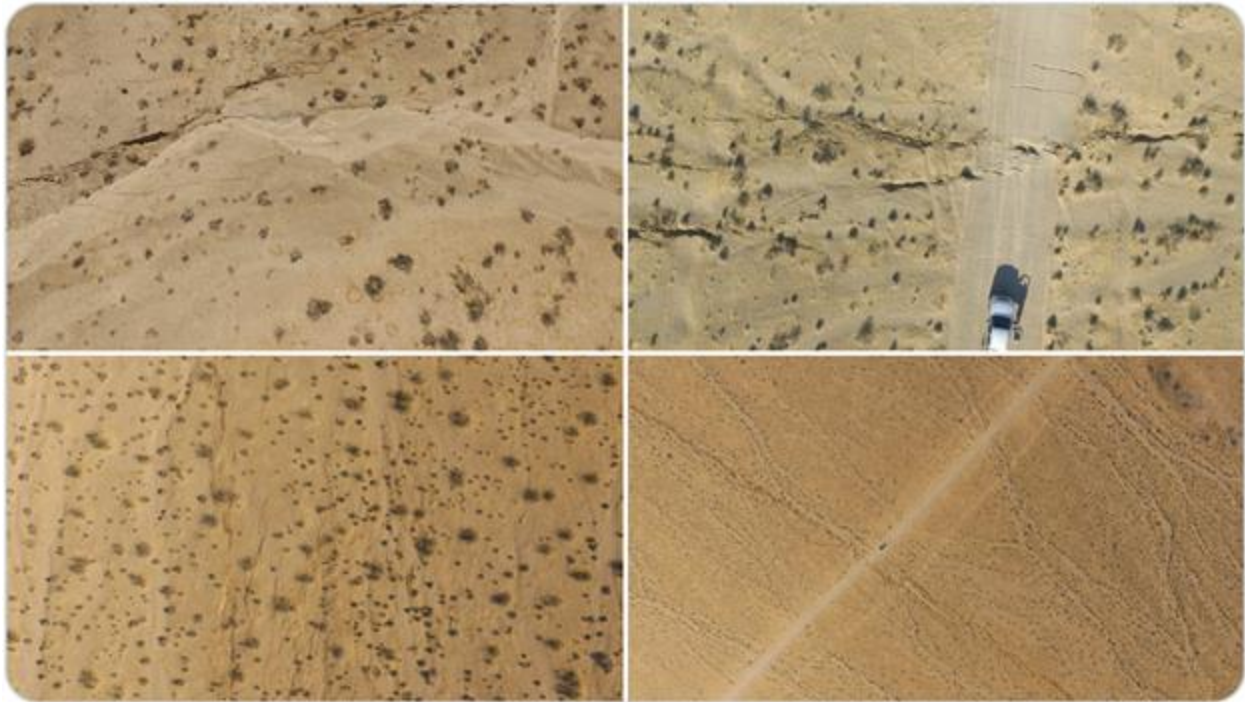
Figure 47. Aerial views of ground failure indicating left-stepping and right-stepping lateral faults reported by Ian Pierce⁵⁵

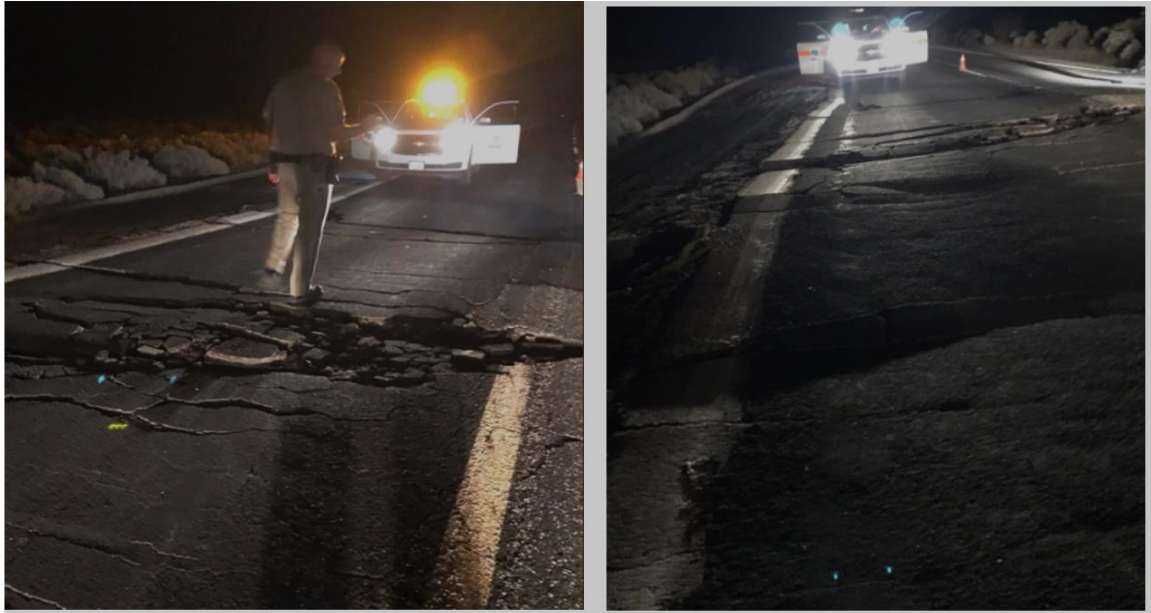
Figure 48. Multiple ground cracks along SR 178 (Source: Caltrans8 Twitter page⁵⁶, taken from the VERT report, Appendix B)

Multiple ground cracks along State Route 178 near Post Mile 8.5 were patched before opening the road to traffic (the duration of closure is now known at this time). According to the Caltrans District 8 Twitter page, Caltrans started permanent construction repairs on State Route 178 approximately six miles east of Ridgecrest. The repairs were done in three separate areas within four mile stretch along the State Route 178. All bridges and highway structures have been evaluated by Caltrans engineers and they have been determined safe for normal operations⁵⁴.

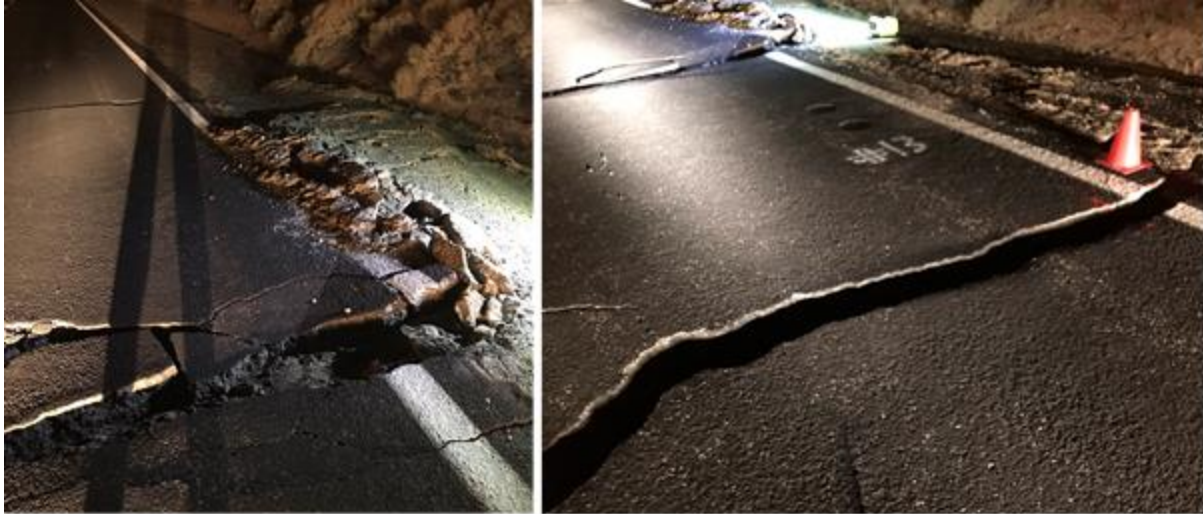
Figure 49. SR 178 near PM (post mile mark) 8.5 Caltrans crews making repairs to patch road before open to traffic⁵⁷ (picture taken 12:53am 07/06/2019)

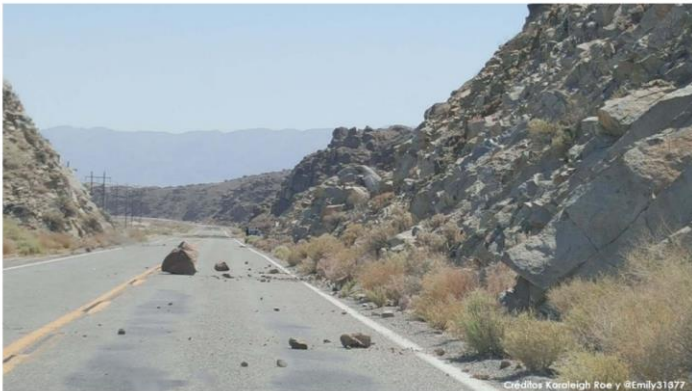
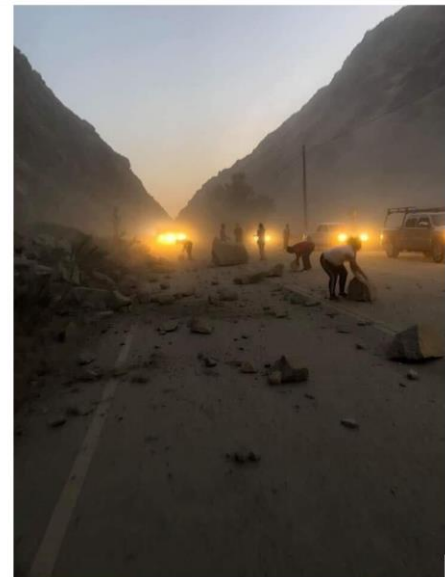
Rockfall caused road closure in State Route 178 between Bakersfield and Lake Isabella. This road was later opened to traffic. Rockfall in State Route 178 between Trona and Ridgecrest caused traffic closure; the rockfall was later cleared. Rockfall was also reported from State Route 190 Townes Pass and State Route 127 near the Tecopas Hot Springs turnoff⁵⁸.

Figure 50. Rockfall damages in Ridgecrest⁵⁹ (left) and Trona⁶⁰ (right). All images reported in the VERT report, Appendix B.

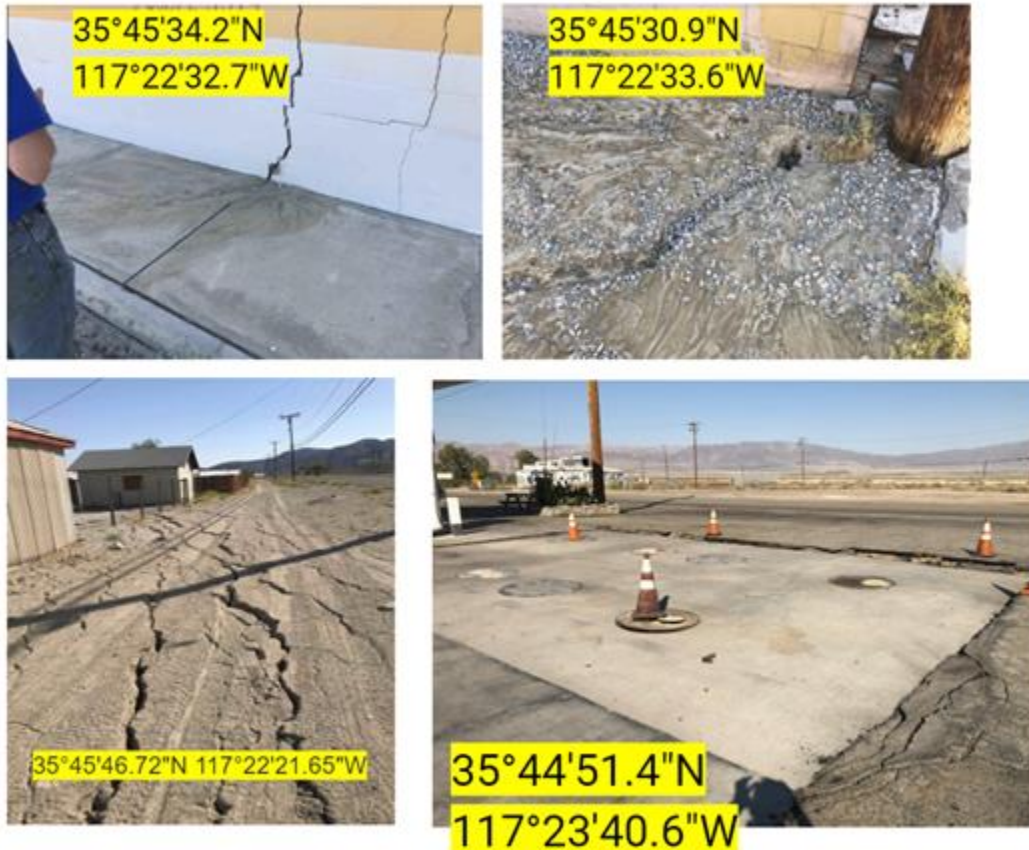
Figure 51. Liquefaction induced lateral spreading and sand boils causing damage to the roadway, and infrastructure in the Trona area (source for all: courtesy of Kenneth Hudson, one of EERI field investigation team members) [clockwise from top left: Esparza restaurant commercial building distance from – closest distance to Searles Lake 0.6 mile; US Post Office Building – closest distance to Searles Lake 1.0 mile; corner of California Street and Argus Avenue; Shell gas station – closest distance to Searles Lake 1.0 mile].

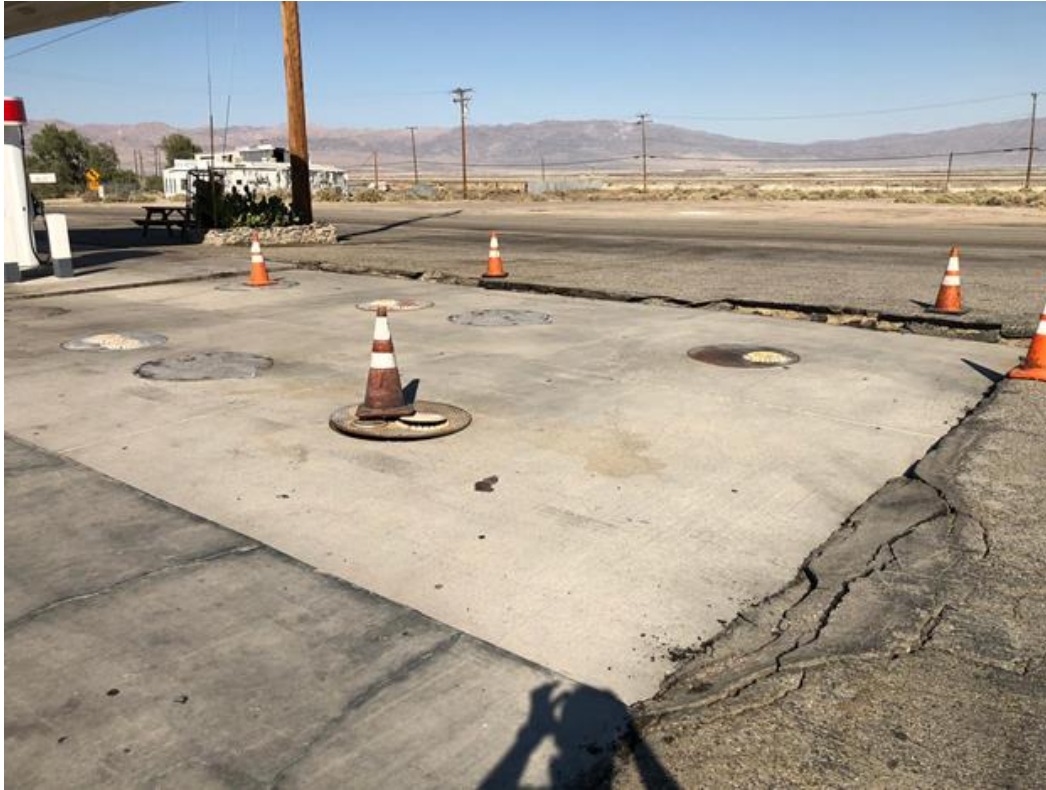
Figure 52. Closer look at ground failure observed at underground storage tank at Shell gas station on Trona Road (Source: courtesy of Kenneth Hudson, one of EERI field investigation team members).
