Oxfam GB

Haiti Earthquake Response

Arup Assignment Report

May 2010

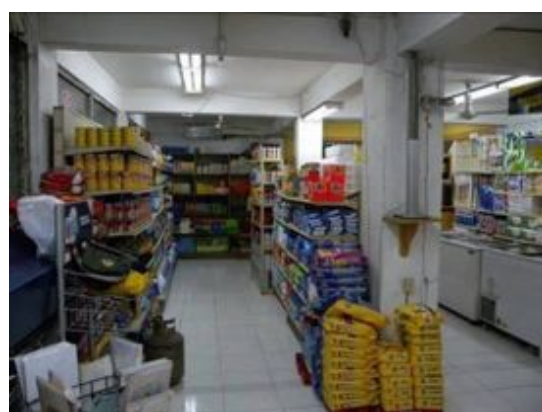
* Generally, C3 type buildings are assumed to have solid slabs and a beam column framing, especially in seismic areas and were not that common. A rare example is shown in Figure 4.

Figure 4 A rare concrete frame building with unreinforced masonry infill walls

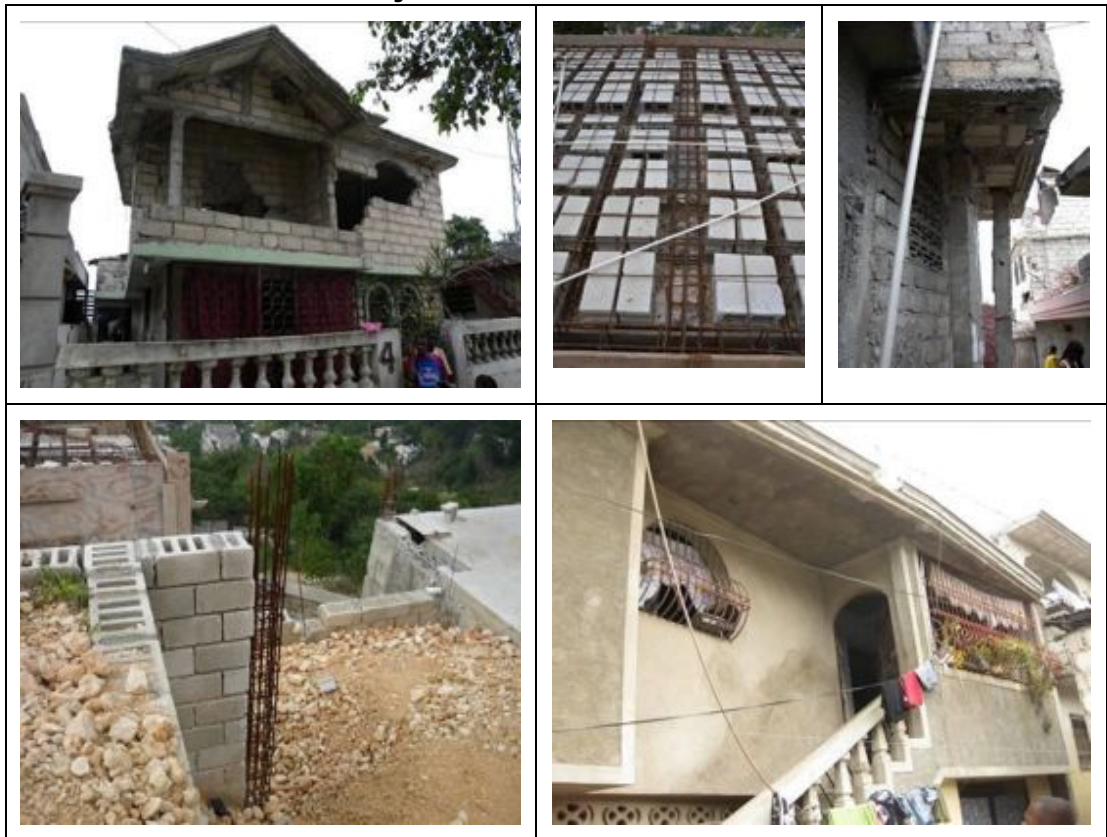
3.2.1 C4-HBFS-UHM, Concrete Hollow Block Flat Slabs with Un-reinforced Hollow Block Masonry Infill

Figure 5 C4-HBFS-UHM, Concrete frame with hollow block flat slabs with un-reinforced hollow block masonry infill

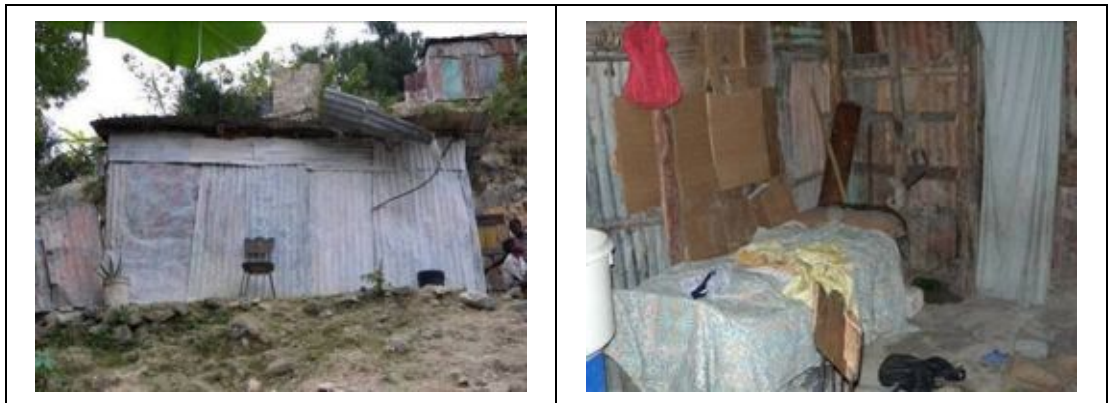
3.2.2 TCWR, Timber and Corrugated Galvanised Iron Walls and Roof

This building is thought to have performed adequately during the earthquake. However it is a vulnerable construction type, especially to high winds.

Figure 6 TCWR, Timber and corrugated galvanised iron walls and roof (similar to type T) also.

- Drainage to be provided to avoid rainwater entering the houses (often with compacted earth flooring).
- Flooring should be raised above the surrounding ground inside the building.
- Foundations are required to anchor the building frame.
- A stone perimeter foundation band to be constructed on to which timber posts rests. This will prevent the timber being in direct contact with the ground.
- May benefit from the introduction of bracing to help stiffen the building.
- At roof level the introduction of a ring beam and straps will help keep the roof attached during heavy winds.
- Typically these buildings do not have latrines or cooking facilities and these activities take place in the surrounding area. Limited questioning appeared to suggest that external latrines exist roughly one between around 20 such houses.

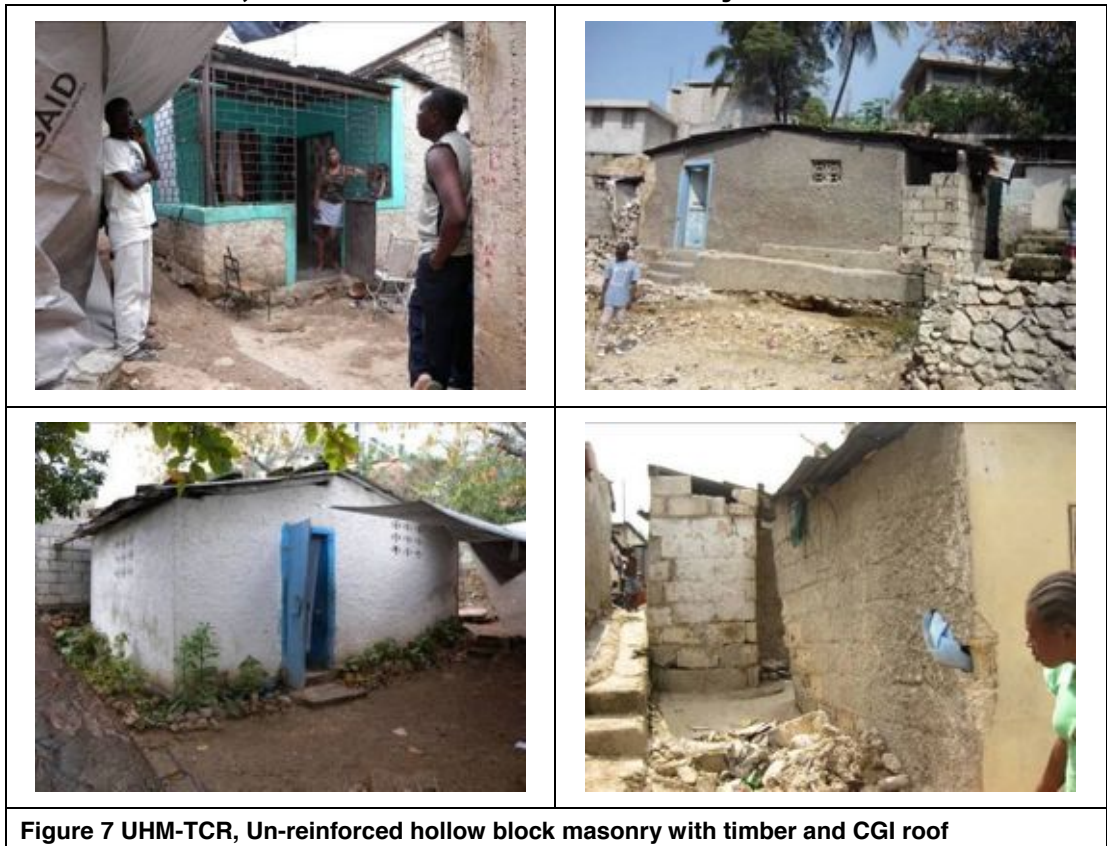
3.2.3 UHM-TCR, Un-reinforced Hollow Block Masonry with Timber and CGI Roof

**Figure 7 UHM-TCR, Un-reinforced hollow block masonry with timber and CGI roof**

- Openings to be placed centrally in walls and be modest in size.
- The addition of vertical corner reinforcement and at major door openings would help tie the building together, especially if properly anchored to a wall ring beam.

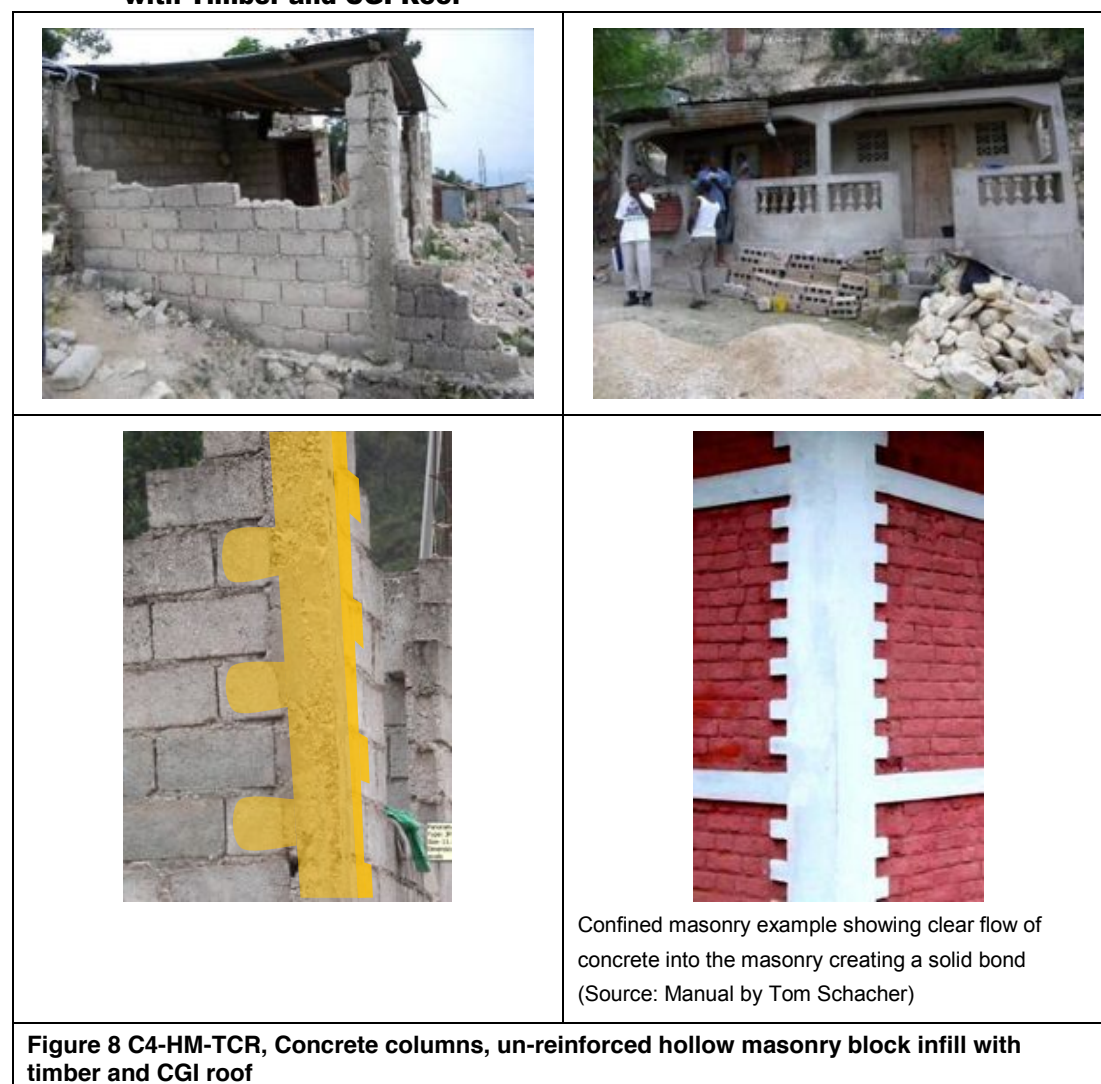
3.2.4 C4-HM-TCR, Concrete Columns, Unreinforced Hollow Masonry Block Infill with Timber and CGI Roof

In many ways these buildings are similar to the UHM-TCR building previously discussed in Section 3.2.3. In fact these houses are more expensive than the masonry only version and have all the ingredients to make good quality seismically resistant houses. Attention to the workmanship should ensure that these buildings perform well. It is not thought that implementing the required improvements (similar to the ones described in Section 3.2.3) would need any additional funds.

One aspect that is crucial for these houses, especially when built on steep terrain is the quality of the stone masonry retaining walls and foundations. Stone masonry foundations are discussed briefly in the next section and further guidance on stone masonry is provided in Section 8.3.3.1.

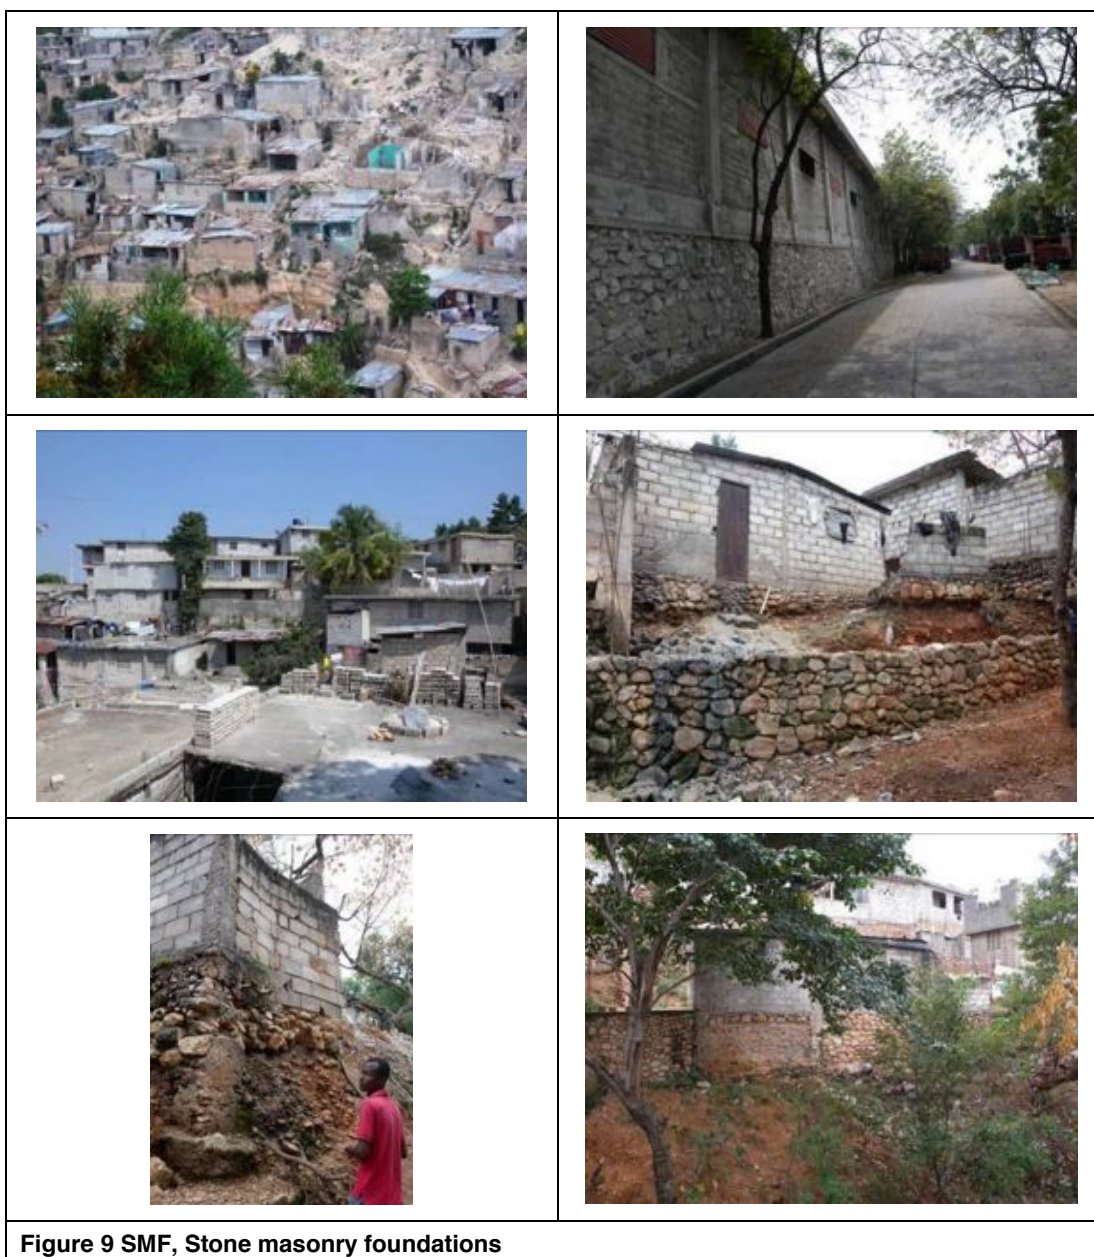
Figure 9 SMF, Stone masonry foundations

The limestone rock appears to be of reasonable quality. However, the quality of the stone masonry in Haiti is generally poor. Little attention is paid to its proper preparation or seismic detailing requirements. Section 8.3.3.1 of this report discusses stone masonry in greater detail.

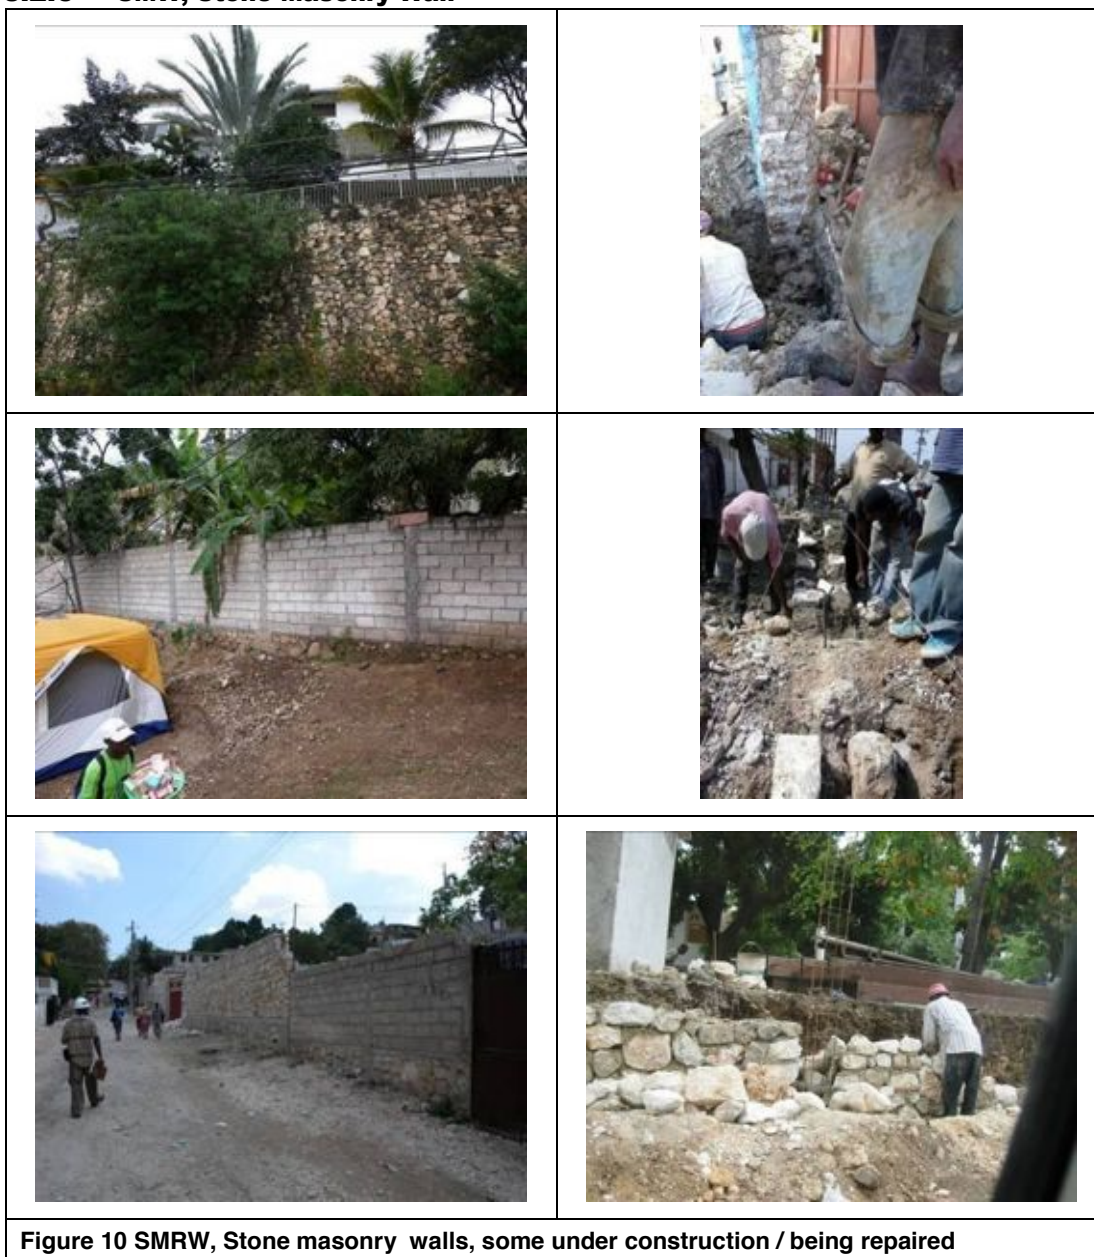
3.2.6 SMW, Stone Masonry Wall

Perimeter walls are important in Haiti, especially given the political instability in the country. Therefore, construction of safe walls is an important consideration for Haitians in terms of reconstruction priorities. As with the previous section the rock is of good quality but its usage in terms of stone masonry is generally poor. Section 8.3.3.1 of this report discusses stone masonry in greater detail.

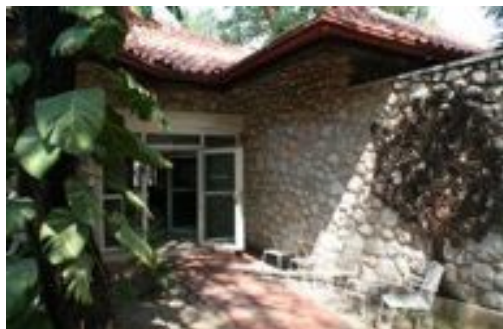
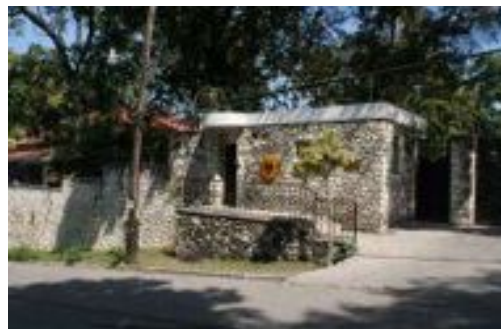
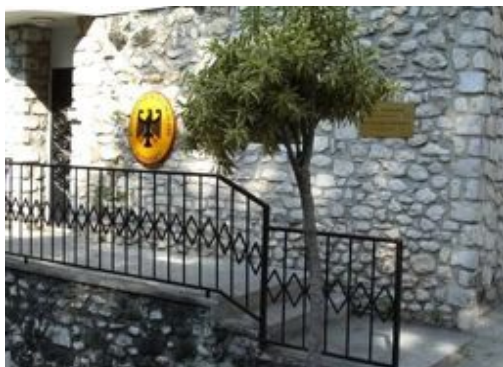
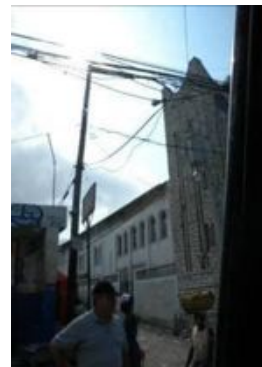
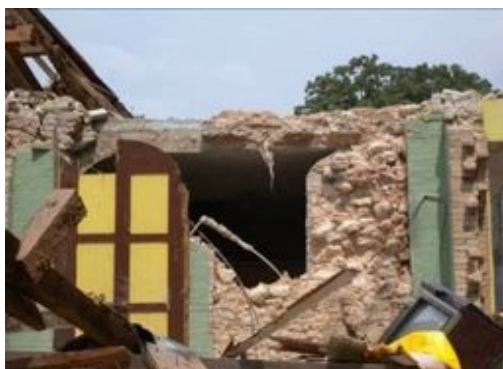
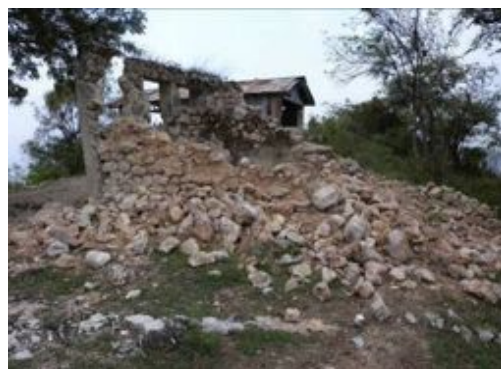
Figure 11 SM, Stone masonry

The performance of stone masonry buildings varied from complete collapse to appearing untouched by the earthquake and examples are shown in Figure 11. The top two and middle left house being details of the German Embassy in Port au Prince which appears undamaged from these photos as does the stone masonry tower in the middle right picture. Both of these building appear to have followed at least some basic stone masonry principals and the stones were laid in a strong mortar and the corners were detailed to be stronger.

The bottom two images in Figure 11, show collapsed stone masonry houses. The collapsed walls reveal that they were mainly constructed from random rubble, laid in mud mortar with no evidence of any preparation of the stones prior to them being used in the wall construction. There is no evidence of the use of through stones or other similar sensible stone masonry practices in their construction. Section 8.3.3.1 of this report discusses stone masonry in greater detail as it is believed to be an important material in the reconstruction efforts of Haiti, especially for those with limited economic means.

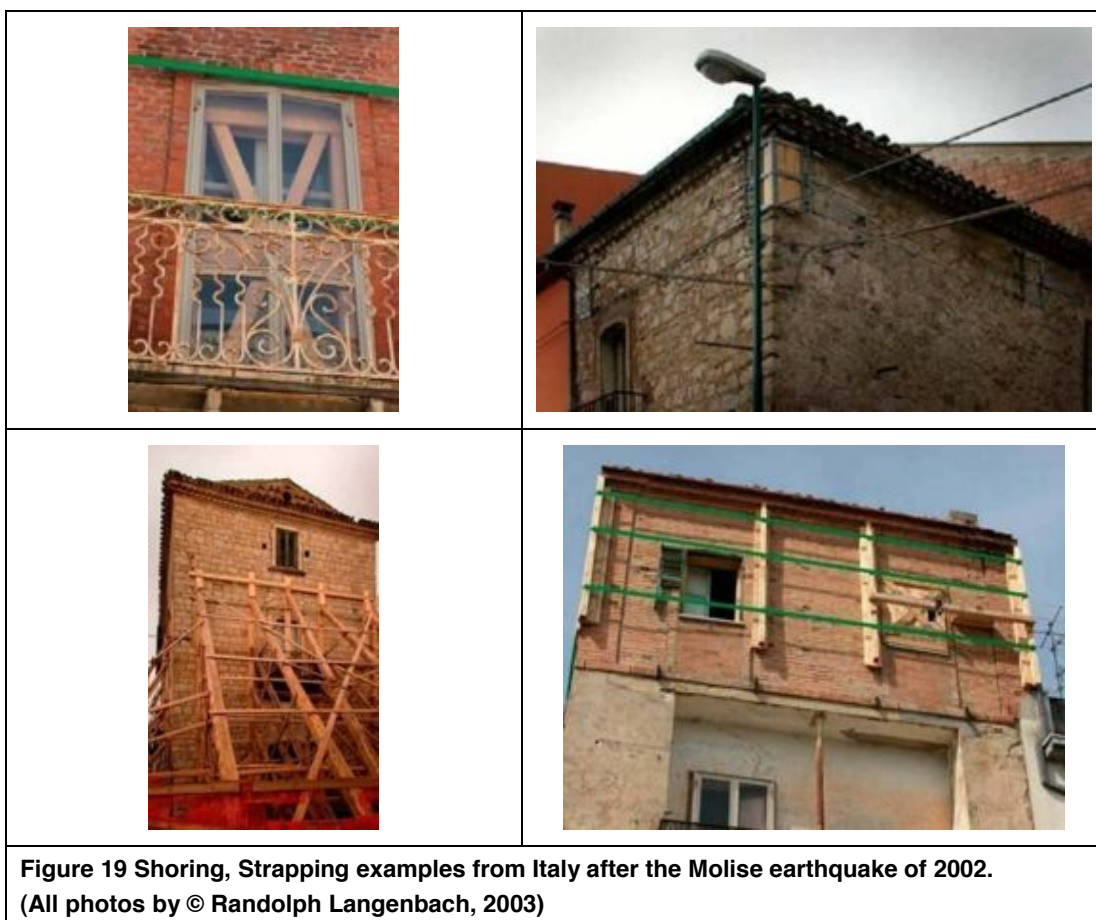
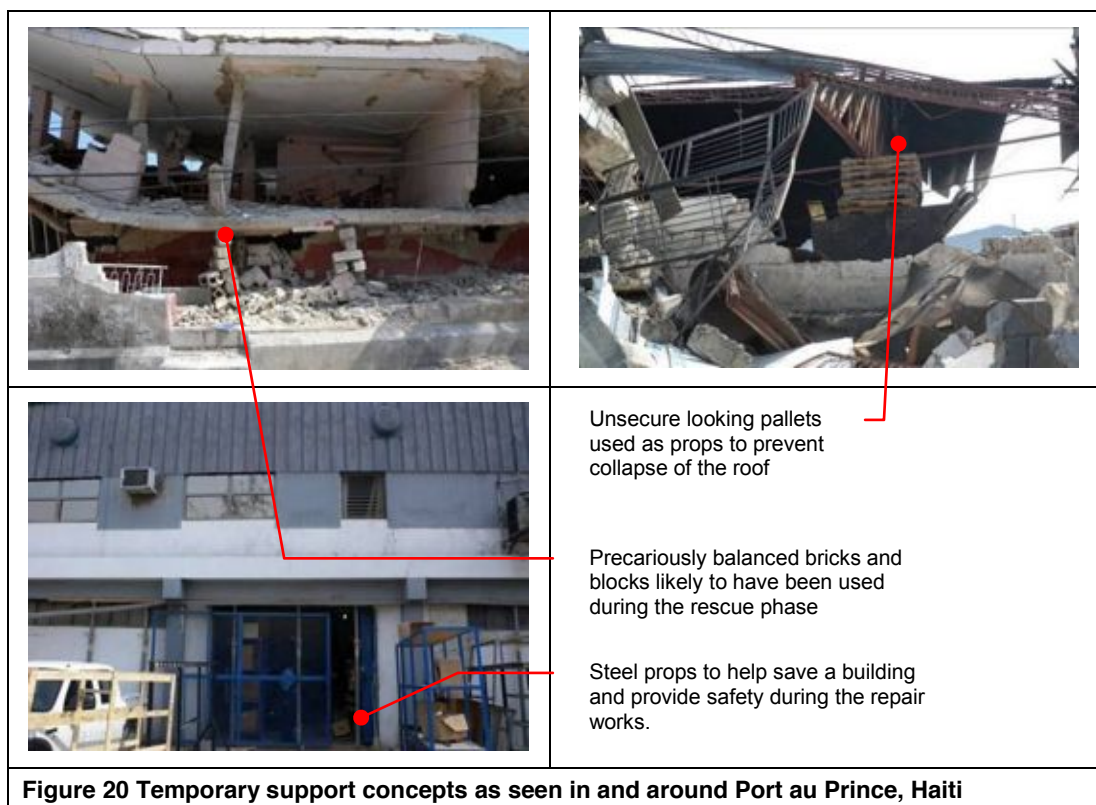
Typically the examples from Haiti indicate that there is room for improvement on the adopted techniques.

- Propping to give property additional vertical support
- Lateral shoring to give the property additional sideways support
- Strapping to help tie a property together
- Bracing around openings to help strengthen any obvious weak spots

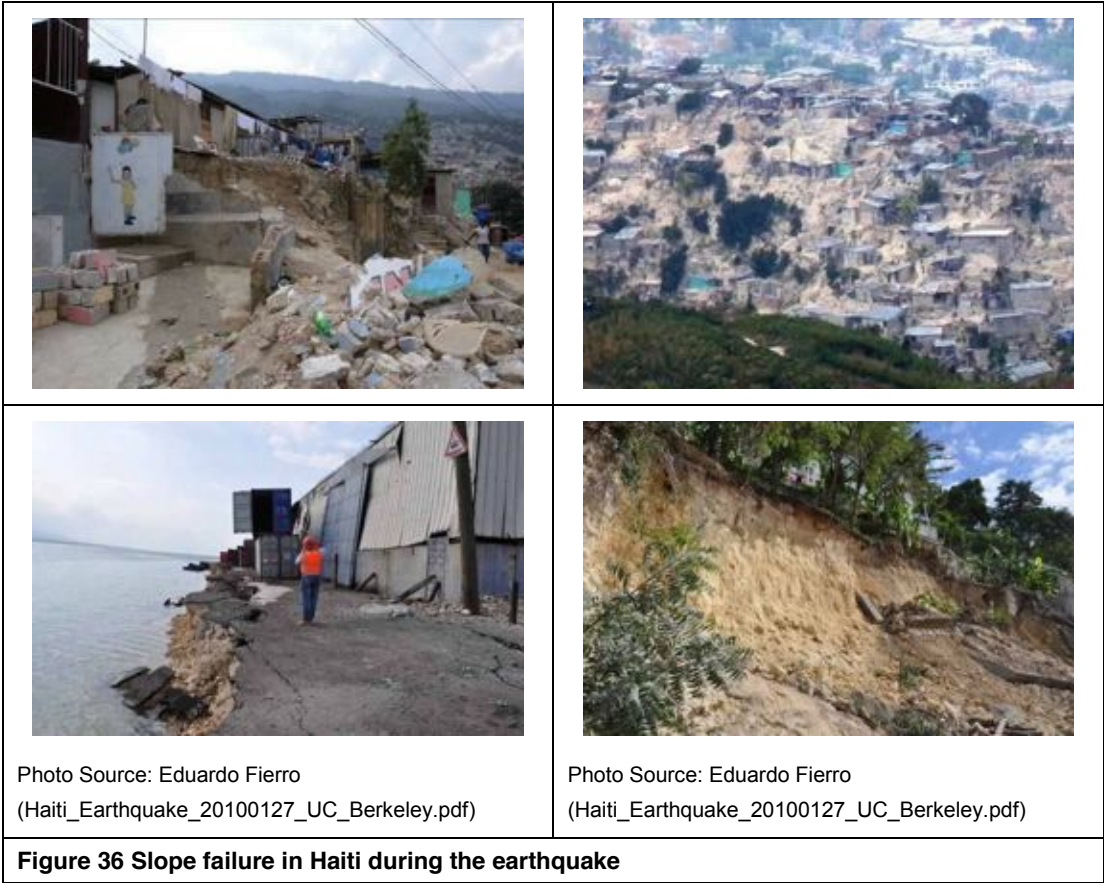
Much of the affected built up area is on relatively steep slopes. Non engineered slopes are prone to catastrophic slope stability failures, especially when the ground is saturated because the water reduces the ability of the soil to carry vertical and horizontal loads, noting that earthquakes will rapidly accelerate dormant slope stability issues as shown in Figure 36

Expert studies are required to establish the extent of likely vulnerable slopes. Typically slopes with thick layers of soil will be more susceptible to slope stability problems compared to rock slopes.

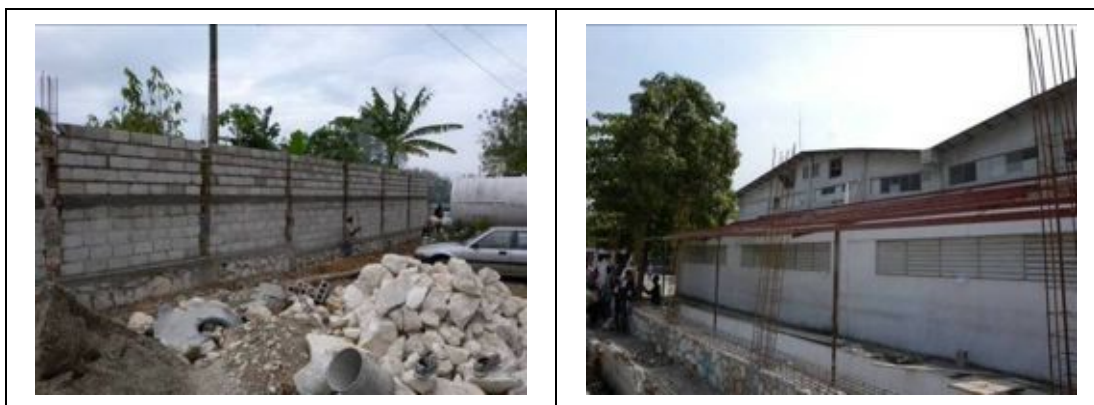
Figure 37 Construction of Strong perimeter walls

Political instability and the harsh economic realities in Haiti means that the protection of property is a key concern amongst the Haitian population. This is evident in the prioritisation of many people in and around Port au Prince to reconstruct their perimeter boundary walls; in effect trying to secure their property before any other work is carried out. This is more of an issue the bigger the property or facility is.

In the long term, political and improved economic conditions will help reduce the perceived need for large walls. However, in the short term, rapid wall construction is going on. It is important that these walls are properly founded in competent ground. The use of intermediate reinforced concrete columns and horizontal band beams are encouraged. Where stone masonry is utilised it is essential that through stones are used regularly in order to bond the two faces of the walls together.

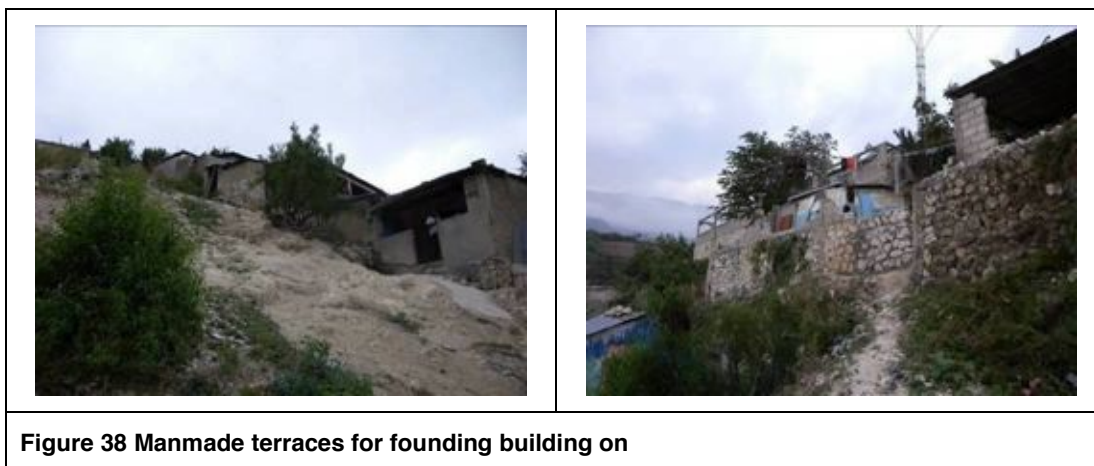
The steep terrain of much of the land on to which people have been building necessitates the creation of manmade terraces as shown in Figure 38. These terraces, if not done well, will have a failure mechanism similar to a geotechnical slope stability problem. Once the mechanism is activated the falling debris / terrace material will quickly slide down hill. This may lead to a domino effect whereby downhill house terraces are made to fail by being caught up in the moving material.

First of all ensure geotechnical stability of the slopes, though this may require the appointment of a geotechnical engineer who knows how to assess seismic slope stability.

The next step is to construct terrace walls in such a manner they themselves are stable given the soil and building weight that they retain. In Haiti, many houses are founded on a stone masonry base, and often terrace walls are made from stone masonry too. Specific issues regarding stone masonry are discussed in Section 8.3.3.1.

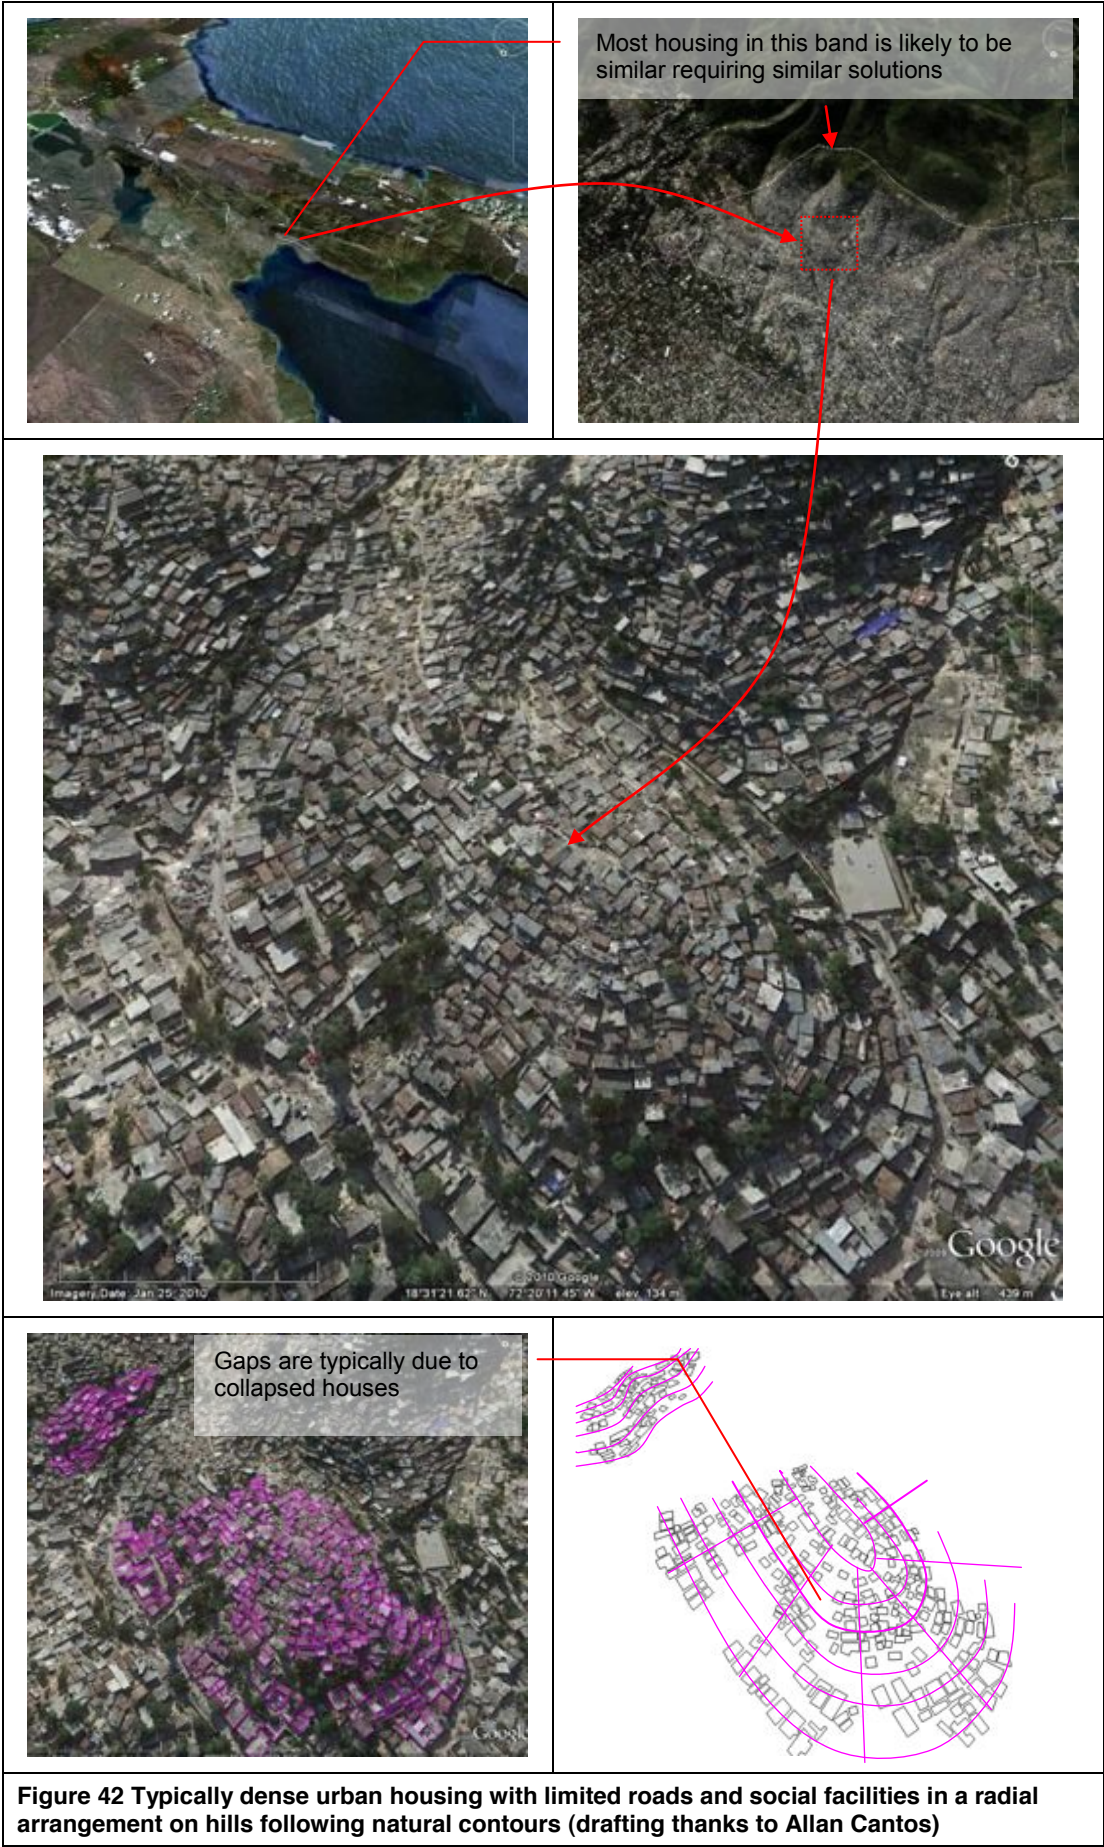
Housing along the outskirts of Port au Prince (consisting of one to two storey houses) shows them to be built along the natural contours of the hills as shown in Figure 42. The density of the housing is high, there are no apparent shared drainage / water flow arrangements, and there is limited vehicular access to name a few of the obvious hazards that have been built into the fabric of these communities. The need for urban planning is very real especially in terms of basic infrastructure provision (roads, utilities and fire truck access) to these urban developments.

No planned drainage.

No vehicular access, especially fire trucks.

Dense housing in danger of cascading on top of each other as has happened in some parts in the vicinity as shown in Figure 41.

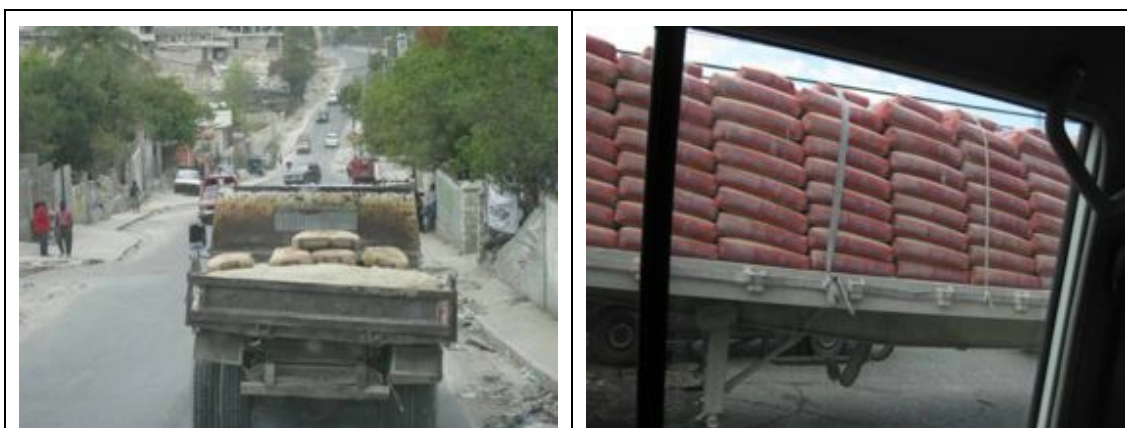
Figure 48 Cement being transported in Port au Prince

Transportation of cement appears to be done in open top lorries as shown in Figure 48. Whilst it is likely that cement will be correctly stored initially (i.e. prevented from getting damp or even wet) it is unlikely that much more consideration is given to the safe transportation and storage of the cement bags.

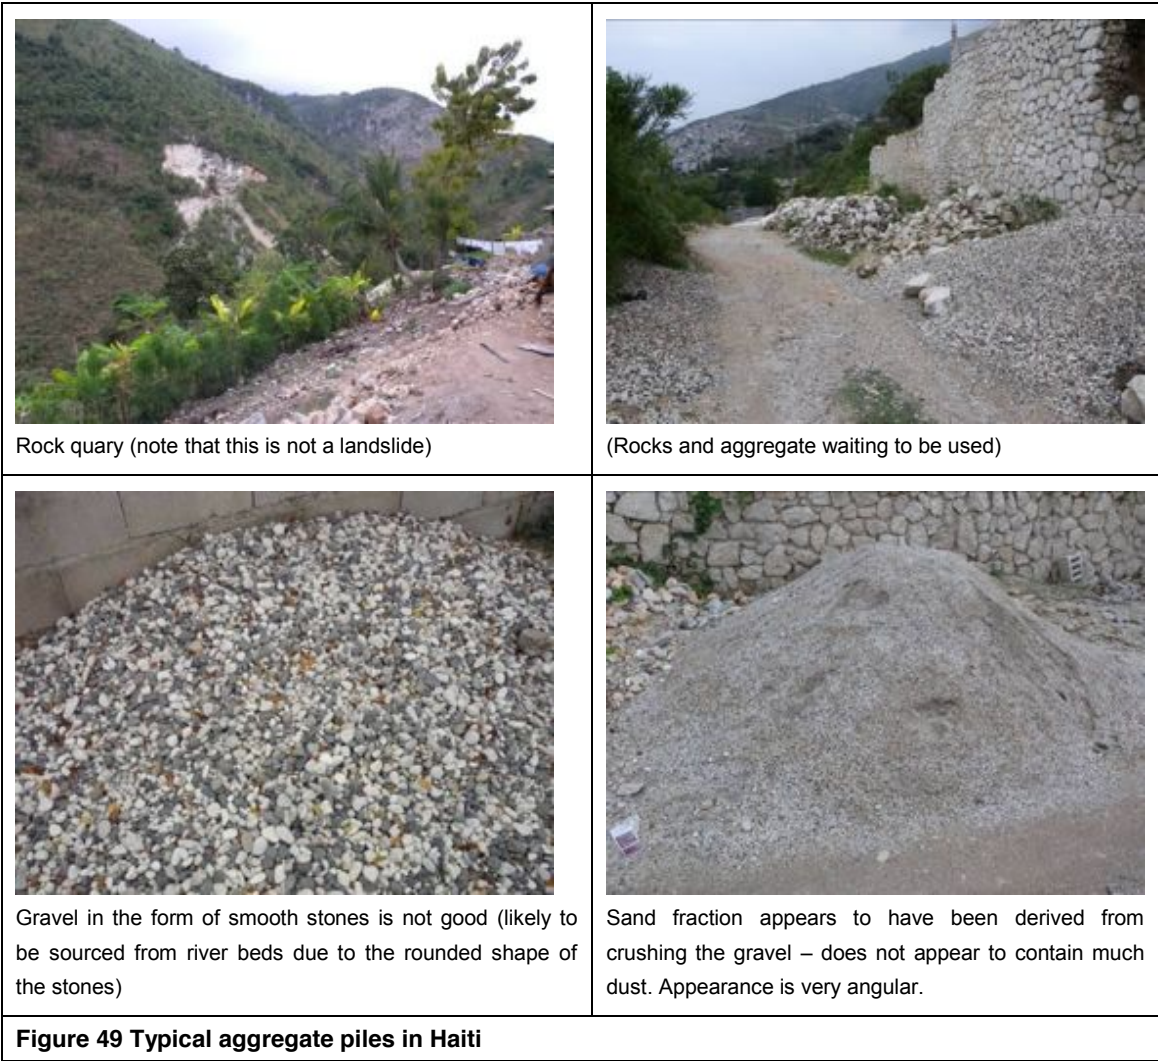
From our observations and conversations with Haitians, sand and aggregate is commonly sourced from local quarries and river beds (See Figure 52). Although we did not see it, there is a reasonable chance that beach sand will have also been used in construction which must be avoided due to the high salt content and generally smooth nature of beach sand.

Visual examination of aggregate piles next to construction activities indicates that the majority of the aggregate is limestone as shown in Figure 52 . Limestone with an adequate density will make a good quality concrete if done properly.

Standard aggregate tests (physical and chemical) are required on the available aggregate to determine its suitability for construction as part of one of the main ingredients of concrete.

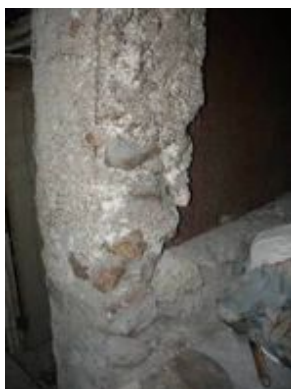
Figure 51 Example of a poorly graded concrete mix with large rocks evident in the mix.

- Aggregate grading: In standard good concrete practice, generally the maximum aggregate size used for reinforced concrete is ~20 mm (to ensure good compaction around reinforcement) and 40 mm for mass concrete structures (where there is less restriction for the flow of concrete). In some cases grading of aggregate had not taken place as can be seen in
-
-
- Figure 51.

The image on the right was taken from a reinforced concrete framed building. Not only have large boulders been used in the construction of this column there was also no apparent reinforcement present, certainly not that could be seen without further investigation.

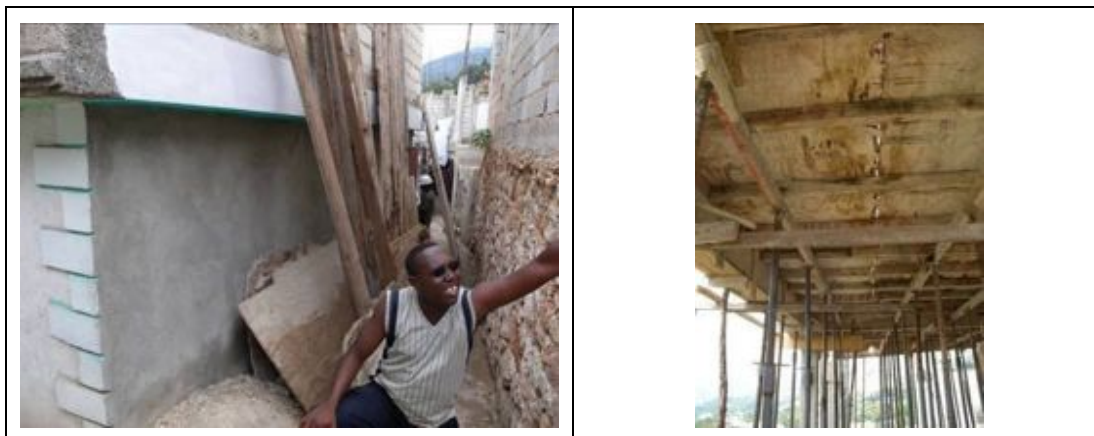
Formwork for floors slabs seems to consist of a standard sized ply wood sheet with a centrally attached post a bit like a advertisement sign post. These are appearing to be recycled from project to project and with time significant damage is encountered along the edges as shown in Figure 56. These gaps allow the cement paste to seep out of the freshly cast floors which negatively impacts on the quality of the final cast and cured concrete.

Figure 56 modular formwork system, that is constantly recycled

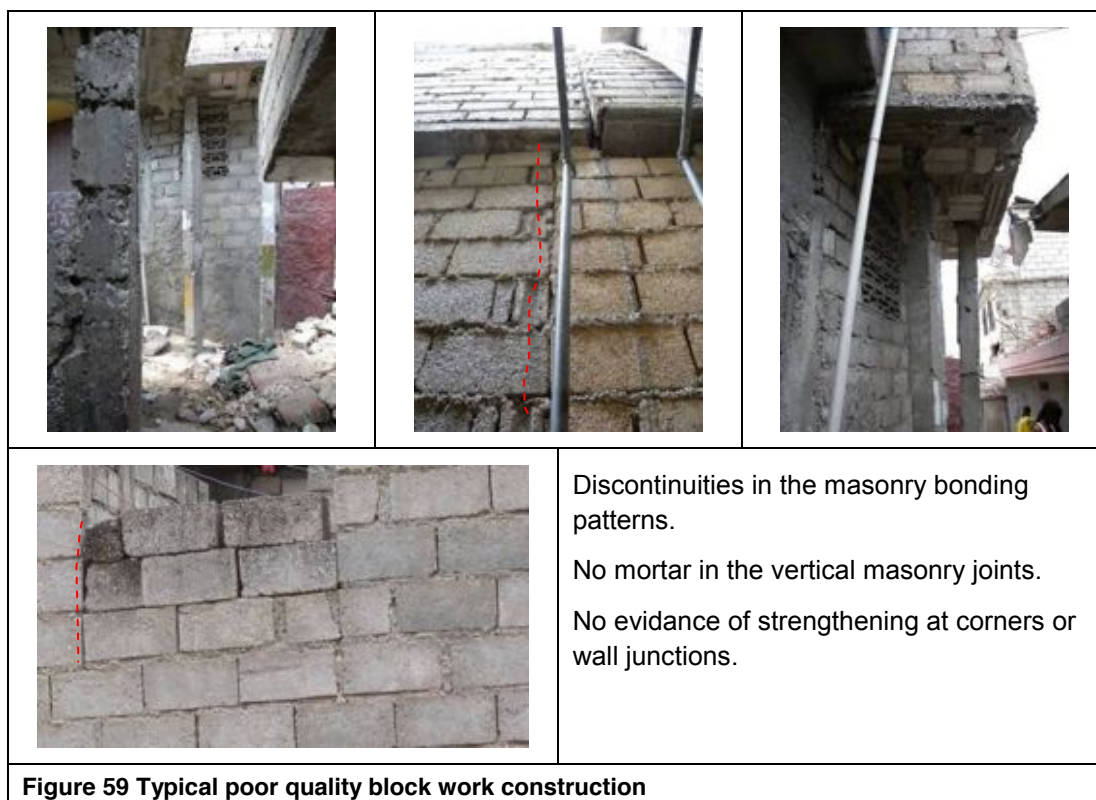
Figure 59 Typical poor quality block work construction

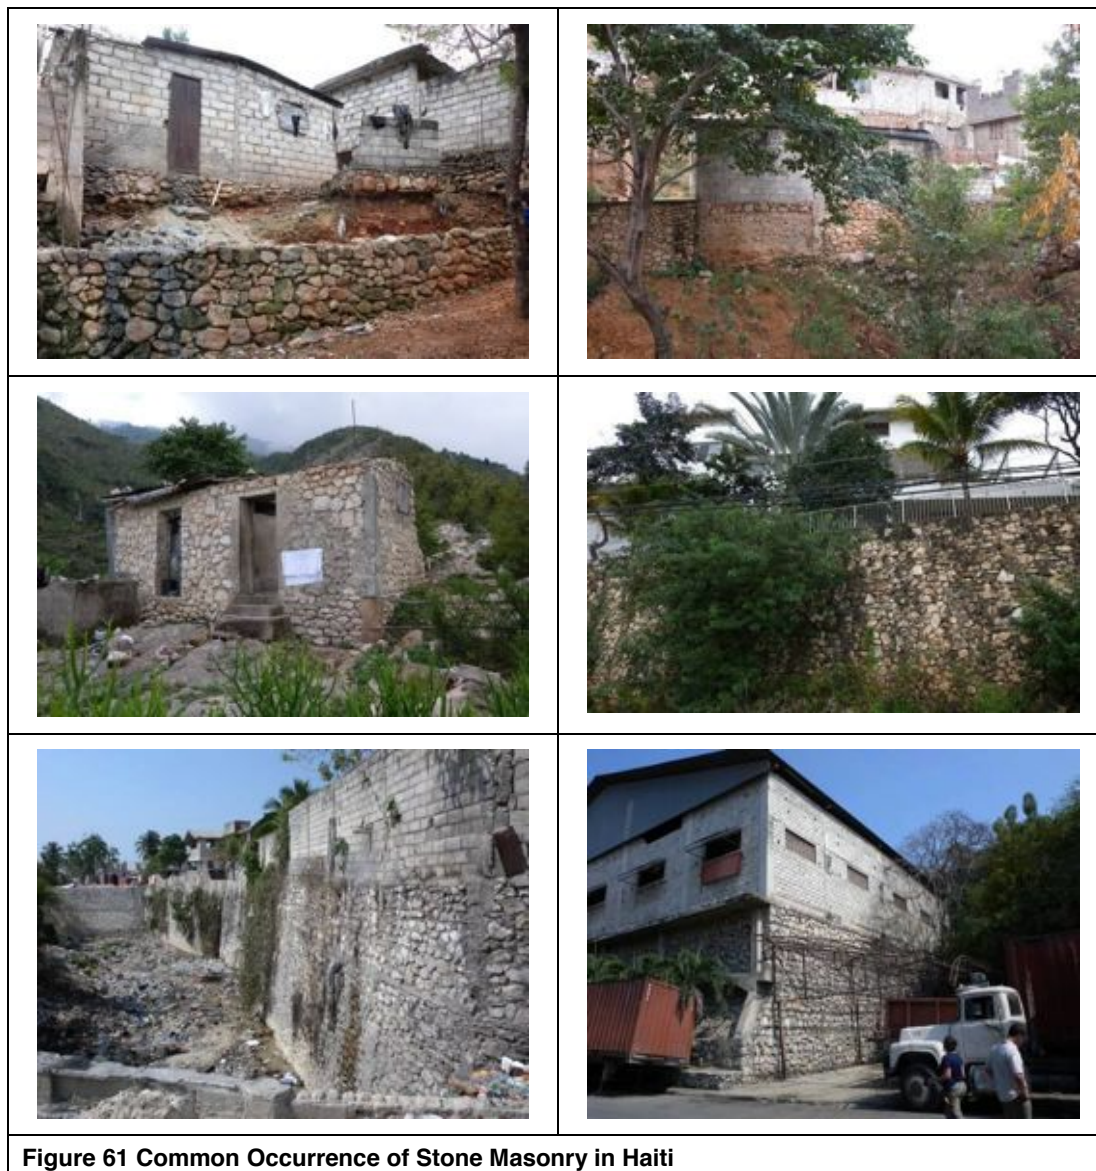
Stone masonry should play an important role in the reconstruction of Haiti as shown by the extensive use of stones, at least in the formation of foundations and retaining walls to terraces as shown in Figure 61. The intrinsic value of the stone has been clearly recognised by the Haitian people as discussed in Section 8.6.3.3.

Figure 61 Common Occurrence of Stone Masonry in Haiti

The photos shown in Figure 61 give an indication of the ground reality that stone masonry is already in significant use in Haiti and that in many instances the stone masonry performed well during the earthquake. Obviously there are instances where stone masonry did not do well but that is no different to modern construction methods and is in its self not a rational reason to ignore stone masonry.

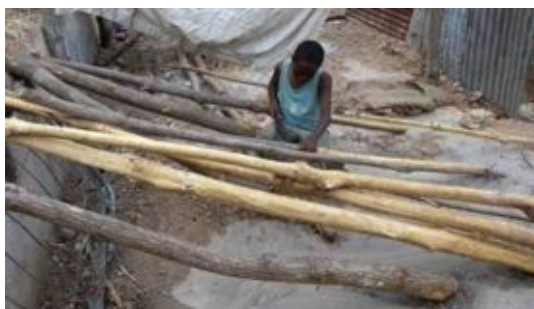
At this point the author does not have sufficient information about the local timber species to comment on their properties but typical timber sections, as shown in Figure 67, were unfortunately a common sight in Haiti.

Figure 67 Trees and branches being prepared for reconstruction works

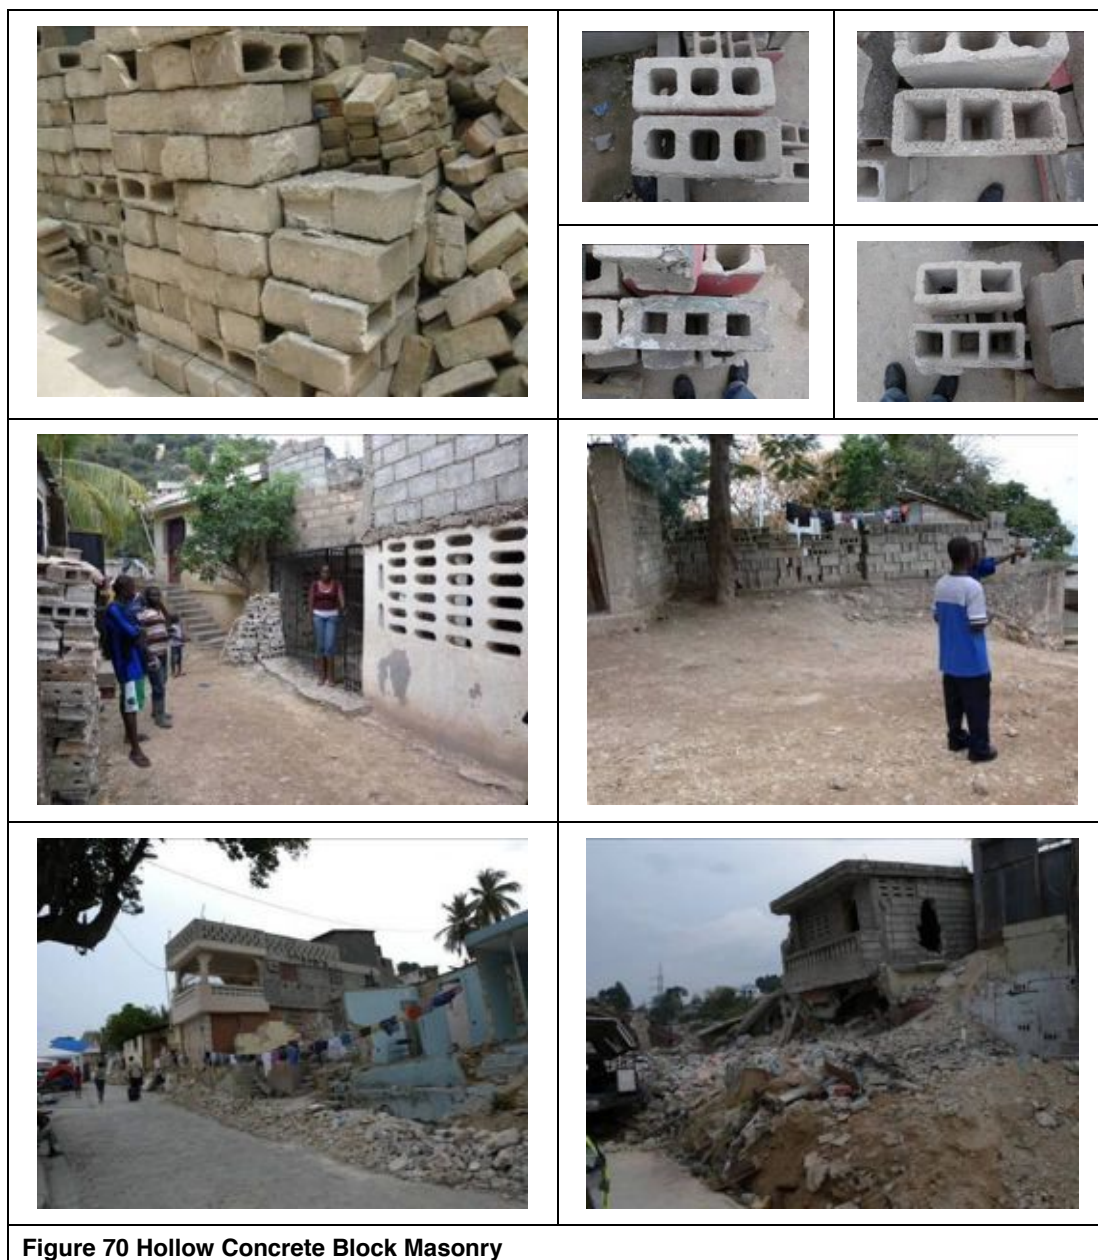
Hollow concrete masonry units are a very popular in Haiti and ready stockpiles are everywhere as shown in Figure 70. However, where these blocks have been damaged, they are of no further use because of their weakness as shown by the building rubble in the bottom images in Figure 70.

The concrete block masonry generally appears weak. There are no known instances of the blocks being reinforced with rebar and concrete to help improve their seismic resistance. Likewise the blocks have no grooves for reinforcement to be placed to help in their seismic resistance once assembled into walls.

It is unlikely that the rubble will be suitable for use as aggregate in the making of new concrete blocks. However it would be prudent to make trial samples and test them to see what strength levels can be obtained.
