Oxfam GB

Haiti Earthquake Response

Arup Assignment Report

May 2010

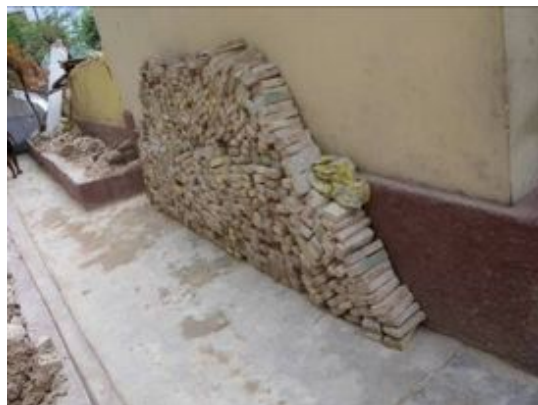
**Figure 71 Fired Clay Brick Masonry**

We came across very few fired clay brick and a rare sample of salvaged bricks is shown in Figure 71. These bricks looked to be of reasonable quality and are well worth salvaging. Testing of such bricks will be necessary to establish their engineering properties.

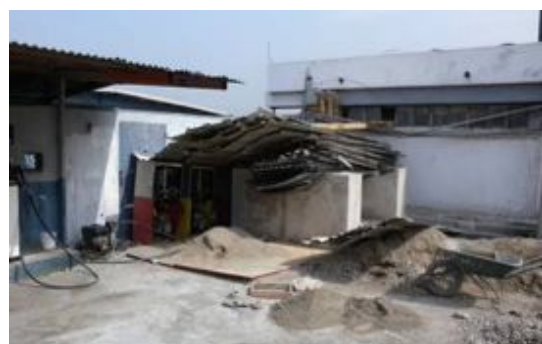
Figure 74 store of corrugated galvanised iron sheets

Only one instance of a stock pile of corrugated galvanised iron (CGI) sheets was seen during our visit as shown in Figure 74. Whilst this material is potentially valuable it is important the gauge of the sheets is checked to ensure they are adequate for the use for which they are intended. Recycled CGI sheets also need to be checked to ensure that they do not have previous fixing holes in the wrong places. In many instances it may be more appropriate to return damaged sheets for proper recycling so that new steel products can be forged.

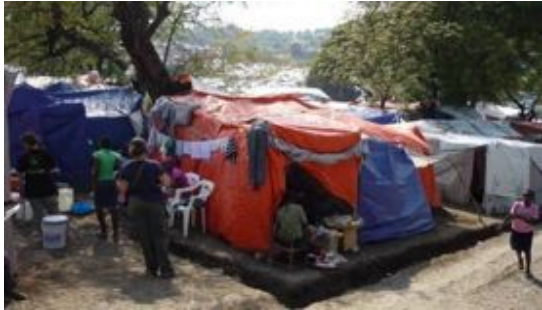
<p>Emergency shelter:</p> <p>Whilst this individual has recognised the need for ample drainage around his shelter the implementation of this is not across the site and nor are the trenches armoured in any way to minimise the risk of scour action. It is also not clear where the rain water will drain in to. Clearly, in camp situations overall site drainage must be evaluated and temporary drainage provided.</p>

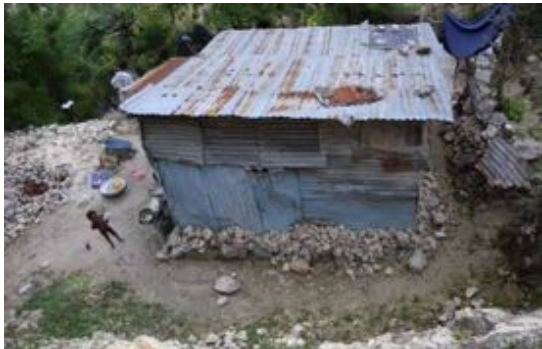
<p>Timber and corrugated galvanised iron walls and roof:</p> <p>This property, built on and around rock should have a stone masonry band to raise the base of the building above the current plot level. As there is no guttering to the roof, it is especially important that an armoured drainage trench be constructed, possibly out of stone masonry. This will help minimise damage near the property base. Consideration needs to be given where the rainfall water from this site is directed to so as not to cause a problem further downhill.</p>

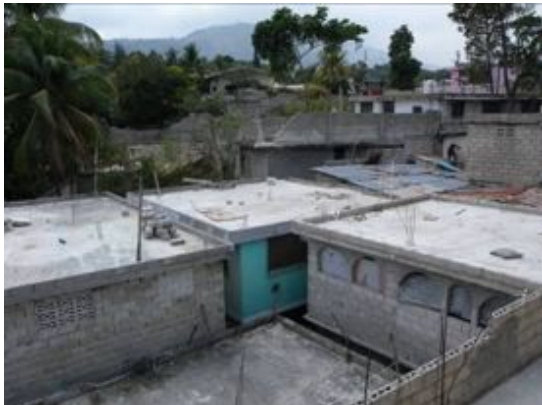
<p>Dense urban construction:</p> <p>Flat slab roofs all have a two block high perimeter parapet. There is no waterproofing to the flat slabs or any obvious thought out drainage. As these houses are built incrementally, the current roof is considered to be a future floor rather than a roof. This means it is laid flat without any a slope to direct rainfall water to a drainage point.</p> <p>A sloping screed and waterproofing will help minimise corrosion damage to the reinforced concrete roof.</p> <p>Currently there is limited application of this for these types of houses.</p>

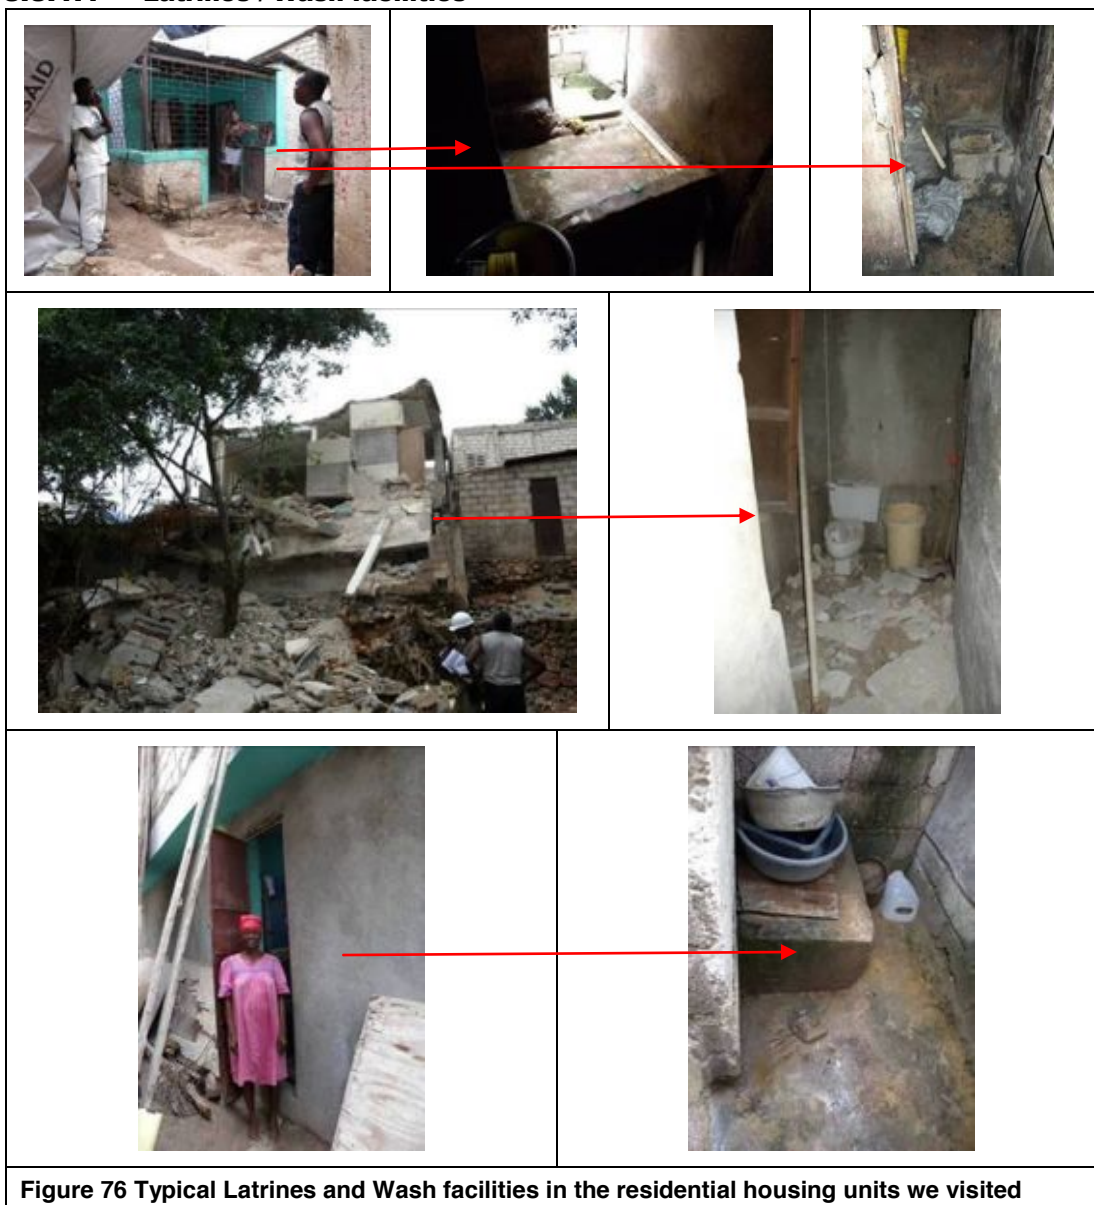
Figure 76 Typical Latrines and Wash facilities in the residential housing units we visited

Generally only the bigger houses have western style toilets. Whilst many have hole in the ground type latrines in their homes, they are dark, poorly ventilated and non of the concrete or cement plaster has been protected with proper tiling. This makes these toilets near impossible to clean and a likely continuous source of re-infection and chronic disease within the communities of Haiti.

Clearly the required reconstruction activities offer an opportunity to build back toilet and wash facilities to a better standard.

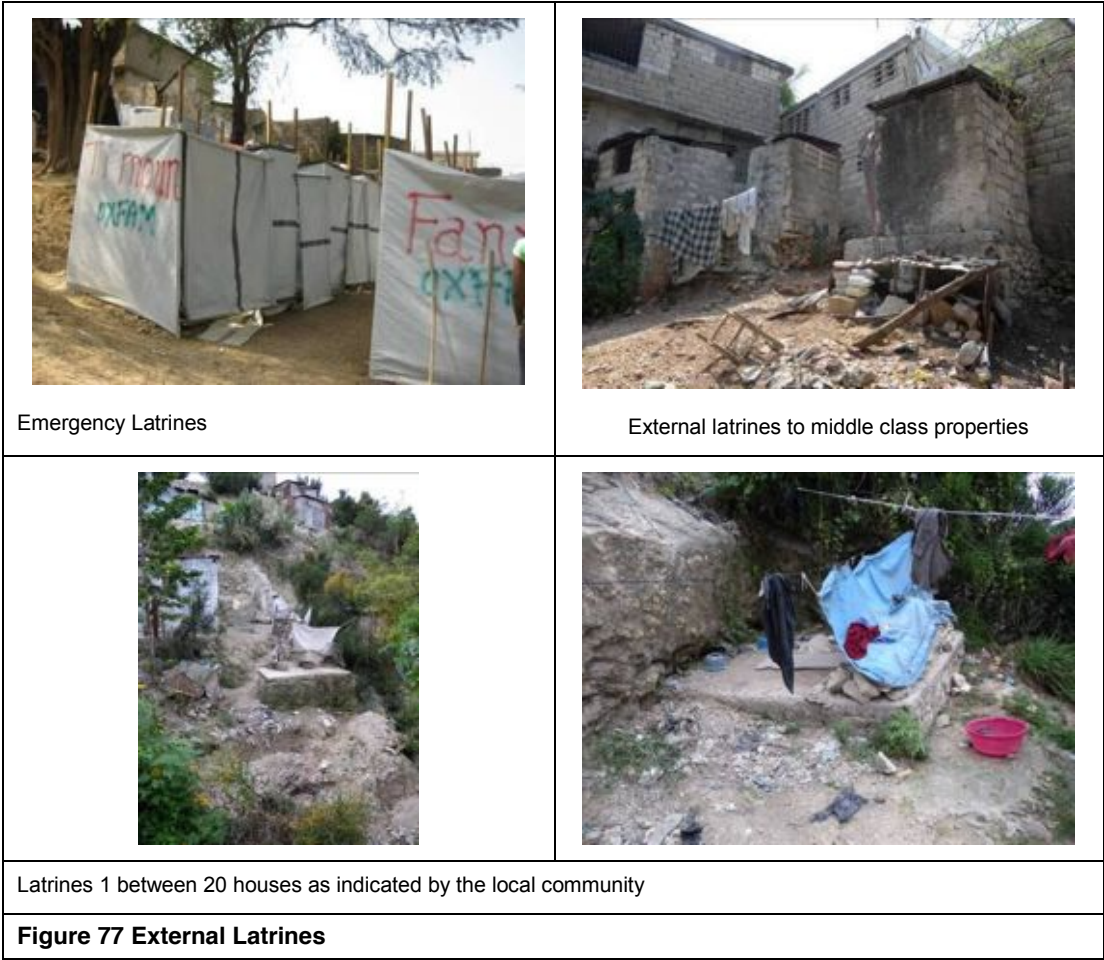
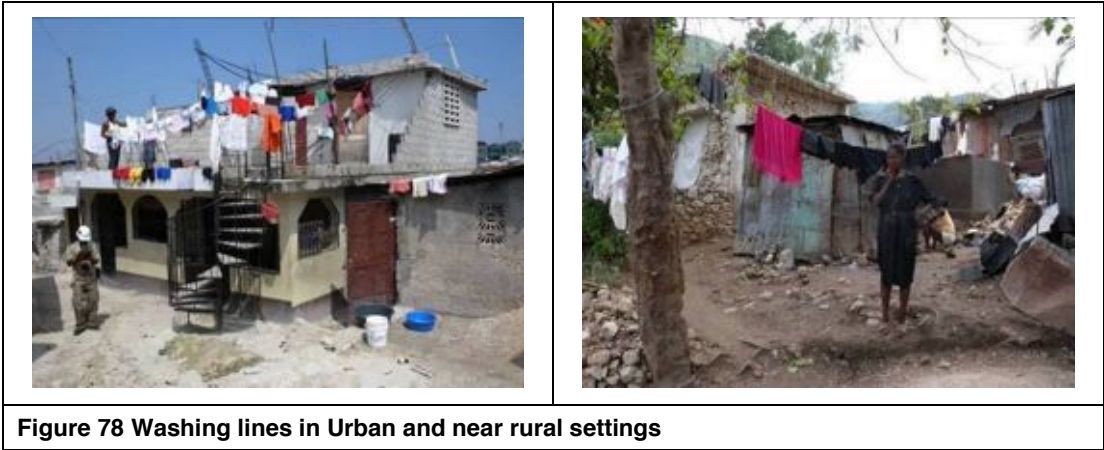
Washing facilities are shared with latrine spaces in many of these houses. Whilst this is not a problem in principle, the poor state of cleanliness does make this a significant issue that needs to be addressed during the reconstruction work.

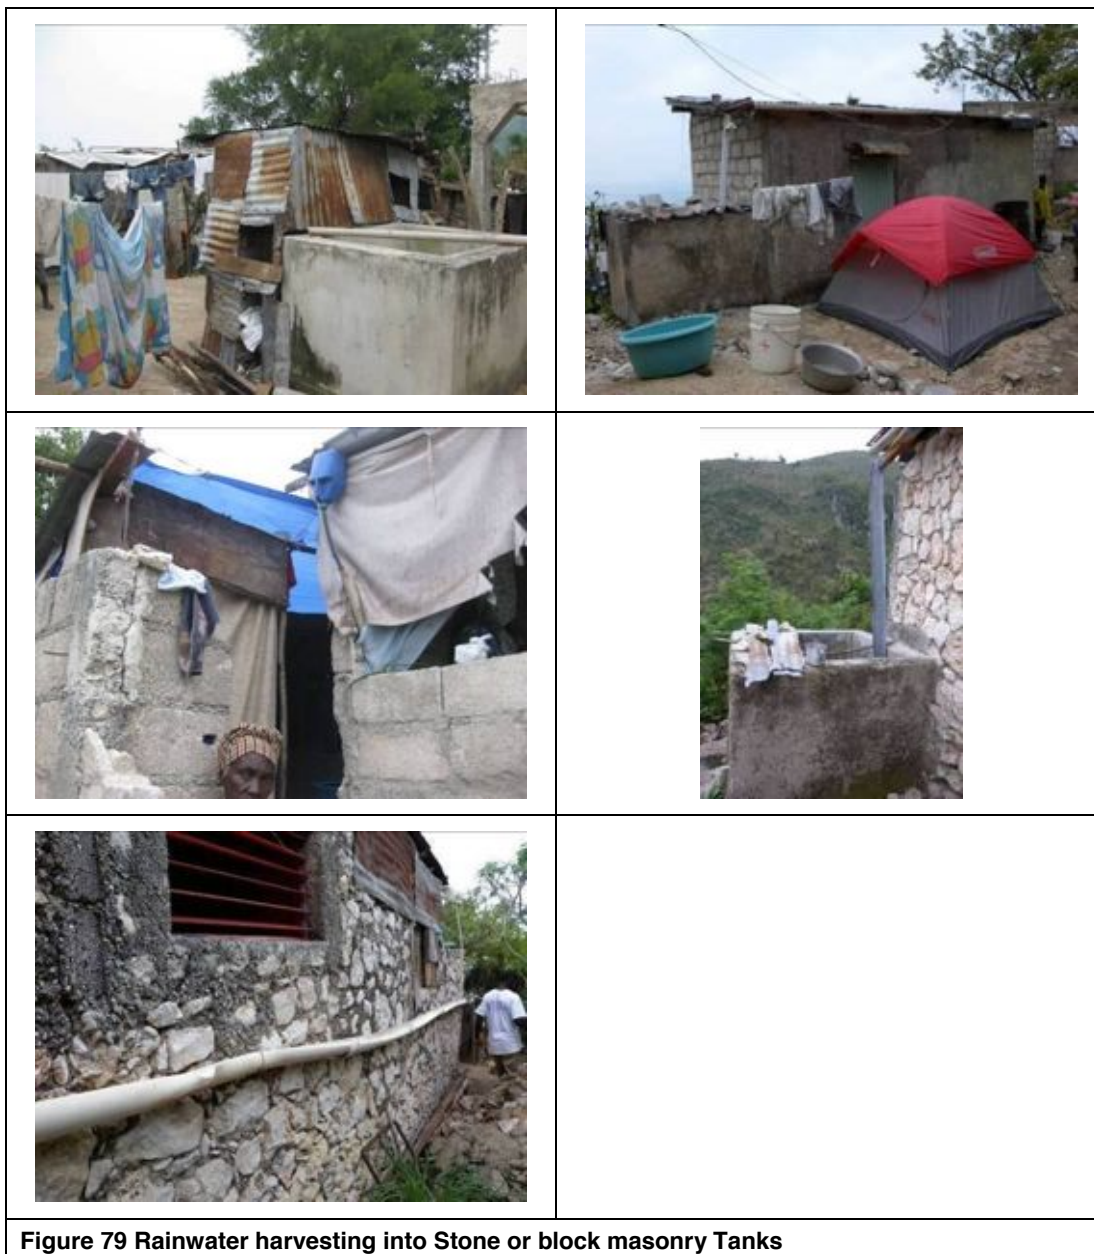
**Figure 79 Rainwater harvesting into Stone or block masonry Tanks**

Harvesting of rainwater is actively done in the more rural communities. Concrete block water tanks with a cement lining, typically about 1m² on plan, can be seen next to most houses on the hilly outskirts Port au Prince. Many of these tanks did not have secure lids to prevent animals and other forms of contamination getting in to the water reservoir. In the more urban settings rain water harvesting was not observed but clearly there is significant potential for this, especially in the design of new housing that is no doubt going to take place.

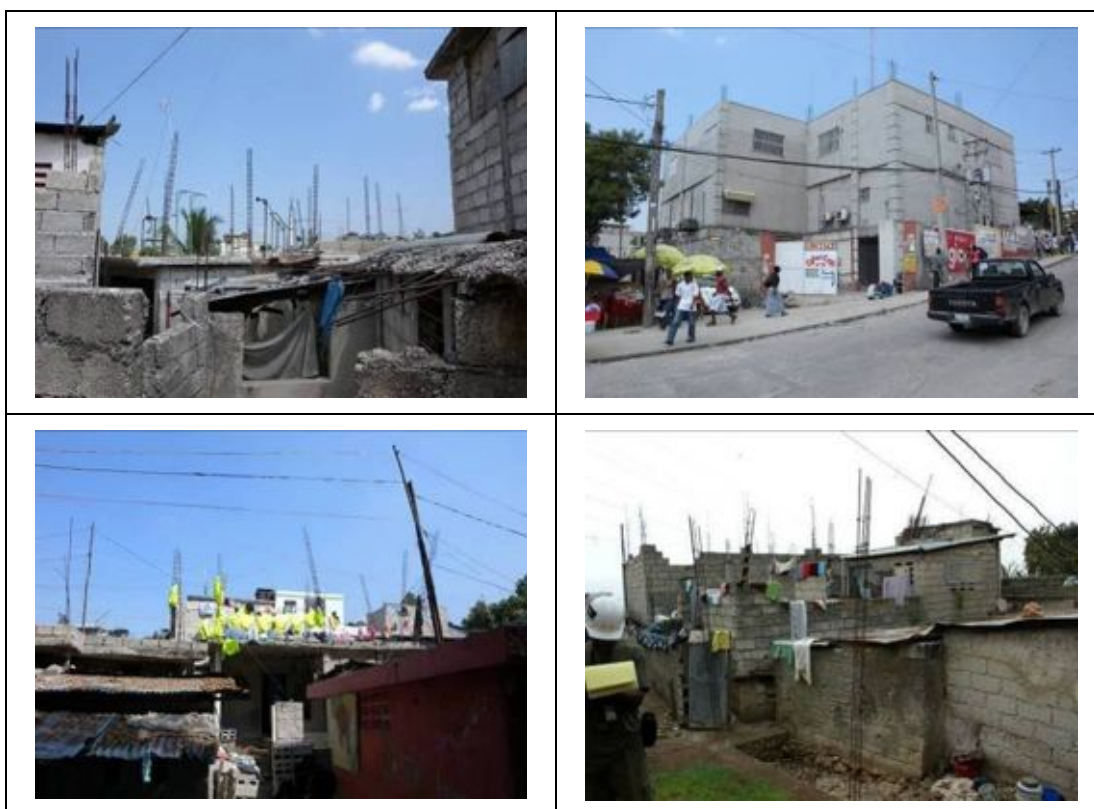
Incremental construction is the norm in most of Haiti. This is especially true for the poorer sections of society who typically start by building their homes one room at a time. As in much of the world column reinforcement for the next increment of construction is left sticking out of the temporary building roof until sufficient funds are available to build the next extension as shown in Figure 85.

During our field surveys, especially in the middle class residential areas, the quality of subsequent levels appears to be of significantly lower quality than the original one or two storeys. A quick way to rapidly improve the likely performance of many incrementally constructed buildings would be for building owners to:

Figure 85 Housing ready for the next level

- Stop building further increments to their houses (this will help stop the problem from getting worse)
- Demolish the last floor that was added, especially the half complete/half damaged levels. This will lead to an immediate reduction of the most damaging seismic mass which was at height.
- Where incremental construction is carried out sideways, either the additional space needs to be fully structurally connected to the old building portion or constructed with an adequate seismic gap.
- Where there are plans to build an additional storey allowance must be made in the base design of the house for this extra load both in terms of foundation loads and seismic lateral force capacities. In addition rebar should extend at least to the mid height of the next level and be encased so as to be protected from corrosion.

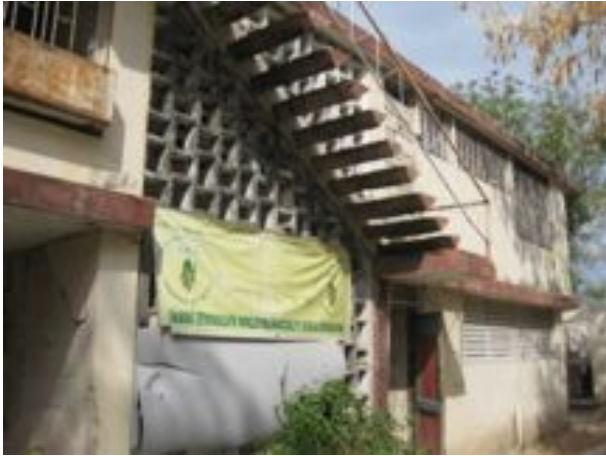
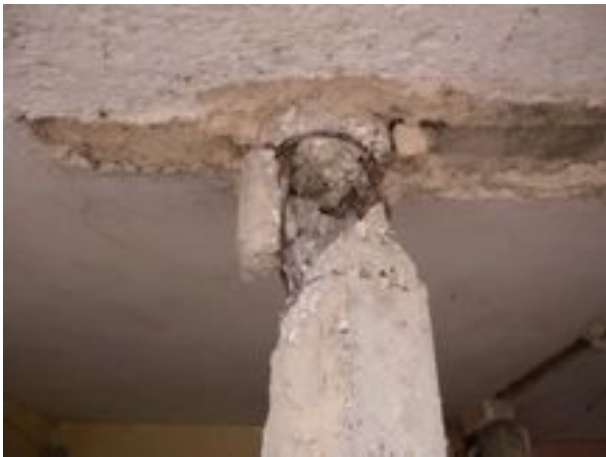
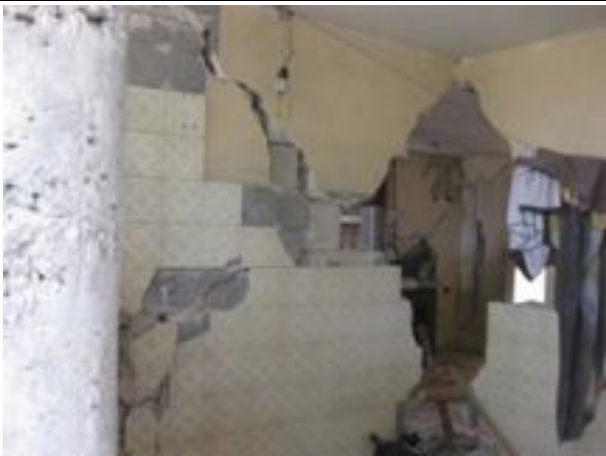
<p>South elevation (west side). delamination of stone masonry wall supporting 1st floor concrete slab</p>	<p>South elevation (east side). Some evidence of drift in lower storey.</p>

<p>North elevation. Note all architectural, hollow masonry infill have fallen out in the panel at lower storey. Unsymetric shape is evident.</p>	<p>Column shear failure at the top of the lower storey due to small column size and limited longitudinal and confinement reinforcement</p>

<p>East elevation showing failure of lower storey. Evidence of permanent drift.</p>	<p>Extensive cracking and failure of internal partitions at ground level.</p>
<p>Building Coordinates</p>	<p>Lat: N18°32.609', Long: W72°24.525'</p>
<p>Building Name:</p>	<p>LAMANTIN 54 Rue Blancourt #132 (Owner not present)</p>
<p>Site</p>	<p>Level ground. Two storey house with small out buildings in the grounds.</p>
<p>Building Description</p>	<p>Reinforced concrete frame with infill hollow concrete block masonry. Built on stone masonry foundations in ~1957.</p>

<p>Assessment Findings</p>	<p>Visible failure of the lower columns and major cracking and failure of the majority of masonry panels at ground level.</p>
<p>Rating</p>	<p>RED</p>
<p>Recommendations</p>	<p>Evacuate people camping in grounds surrounding house, cordon off the area and demolish using safe techniques.</p>

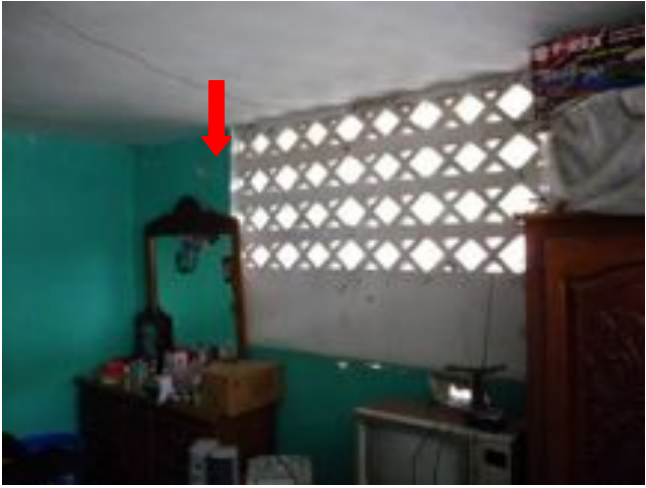
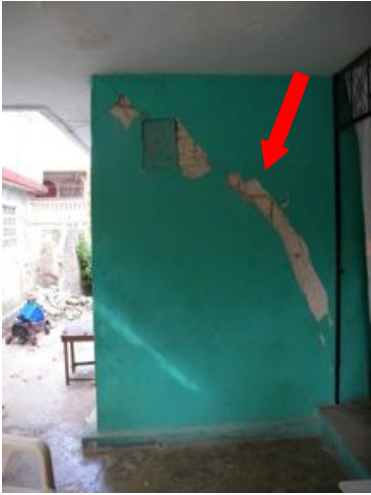
Minor cracking around blockwork window	Diagonal cracking in hollow concrete block wall damage is repairable

Rating	One storey house: YELLOW (This house may need to be rated RED depending on how neighbouring structures are dealt with.) Two storey house: RED Out house/kitchen structure: RED
Recommendations	The two storey house and the out house have been severely compromised by the earthquake and need to be demolished. The entire property should be cordoned off with protection provided to the single storey house and the 2 storey house and kitchen out house structure then demolished using safe techniques. Before demolition of adjacent buildings access to single storey house should be very limited and only to the south west corner of the house. Once dangerous structures in the compound are dealt with adequately, repairs to internal partitions in single storey can take place. Damaged blockwork to be replaced with new masonry panels.

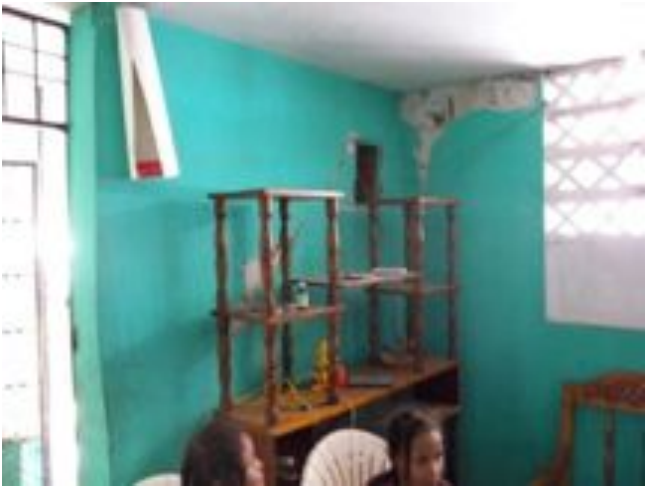
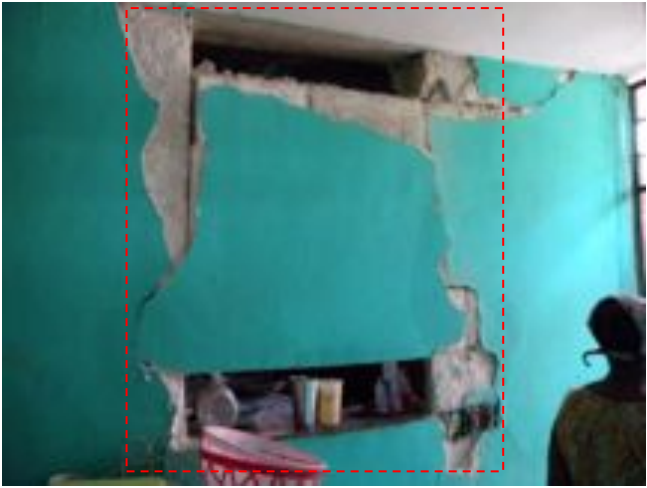
Shear damage in hollow concrete block walls	Failure of blockwork portion due to complete lack of masonry binding between adjacent wall panels and the fact that a lintel beam or similar was not used
Building Coordinates	Lat: N18° 32.630', Long: W72° 24.531'
Building Name:	LAMANTIN 54, Rue Blancourt #772 (Owner/Occupier: Anelia Paul)
Site	Level ground. Single storey house. Built in 1996.
Building Description	Single storey concrete frame with concrete hollow block infill masonry panels. Concrete roof (likely to contain hollow blocks as void formers). House was rectangular and had many internal walls. Relatively rigid roof diaphragm will have mobilised all walls to help resist the earthquake. The fact that the 2 nd floor had not been built was very lucky. Building was being used during the day. Unclear if people slept in it during the night.

Assessment Findings	Shear failure of hollow concrete infill blocks.
Rating	YELLOW
Recommendations	Repairs required to internal partitions. Damaged blockwork to be replaced with new masonry panels. Add lintel beams or similar where necessary. Do not construct a second level unless significant strengthening work is undertaken.

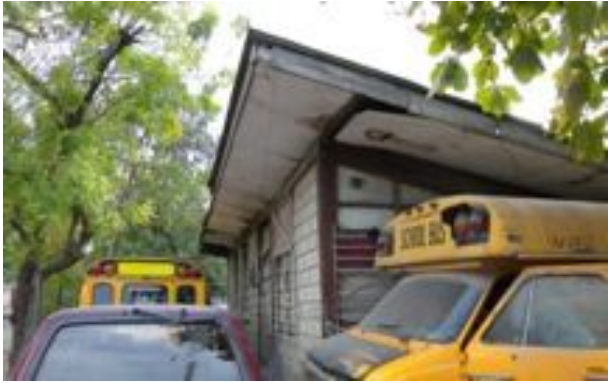
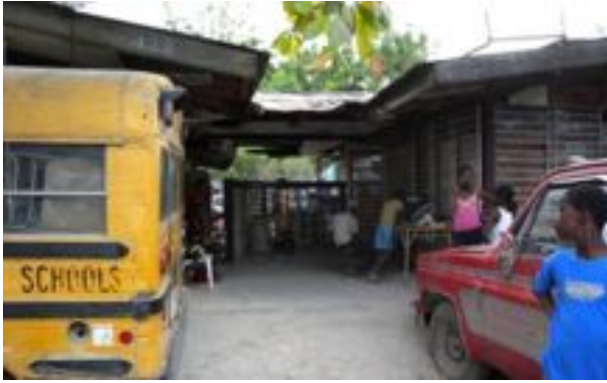
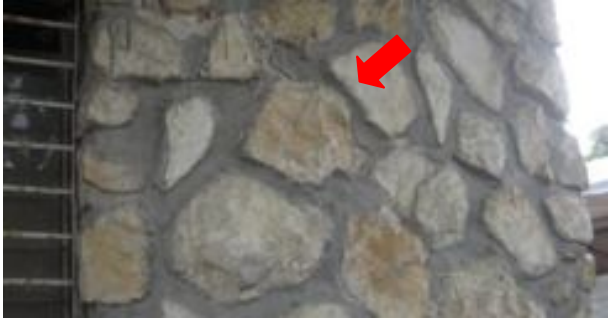
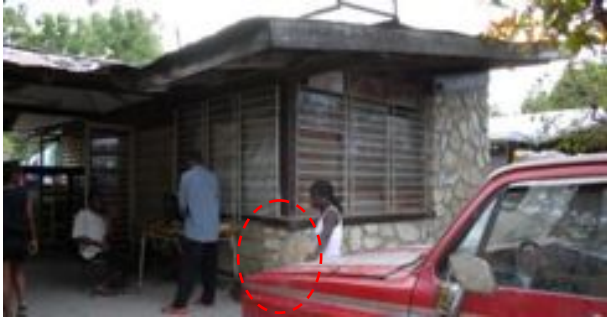
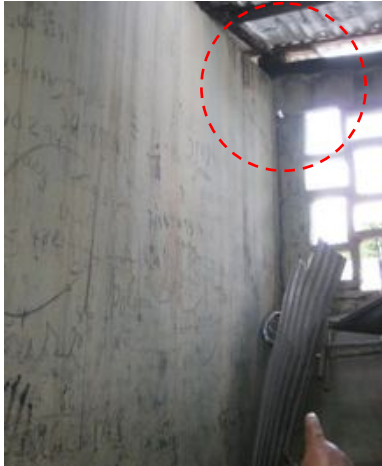
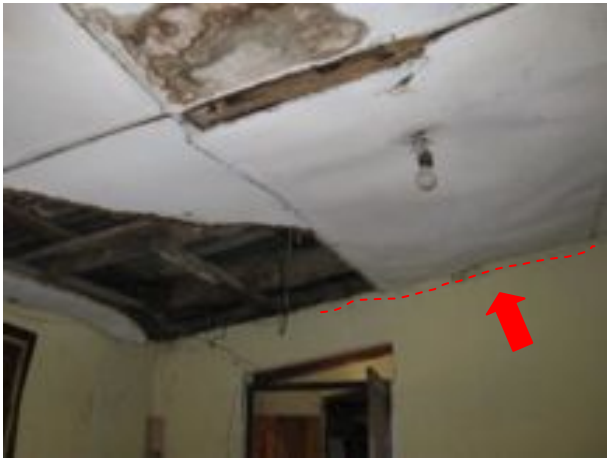
View of east wing of the house	View of both east and west wing of the house with a roof link

Very minor cracks evident in stone masonry panel at front of house	View of west wing of the house. Stone masonry looks as if it is a facade

Minor cracking at orthogonal wall junction and opening	Cracking at the head of the walls where one would normally find ring beam or timber head element – possibly there is one present
Building Coordinates	Lat: N18° 32.621', Long: W72° 24.540'
Building Name:	LAMANTIN 54, Rue Blancourt #133 (Owner/Occupier: Kethly G Bloncourt)
Site	Level ground. Single storey house.
Building Description	Single storey building (built in 1957) has two wings which are linked by a covered area in the centre. Building is a appears to be a combination of reinforced concrete and hollow concrete block masonry. House has been incrementally increased in size on plan. Roof is a slanting light weight timber frame roof with metal sheeting in a poor state of repair.

Assessment Findings	Some minor cracking in stone and block masonry, however much of these could have been prior to earthquake. Concrete blocks are laid in even courses using strong mortar in both the horizontal and vertical joints.
Rating	GREEN
Recommendations	Owner had plans to replace the roof due to its poor state of repair since before the earthquake with a new lightweight roof. The owner should at the same time review the state of the perimeter walls when the current roof is removed and replace any masonry which appears cracked and loose. Before installation of new roof the owner needs to ensure that there is an adequate ring beam structure at the top of the walls.

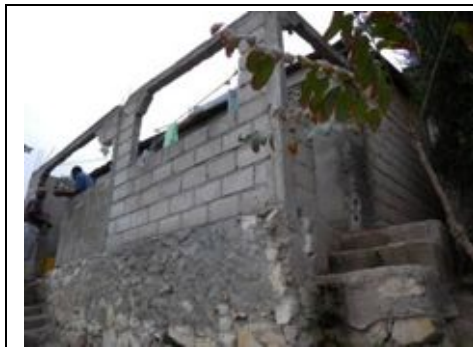
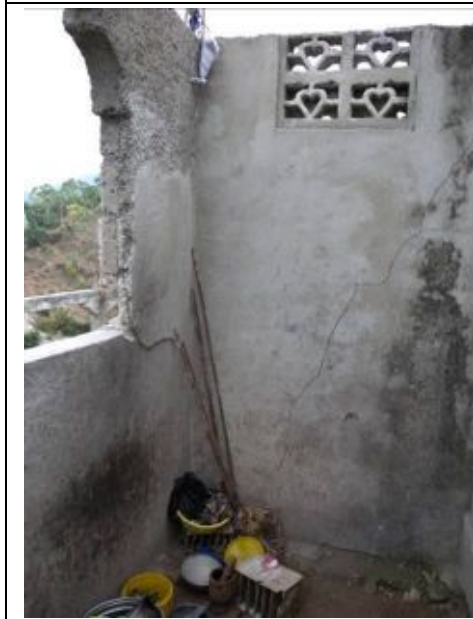
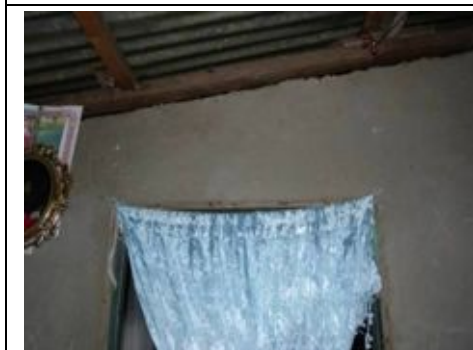
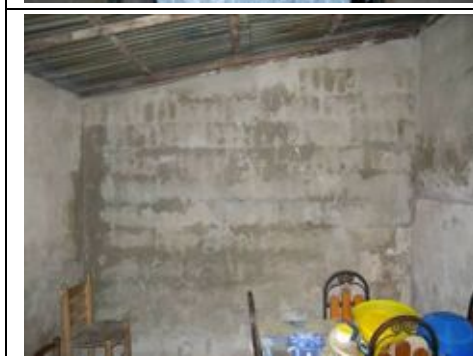
Property 1, Housing Type (C3-HM-TCR)

- Foundation is made of stone masonry.
- Building frame does not appear to be anchored into the foundations.
- Roof level diaphragm missing on the front, possibly veranda portion.
- Top of walls in the portion with a roof does not appear to have a ring beam.
- Roof overhang is small, providing limited protection to the walls from heavy rain.
- Building is built very close to terrace edge.
- No lintel beams over doors.
- Not apparent that roof is adequately strapped to the walls and columns.

- Move front veranda wall back from the edge of the terrace.
- Add lintel beams across doors.
- Add roof ring beam across all walls (connecting into the columns).
- Provide strapping to tie roof to ring beam.
- Repair cracked blocks with new masonry blocks.
- Do not ever extend upwards.
- Provide proper framing around windows and doors.
- Add gutters to the roof.
- Anchor walls into the foundations (this will require temporary shoring and is tricky work).

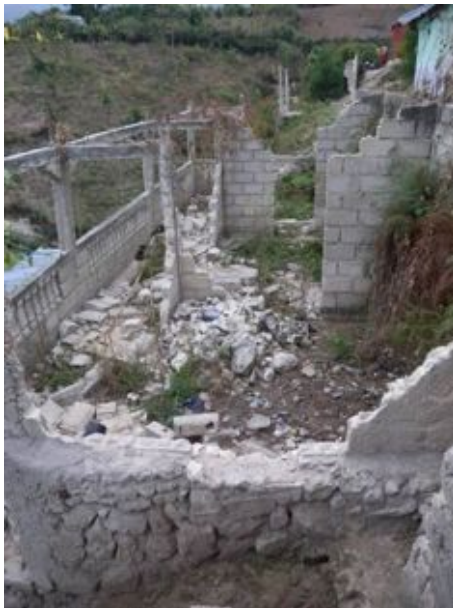
Property 2, Housing Type (C3-HM-TCR)

- Building was incomplete at the time of the earthquake.
- Foundation is made of stone masonry.
- Building frame does not appear to be anchored into the foundations.
- Rear building wall is built against the slope.
- Next to no mortar in the vertical masonry joints.

- Move back wall away from the back slope.
- Provide regular cross walls / buttresses to walls (ensure blocks are interlocked).
- New RC members to make use of seismic hooks
- Add lintel beams across doors.
- Add roof ring beam across all walls (connecting into the columns).
- Provide strapping to tie roof to ring beam.
- Do not ever extend upwards.
- Provide proper framing around windows and doors.
- Add gutters to the roof.

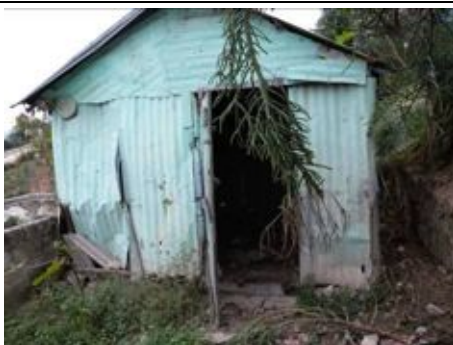
Property 3, Housing Type (TCWR)

- Appears unaffected by the earthquake
- Currently not habitable due to the dirt inside the building.
- Foundation is made of stone masonry (terrace front wall)

- Building to be cleaned
- May require a new floor
- Building frame to be strengthened
- Gutters are required
- Holes to be patched
- See basic shelter guidelines

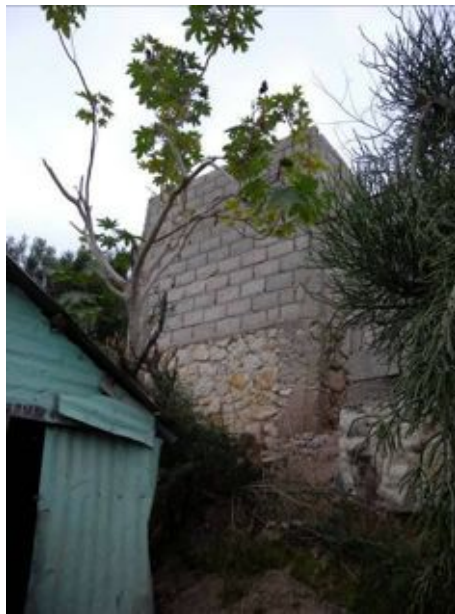
Property 4 Housing Type (C3-HM-TCR)

- Foundation is made of stone masonry.
- Building frame does not appear to be anchored into the foundations.
- One wall face built on same line as the terrace wall.
- Next to no mortar in the vertical masonry joints.

- Move wall away from the front terrace wall
- Provide regular cross walls / buttresses to walls (ensure blocks are interlocked).
- New RC members to make use of seismic hooks
- Add roof ring beam across all walls (connecting into the columns) and strap roof to the ring beam.
- Do not ever extend upwards.
- Add gutters

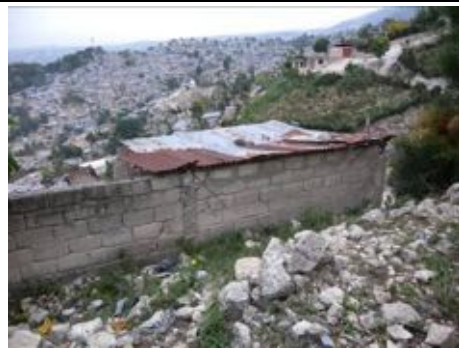
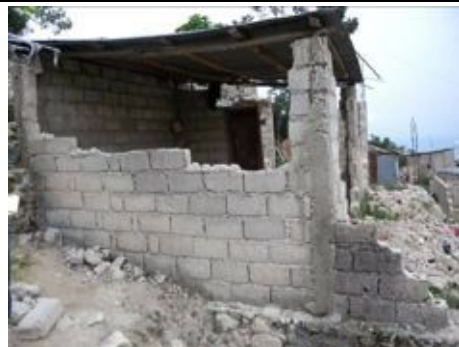
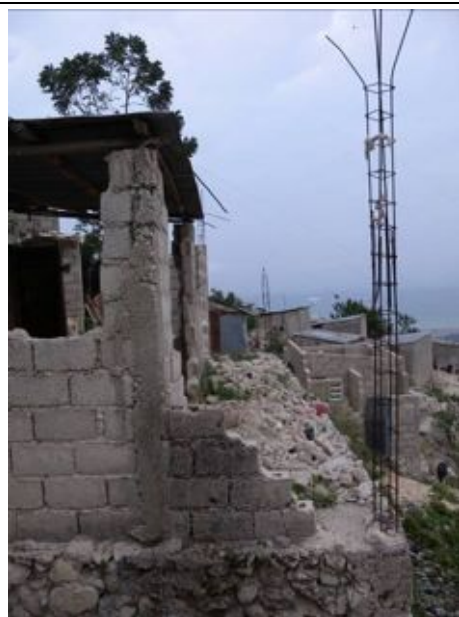
Property 5 Housing Type (C3-HM-TCR)

- Building was partially incomplete at the time of the earthquake.
- Foundation base is SMF.
- Building frame does not appear to be anchored into the foundations.
- Rear building wall is partially built against the slope.
- Next to no mortar in the vertical masonry joints.

- Move back wall away from the back slope.
- Provide regular cross walls / buttresses to walls (ensure blocks are interlocked).
- New RC members to make use of seismic hooks
- Add lintel beams across openings.
- Add roof ring beam across all walls (connecting into the columns) and properly strap to tie roof to ring beam.
- Do not ever extend upwards.
- Add gutters to the roof.

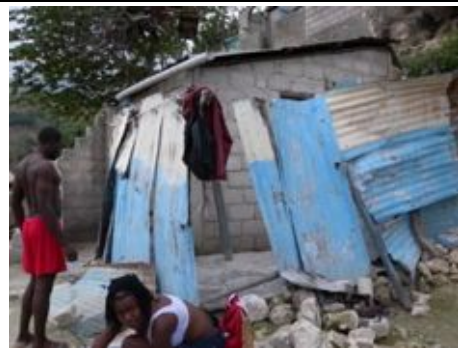
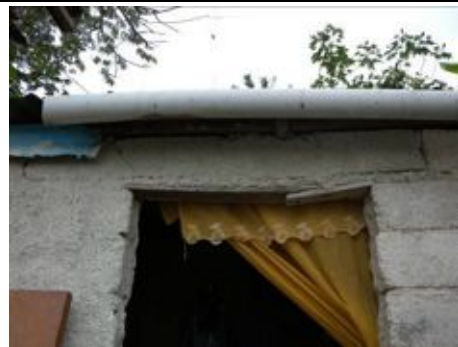
Property 6 Housing Type (UHM-TCR)

- Foundation system unknown.
- Rear building wall appears to be built against the slope.
- Size approximately 3x3m
- Next to no mortar in the vertical masonry joints.

- Move back wall away from the back slope.
- Add roof ring beam across all walls (connecting into the columns) that doubles as lintel beam.
- Provide strapping to tie roof to ring beam.
- Do not ever extend upwards.

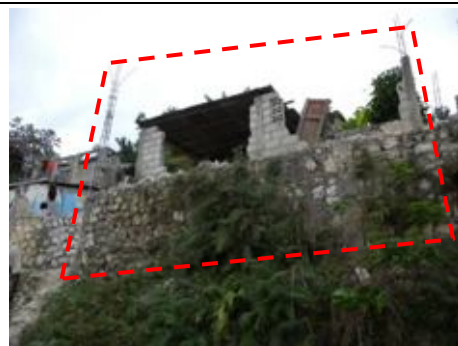
Property 7 Housing Type (C3-HM-TCR)

See Recommendations for property 5 – In reviewing the photo this is probably property 5 photographed one level further down the hill.
Note the extensive stone masonry walls to form the terraces.

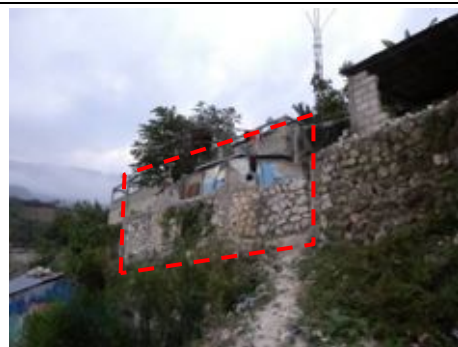
Property 8 Housing Type (TCWR)

- Appears unaffected by the earthquake
- See basic shelter guidelines
- Repair stone masonry walls if so required.

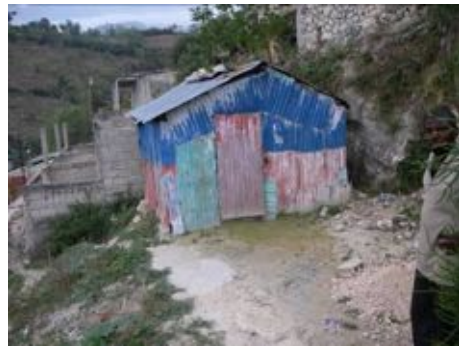
Property 9 Housing Type (TCWR)

- Appears unaffected by the earthquake
- In danger of rock fall from higher ground
- See basic shelter guidelines as these will be more appropriate for this type of property

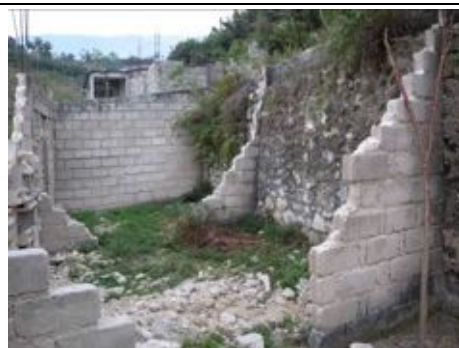
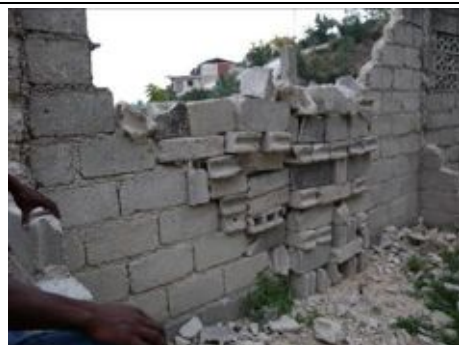
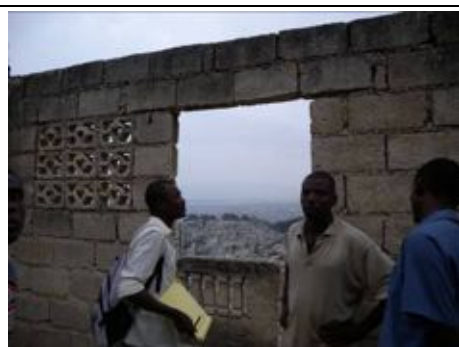
Property 10 Housing Type (C3-HM-TCR)

- Building was partially incomplete at the time of the earthquake.
- Foundation base is SMF (certainly for the terraces).
- Rear building wall is built against the slope.
- Rear wall was made from stone masonry that appears to be undamaged
- Next to no mortar in the vertical masonry joints.

- Move back wall away from the back slope if possible to do so
- Provide regular cross walls / buttresses to walls (ensure blocks are interlocked), may want to introduce small buttress lines to internal cross walls.
- Add lintel beams across openings.
- Add roof ring beam across all walls (connecting into the columns) and properly strap to tie roof to ring beam.
- Do not ever extend upwards.
- Add gutters to the roof.

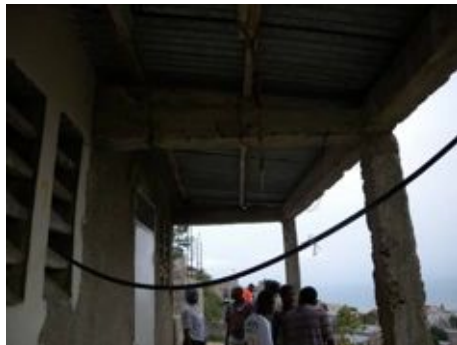
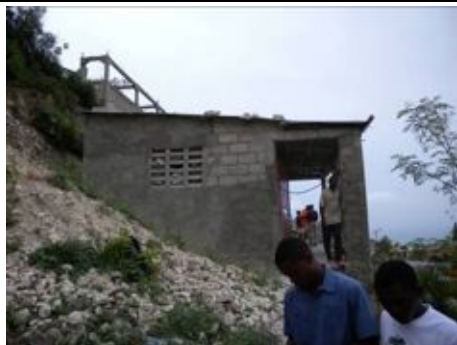
Property 11 Housing Type (C3-HM-TCR)

- Foundation base is SMF (certainly for the terraces).
- Rear building wall is built partially built against slope.
- Next to no mortar in the vertical masonry joints.
- Roof held down by rocks.
- Openings are small and central

- Move back wall away from the back slope if possible to do so.
- Add lintel beams across openings.
- Add roof ring beam across all walls (connecting into the columns) and properly strap to tie roof to ring beam.
- Do not ever extend upwards.
- Add gutters to the roof.
- Consider adding reinforced concrete stitches at corners

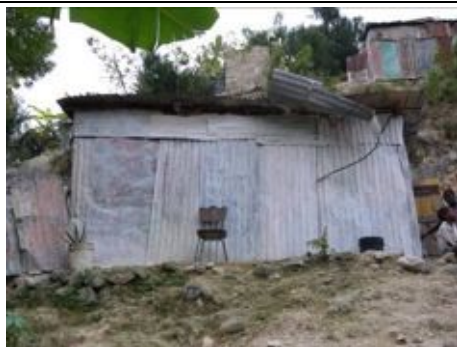
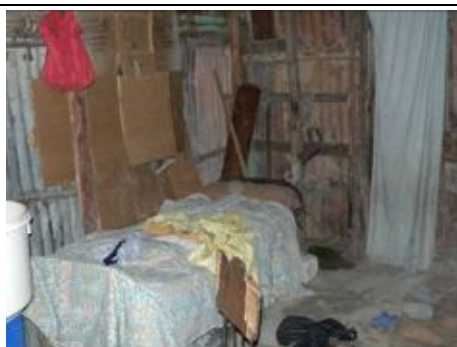
Property 12 Housing Type (TCWR)

- Appears unaffected by the earthquake
- Terrace walls are virtually non existent.
- See basic shelter guidelines as these will be more appropriate for this type of property.
- (There were 3-4 children under the aged of 5/6 in this house without adults during the day)

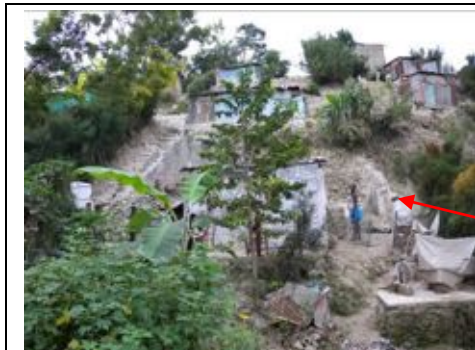
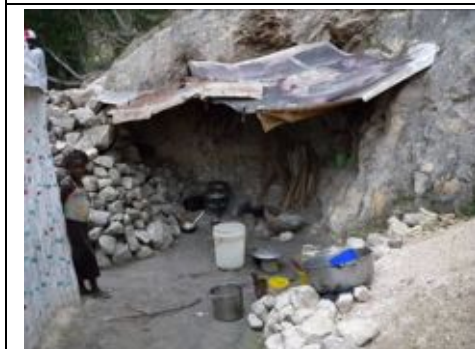
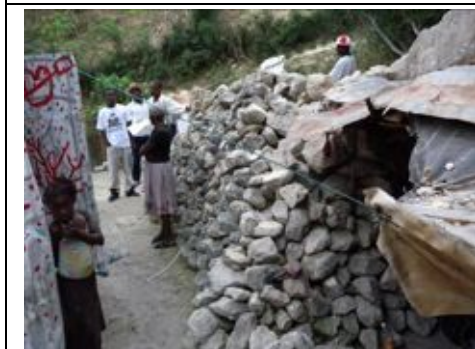
Property 13 Housing Type (TCWR)

- Appears unaffected by the earthquake
- This building plot was fairly unique in that the plot appears to have been carved into the rock.
- Even the plot wall appears to have been carved out of the rock.
- Plot is on the edge of the community close to the natural drainage path of the hillside.
- See basic shelter guidelines as these will be more appropriate for this property.
- Residents were adamant that their rock piles had not fallen over during the earthquake.
- It is possible that the residents traded in the stones, though this was not totally clear during the brief visit to the property.
- Kitchen is outside
- The plot has a latrine which was on the whole unusual for this community.

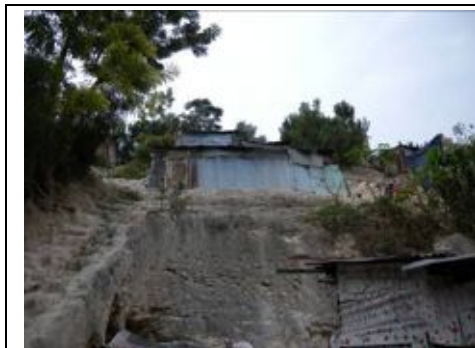
**Property 14 Housing Type (TCWR)**

- Appears unaffected by the earthquake
- Lower terrace wall was carved into the hillside and is the rear wall for property 13.
- See basic shelter guidelines as these will be more appropriate for this type of property.

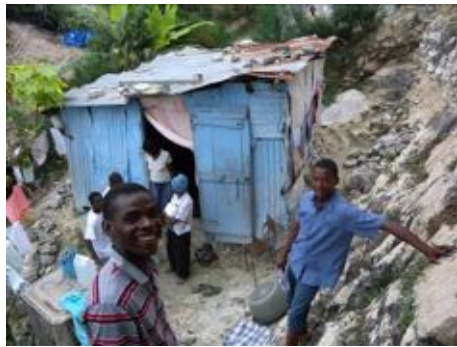
Property 15 Housing Type (TCWR)

- Appears unaffected by the earthquake
- Lower terrace wall was carved into the hillside.
- See basic shelter guidelines as these will be more appropriate for this type of property.

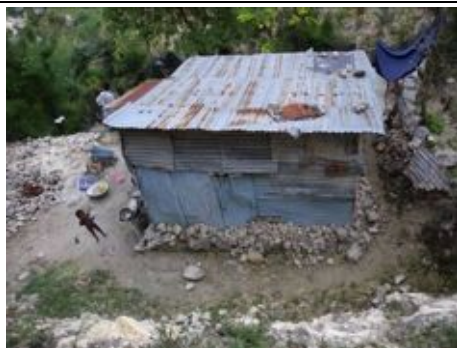
Property 16 Housing Type (TCWR)

- Appears unaffected by the earthquake
- Lower terrace wall was carved into the hillside.
- See basic shelter guidelines as these will be more appropriate for this type of property.
- Note the rock armour around the building base

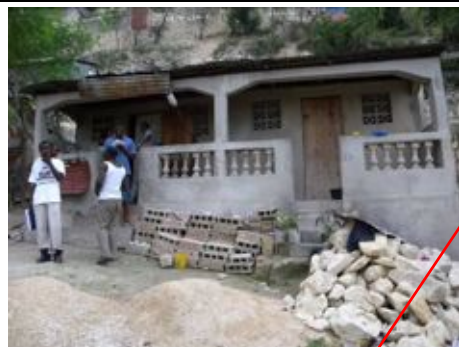
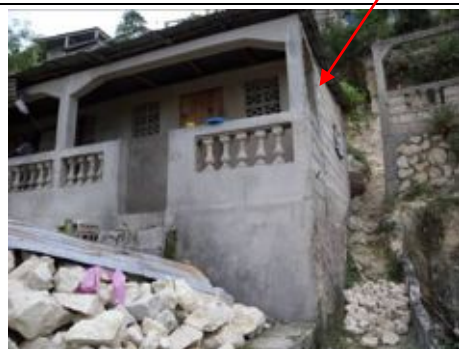
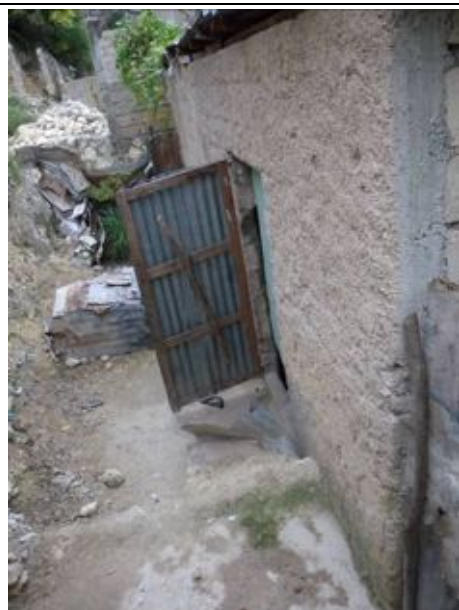
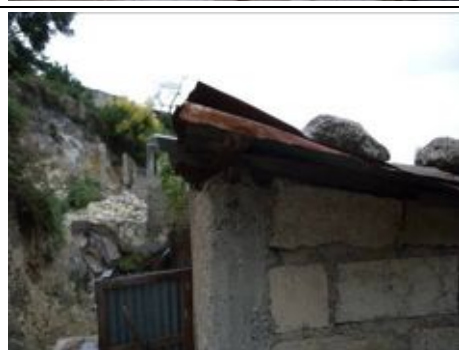
Property 17 Housing Type (C3-HM-TCR)

- Building appears in relative good condition.
- Some bulging of walls perpendicular to the hill
- Foundation base is SMF.
- Rear building wall is partially built against the slope.
- Next to no mortar in the vertical masonry joints.

- Provide regular cross walls / buttresses to bulging walls (ensure blocks are interlocked).
- Add lintel beams across openings if this does not exist.
- Add roof ring beam across all walls (connecting into the columns) and properly strap to tie roof to ring beam (currently rocks are being used to help hold the roof down).
- Do not ever extend upwards.
- Add gutters to the roof.
- Consider post installing reinforced concrete stitches to better link the columns to the masonry
- Entrance door appears to be on a low point within the building plot. This is not good in terms of preventing water entry during heavy rainfall.

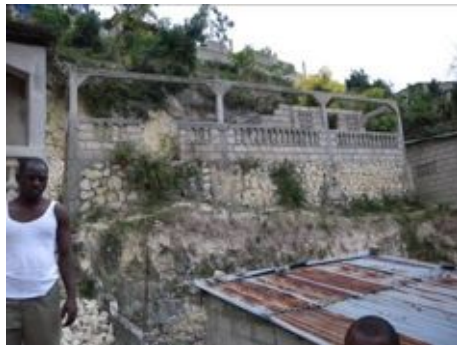
Property 18 Housing Type (C3-HM-TCR)

- Building was not complete.
- Hollow block walls appear to have failed.

- If house is to be completed, good opportunity exists to strengthen and complete using appropriate seismic design features.
- Evaluate stability of front terraces and rear plot face which appears to have been cut into the hill.

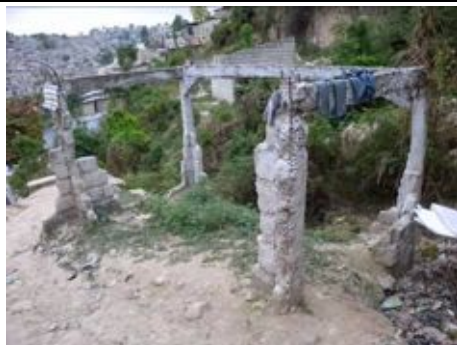
Property 19 Housing Type (C3-HM-TCR)

- Location is also next to the water course which is why it looks as though it has been abandoned
- Building was not complete and even then what is here looks to be in poor state.

- In all probability do not consider building at this location due to proximity to water path.

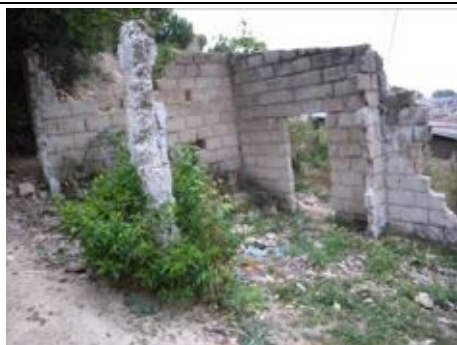
Property 20 Housing Type (C3-HM-TCR)

- Unclear why it looks as though it has been abandoned.
- Building was not complete and even then what is here looks to be in poor state.

Evaluate safety of the plot before doing anything else.

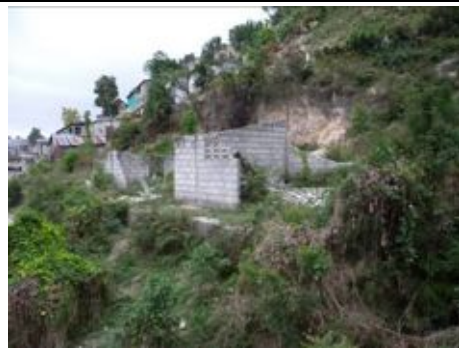
Property 21 Housing Type (C3-HM-TCR)

- Unclear why it looks as though it has been abandoned.
- Building was not complete

Evaluate safety of the plot before doing anything else. Terrace front and rear walls need to be built.

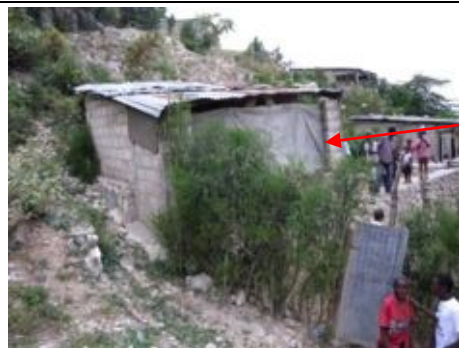
Property 22 Housing Type (UHM-TCR)

- Side walls appear to have fallen though masonry appears undamaged. Either way the side is closed by plastic sheeting.
- Foundation base is SMF.
- Rear building wall is partially built against the slope.
- Next to no mortar in the vertical masonry joints.

Consider post installing reinforced concrete stitches to better link the columns to the masonry

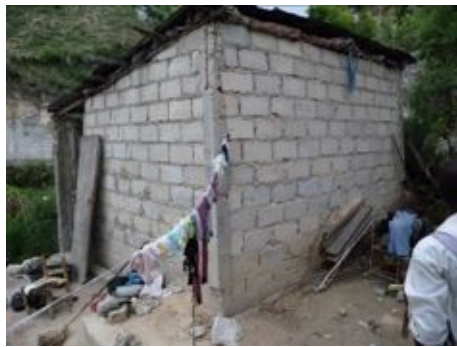
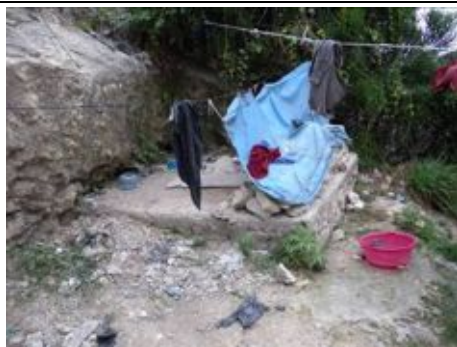
Property 23 Housing Type (C3-HM-TCR)

- Simple one room house (~3x3m, max 4x4m)
- Foundation base is SMF.
- Surprisingly there is mortar in the vertical masonry joints.
- Some sort of timber wall ring beam is present.
- Light roof, no gutters
- External latrine is present, again made from stone masonry.

- Add roof ring beam across all walls (connecting into the columns) and properly strap to tie roof to ring beam (currently rocks are being used to help hold the roof down).
- Do not ever extend upwards.
- Add gutters to the roof.
- Consider post installing reinforced concrete stitches to better link the columns to the masonry
