Oxfam GB

Haiti Earthquake Response

Arup Assignment Report

May 2010

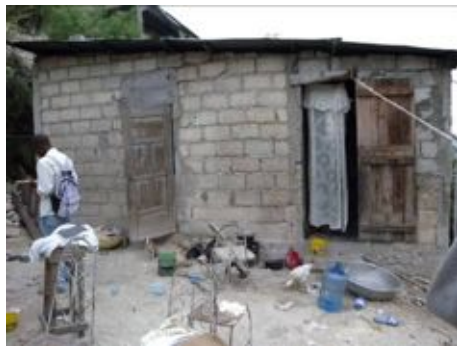
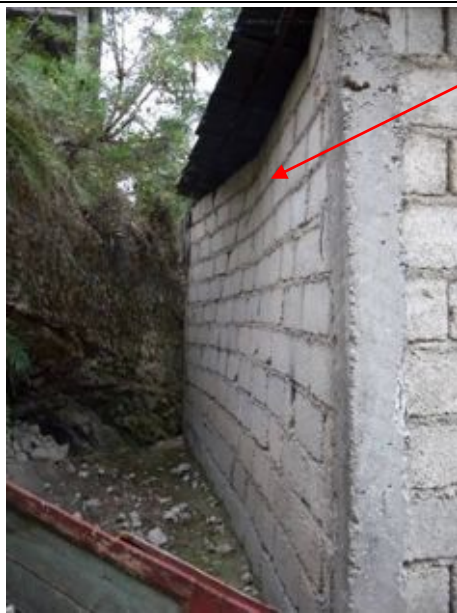
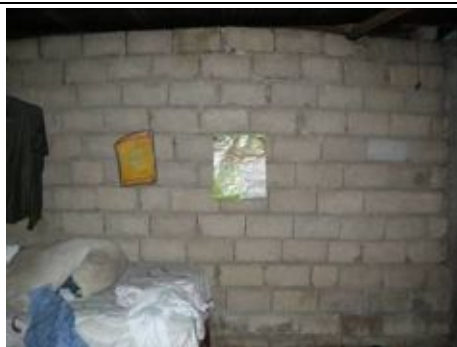
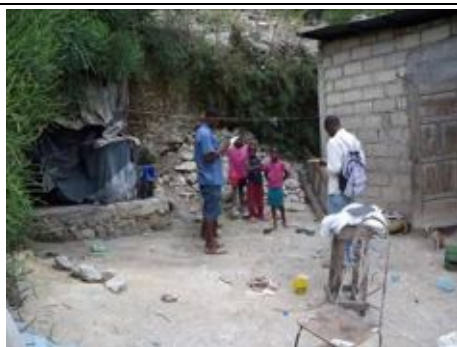
Property 24 Housing Type (C3-HM-TCR)

- Two room house (rooms are ~3x3m, max 4x4m)
- Foundation base is SMF.
- Next to no mortar in the vertical masonry joints.
- Light roof, with some sort of gutters
- External latrine is present, again made from stone masonry.
- Rear wall has nearly failed out of plane and is showing severe levels of bulging. No ring beam present.
- Property has been built incrementally
- No lintel beams were used.

- Rebuild rear wall.
- Add roof ring beam across all walls (connecting into the columns) and properly strap to tie roof to ring beam (currently rocks are being used to help hold the roof down).
- Do not ever extend upwards.
- Add gutters to the roof.
- Consider post installing reinforced concrete stitches to better link the columns to the masonry
- Stability of plot rear soil wall to be evaluated – could be unstable and result in small local slope stability problem.

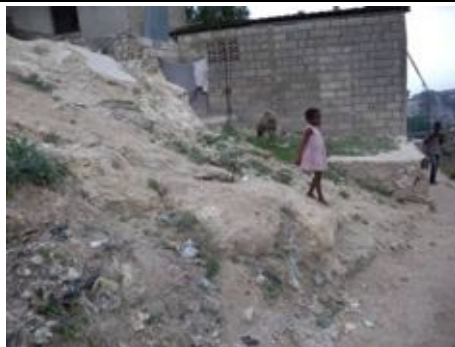
Property 25 Housing Type (C3-HM-TCR)

- Foundation base is made from stone masonry
- Next to no mortar in the vertical masonry joints.
- Light roof
- Property has been built incrementally (door has been boarded up)
- No lintel beams have been used though some sort of a timber ring beam is present

Consider post installing reinforced concrete stitches to better link the columns to the masonry

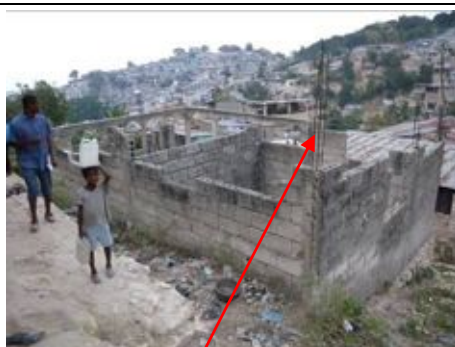
Property 26 Housing Type (C3-HM-TCR)

Note the triangular column reinforcement cages with next to no hoops.

- Incomplete 2 to 3 bed room property
- Foundation base is made from stone masonry
- Next to no mortar in the vertical masonry joints.
- Assume it would have had a light roof
- No lintel beams have been used and concrete ring beams are not present over the masonry walls which have started to fail out of plane.
- Rear wall is built against the slope (this may have limited the levels of free vibration of the building during the earthquake).

- Add roof ring beam across all walls (connecting into the columns) and properly strap to tie roof to ring beam (currently rocks are being used to help hold the roof down).
- Rebuild columns and properly anchor them into the foundations.
- Add gutters to the roof.
- Consider post installing reinforced concrete stitches to better link the columns to the masonry

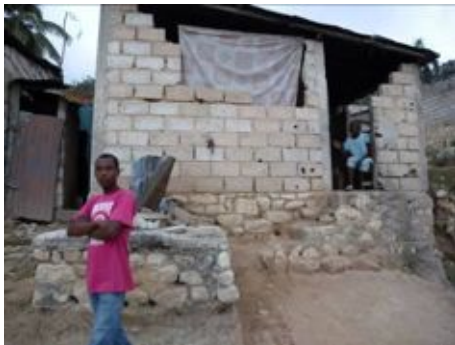
Property 27 Housing Type (C3-HM-TCR)

- Foundation base is made from stone masonry which appears undamaged
- Surprisingly there is mortar in the vertical masonry joints though the mortar looks more like soil mortar than sand cement mortar
- Light roof
- No lintel beams have been used though some sort of a timber ring beam is present
- Out of plane failure of walls present
- The blocks that were used look second hand
- No apparent connection between the concrete and block masonry wall construction and the stone masonry foundations.

- Add roof ring beam across all walls (connecting into the columns) and properly strap to tie roof to ring beam (currently rocks are being used to help hold the roof down).
- Add gutters to the roof.
- Consider post installing reinforced concrete stitches to better link the columns to the masonry
- Consider extending the foundation base so that the building is not so much on the edge of the wall.

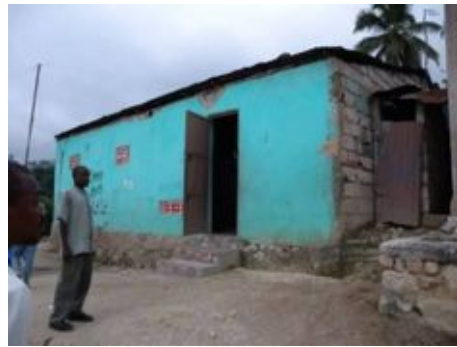
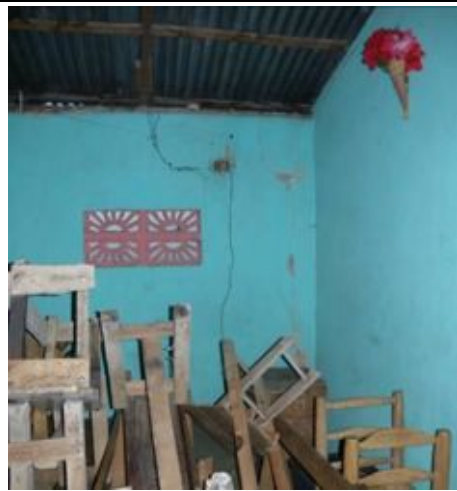
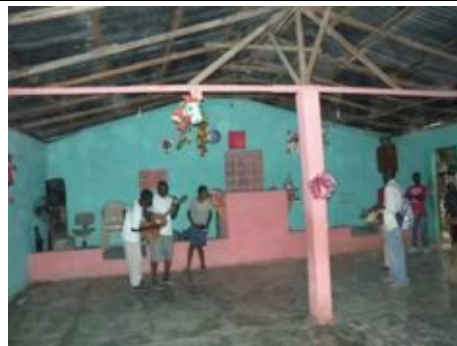
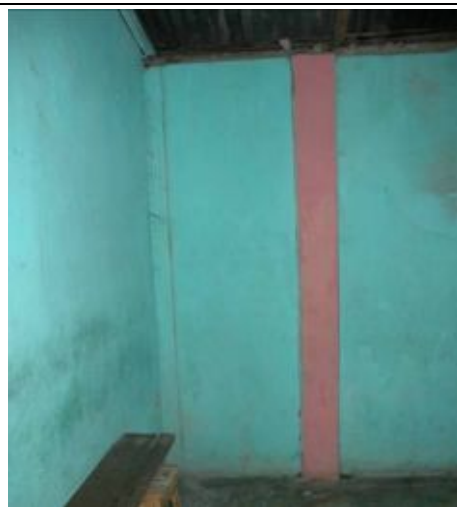
Property 28 - Church Housing Type (C3-HM-TCR)

- Foundation base is made from stone masonry which appears undamaged
- Timber roof truss only building with a larger span in this community
- No lintel beams appear to have been used
- A timber ring beam is present at the top of the walls
- Out of plane failure of walls was not observed.
- Very few opening and then they are small
- Regular shape

- Strengthen roof ring beam across all walls (connecting into the columns) and properly strap to tie roof to ring beam (currently rocks are being used to help hold the roof down).
- Add gutters to the roof.
- Consider post installing reinforced concrete stitches to better link the columns to the masonry
- Consider extending the foundation base so that the building is not so much on the edge of the wall.
- Consider adding horizontal in plane bracing to the roof trusses and vertical cross bracing between the centre of adjacent trusses
- Repair damage masonry blocks by replacing them with new blocks.

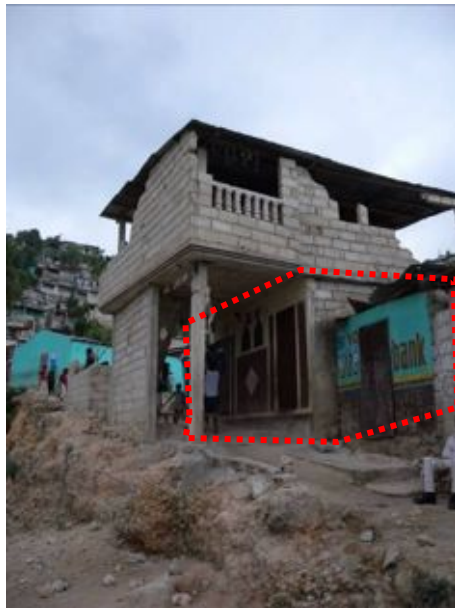
Property 29 Housing Type (C3-HM-TCR)

- Foundation base is made from stone masonry
- Only two storey building seen within this community
- No lintel beams appear to have been used
- Wall ring beam are missing
- Out of plane failure of upper walls was observed.
- Very many openings and irregular shape (surprising that it did not collapse)

- Community should reconsider having a building straddling the community walkway.
- Building needs proper foundations
- Suggest removal of the top storey and the portion over the path – Consider only retaining the section shown within the red box.
- Walls to be strengthened against out of plane failure (add extra posts or masonry buttresses to the existing masonry walls)

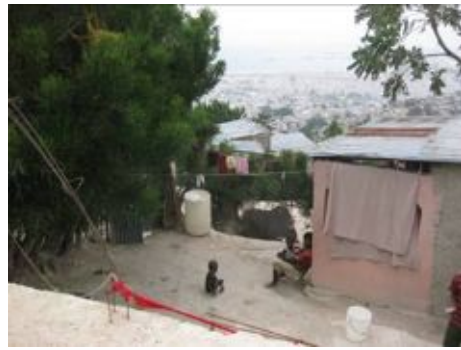
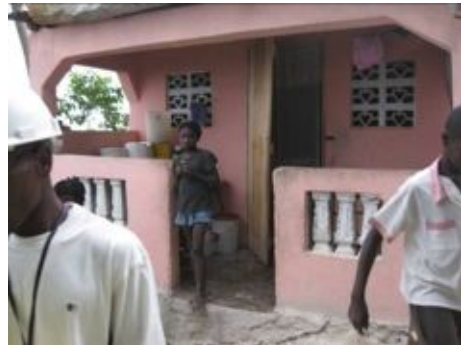
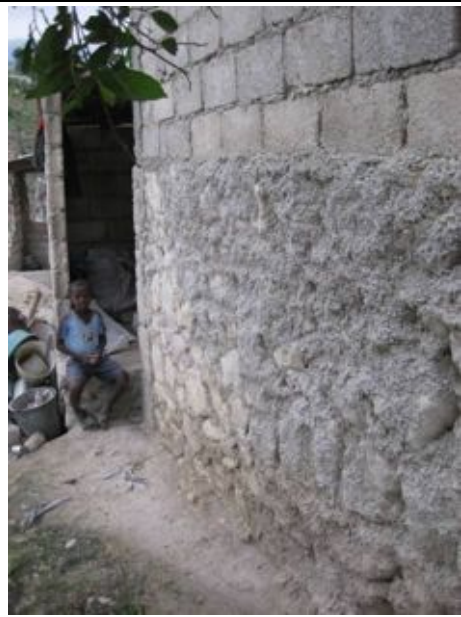
Property 30 Housing Type (C3-HM-TCR)

- Foundation is made of stone masonry.
- No apparent significant damage
- Light timber sloping roof
- Wall ring beam missing
- Limited mortar in the vertical masonry joints.

- Evaluate stability of front terrace wall
- Add wall ring beam if it is missing

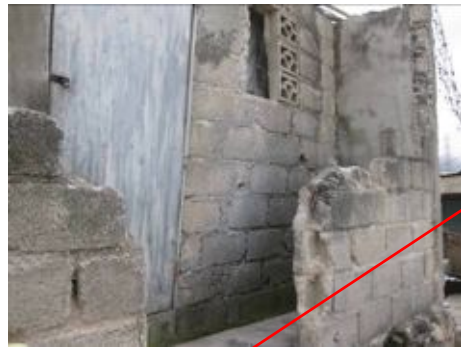
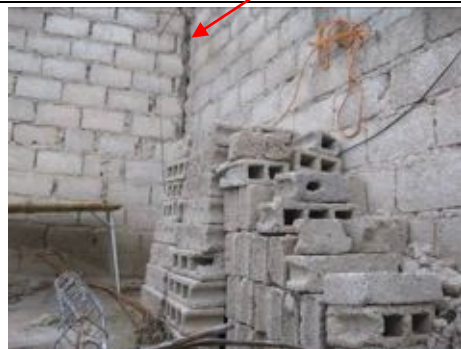
Property 31 Housing Type (C3-HM-TCR)

- Foundation is made of stone masonry.
- Start of separation at poorly interlocked wall junctions
- Limited mortar in the vertical masonry joints.

- Consider rebuilding wall corners in reinforced concrete that is stitched into the existing walls.
- Add lintel beams across openings
- Add roof ring beam across all walls (connecting into the columns).
- Provide strapping to tie roof to ring beam.
- Do not build a second floor

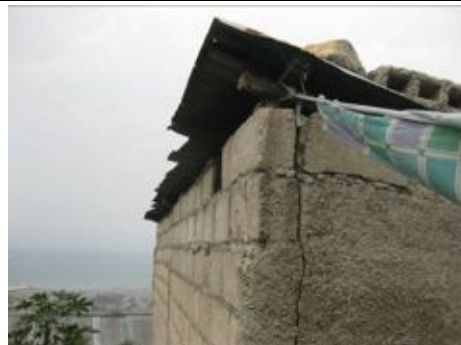
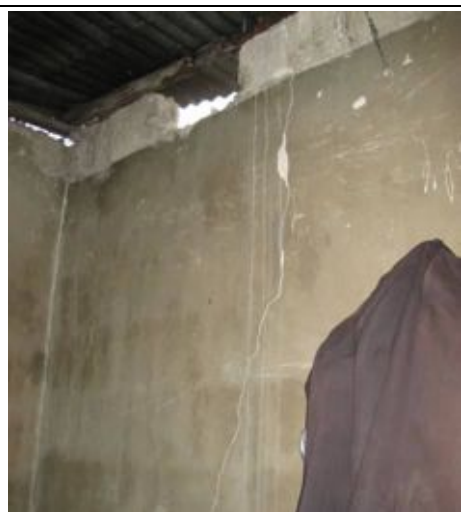
Property 32 Housing Type (UHM-TCR)

- Foundation is made of stone masonry.
- Top of walls does not appear to have a ring beam.
- Roof is not adequately strapped to the walls
- Separation of walls at wall junctions (poor interlock of walls)

- Provide regular cross walls / buttresses to walls (ensure blocks are interlocked).
- Consider post installing members in corners (make use of seismic hooks) and bond into existing wall panels
- Add roof ring beam across all walls (connecting into the columns).
- Provide strapping to tie roof to ring beam.
- Do not ever extend upwards.
- Add gutters to the roof.
- Repair cracked blocks with new masonry blocks.

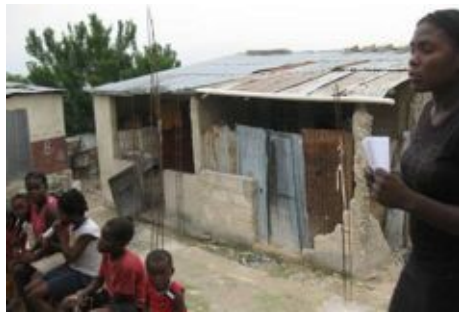
Property 33 Housing Type (C3-HM-TCR)

- Foundation is made of stone masonry.
- Top of walls does not appear to have a ring beam.
- Out of plane failure of cantilevering wall portions observed

- Provide capping beams to half height walls to help restrain them against out of plane failure
- New RC members to make use of seismic hooks
- Add lintel beams across door and windows.
- Add roof ring beam across all walls (connecting into the columns).
- Provide strapping to tie roof to ring beam.
- Do not ever extend upwards.
- Add gutters to the roof.

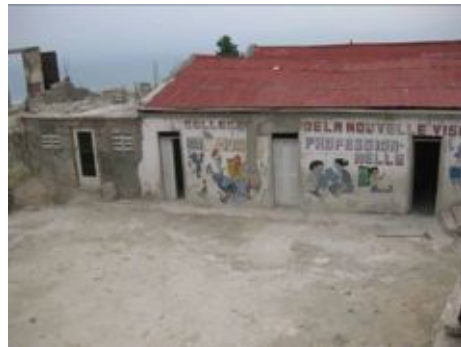
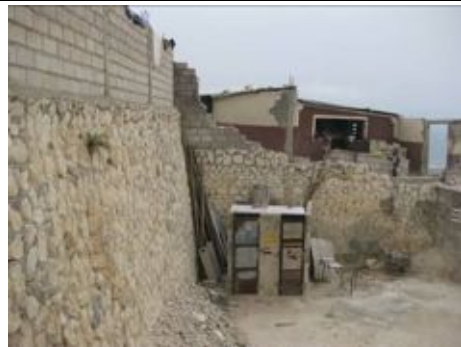
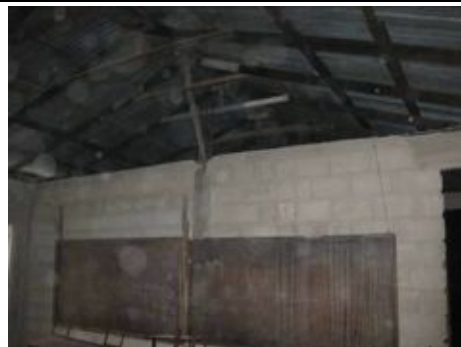
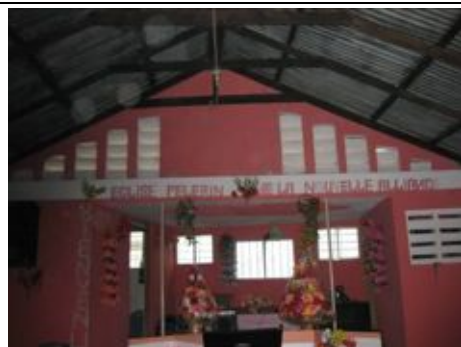
Property 34 – Community Hall / School/ Church Housing Type (C3-HM-TCR)

- High stone masonry perimeter wall. Block work wall built on top partially collapsed probably pulling top portions of the stone wall down with it
- Foundation of building is made of stone masonry.
- Roof in one portion is concrete block and beam slab construction (C4-HBFS-UHM)
- One support column removed for room size alteration
- Building is built very close to terrace edge.
- Not sufficient top restraint to large internal block work walls.

- Provide regular cross walls / buttresses to walls (ensure blocks are interlocked).
- Add lintel beams across doors and windows
- Add roof ring beam across all walls (connecting into the columns).
- Provide strapping to tie roof to ring beam.
- Do not ever extend upwards.
- Provide horizontal bracing at wall level
- Add gutters to the roof.
- Move front veranda wall back from the edge of the terrace.
- Repair cracked blocks with new masonry blocks

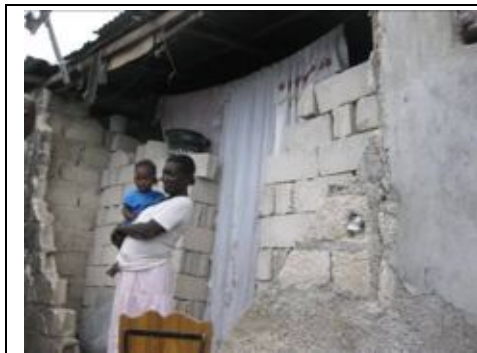
Property 35 Housing type (C3-HM-TCR)

Broadly see comments for property 27

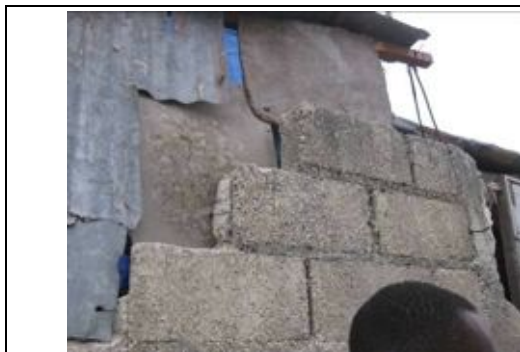
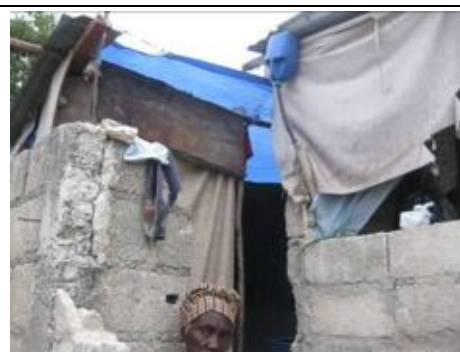
Property 36 Housing type (C3-HM-TCR)

Broadly see comments for property 27

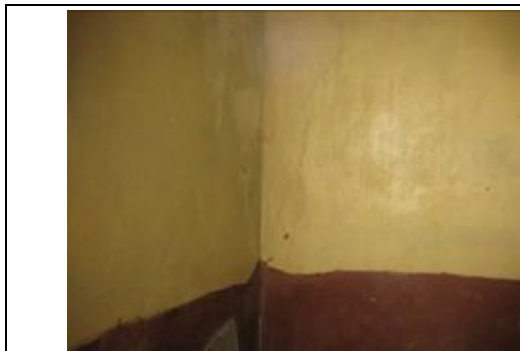
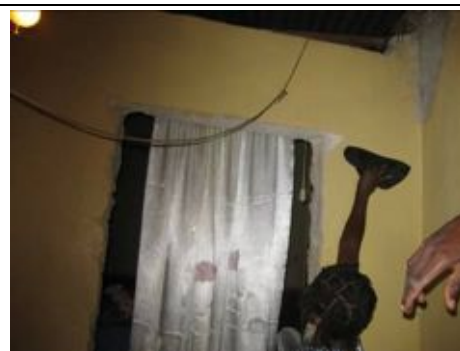
Property 37 Housing Type (UHM-TCR)

Broadly see comments for property 32

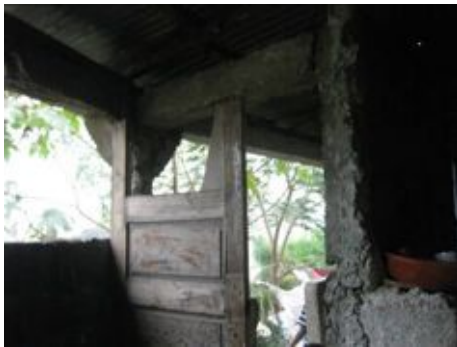
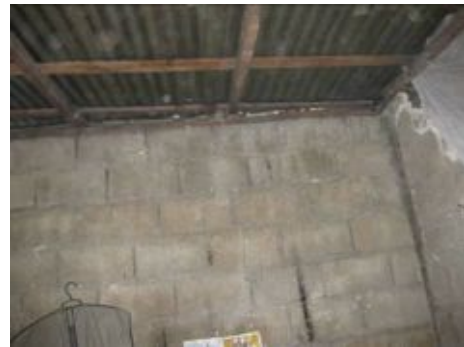
Property 38 Housing type (C3-HM-TCR)

Broadly see comments for property 27

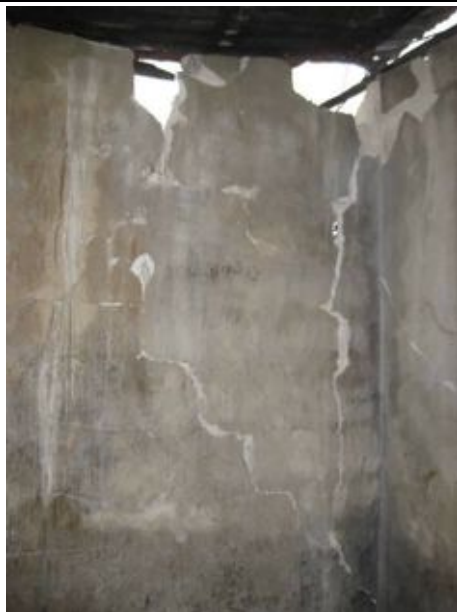
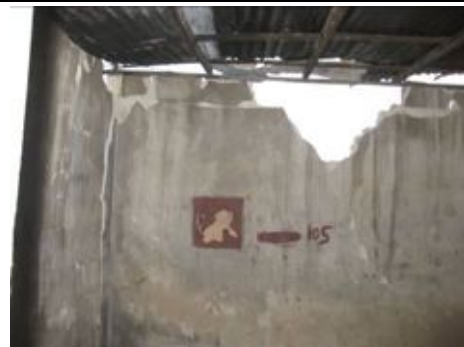
Property 39 Housing Type (C3-HM-TCR)

Broadly see comments for property 27

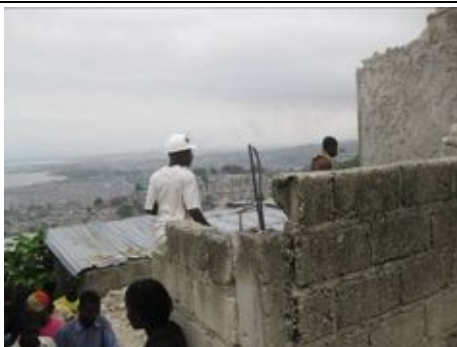
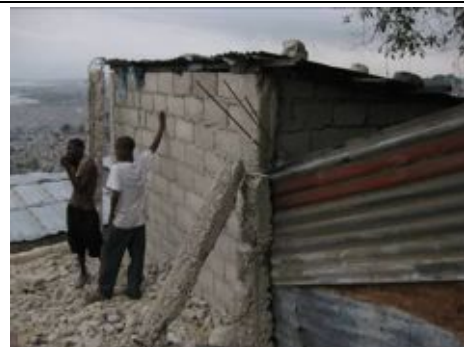
Property 40 Housing type (C3-HM-TCR)

Broadly see comments for property 27

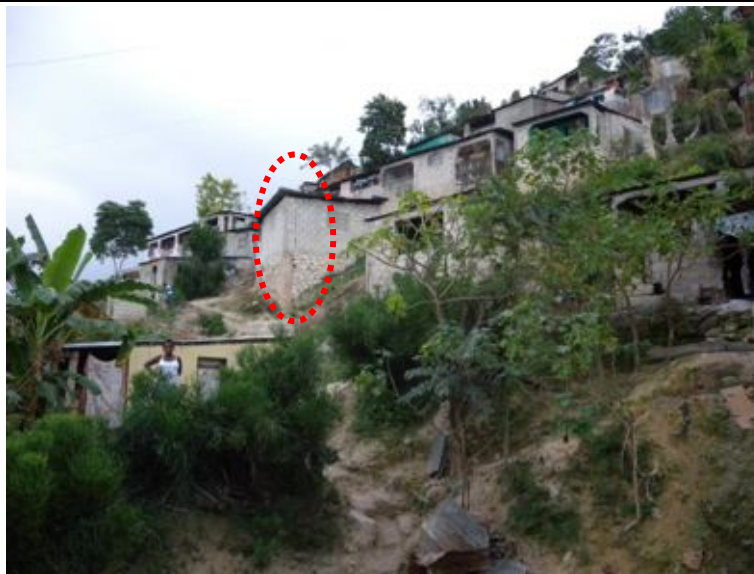
Severe cracking in concrete block wall due to movement of the terrace foundation. Collapse of this terrace could trigger a cascading effect like a small rock avalanche.

It is possible that many such walls are close to their limit and their performance is crucial, therefore, there assessment and repair/retrofitting are very important.

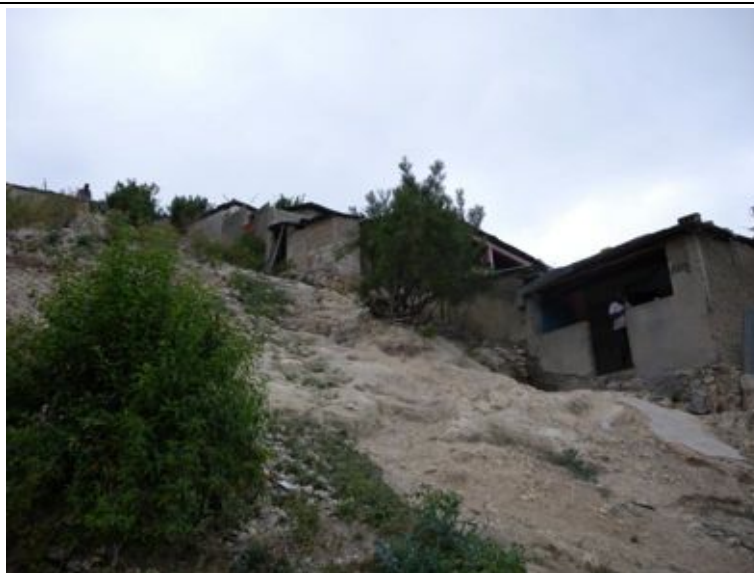
Note the steep nature of the hills.

These house do appear to be built on rock but in other communities this does not appear to have been the case leading to catastrophic cascading failures over many properties

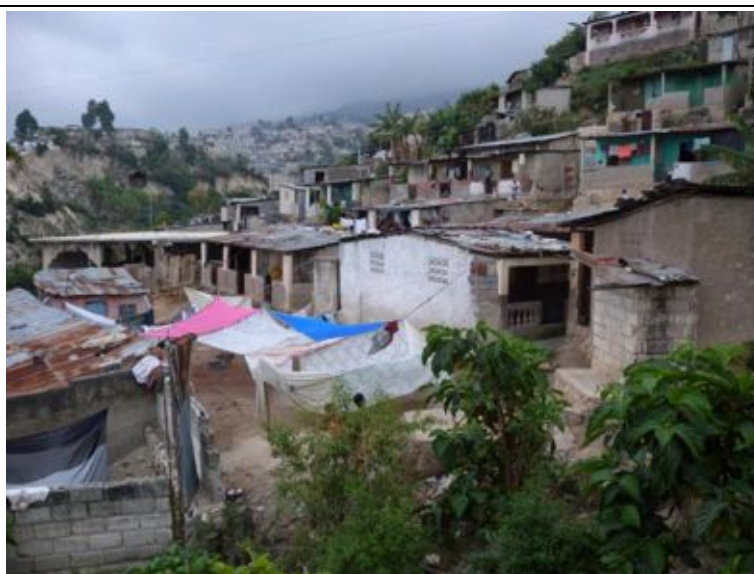
Typical dense urban housing consisting of 1 to 2 to 3 to 4 bedrooms. Generally all 1 storey tall. Constructing higher within the observed construction should not be allowed.

Fire truck access is presently impossible.

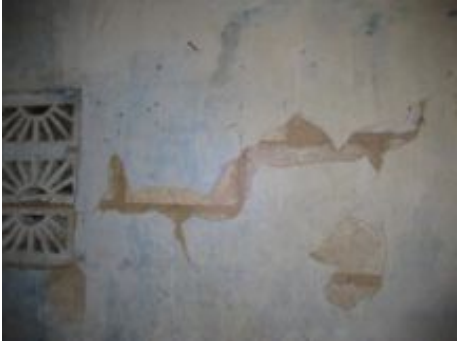
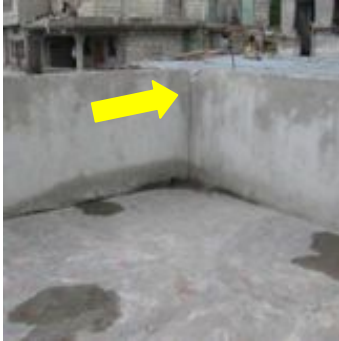
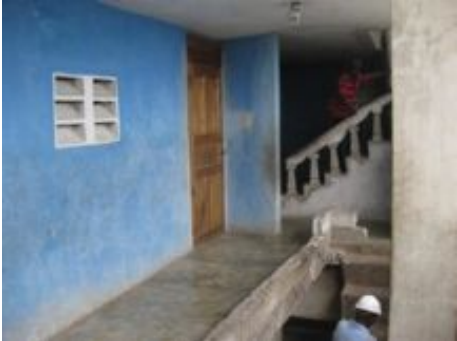
Some cracking of plaster observed in only a couple of locations on ground floor.	Cracking in parapet at corner junction due to separation of orthogonal walls	First floor level. No visible damage.

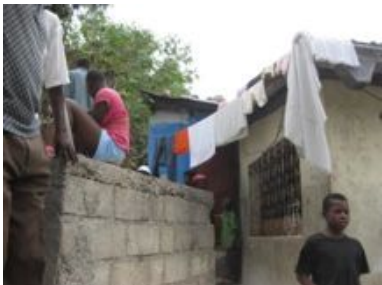
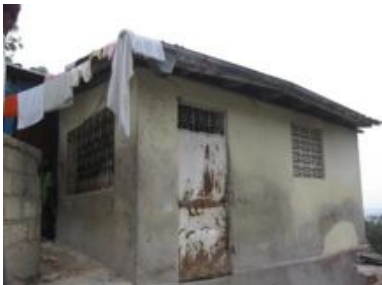
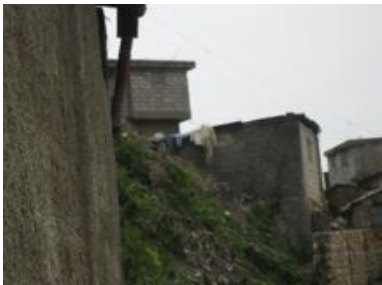
<p>View of west side of house.</p>	<p>View of south east elevation of house. No apparent lintel or wall ring beams</p>	<p>View of houses on adjacent slope. House in question on left in foreground of picture.</p>

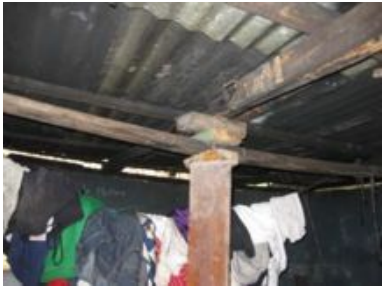
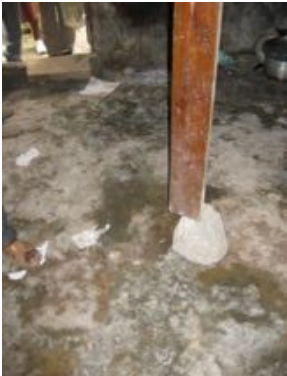
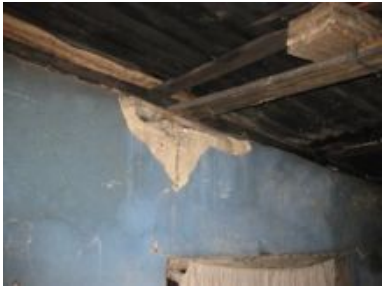
<p>Temporary support to roof which is holding up the roof which is on the verge of collapse. (It is uncertain whether the roof condition was questionable before the event.)</p>	<p>Base of temporary support for roof.</p>	<p>Cracking of masonry at top of wall below timber capping member. Note that the lintel across the door inadequate.</p>

Assessment Findings	<p>There is apparent settlement of the ground behind the retaining wall. There is also some evidence of minor cracking the in masonry walls. The roof structure in one room has failed and is on the verge of collapse.</p> <p>Retaining wall does not appear to be fissured however the base is easily undermined.</p> <p>There is evidence from aerial imagery of landslides in the vicinity.</p> <p>Interview with neighbour indicates this area prone to runoff from heavy rains draining down the slope (neighbours house had previously been destroyed in this manner and has been rebuilt.)</p>	
Rating	RED	
Recommendations	<p>Normally given the cracking observed within the building one would give this a YELLOW rating, however, given the hazards of the site, and, in particular, the uncertainty of the stability of the slope and retaining wall, this property is given a RED rating. (It is noted that the retaining wall has survived the earthquake.)</p> <p>In general the slopes stability in this area should be investigated.</p> <p>The retaining wall in question should be examined further. Investigations should include establishment of the base of wall. Remedial measures may be required to strengthen the wall and ensure its stability. This may include introduction of drainage through the wall etc. Drainage routing around the property needs to also be considered.</p> <p>Once the slope stability checked and retaining wall has been passed as OK the remedial work to the structure of the house should take place. This will involve removing the roof that is on the verge of collapse and any masonry which may be affected. Masonry replaced with new blocks and tie beam needs to be constructed at the top of the wall before building the new roof. It is recommended that the roof be of lightweight timber frame and metal sheeting construction and not a heavy roof which will add mass to the structure (and provide further surcharge behind retaining wall). Timber frame should be of good quality.</p> <p>Until investigations on wall are done and any necessary remedial works to wall and building are complete it is advised that access to the building is limited.</p>

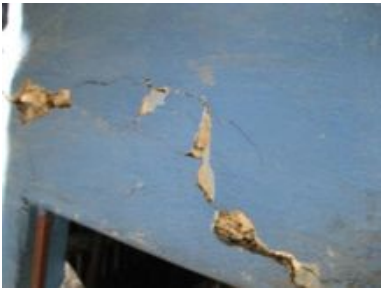
<p>Cracking in masonry above door opening. (Timber lintel over door.)</p>

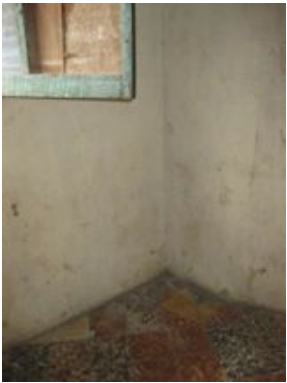
<p>Cracking at the junction between the floor and the walls in the room to the east side of house which is directly above the retaining wall. Possible evidence of subsidence of the ground behind the retaining wall.</p>
Building Coordinates	Lat: N18° 31.171', Long: W72° 20.659'	
Building Name:	Impasse Eddy Prolongé (Owner/Occupier: Yolande Louis Jeune)	
Site	Steep sloping ground. Terraces formed using stone masonry retaining walls. Relatively congested built up area given the steep topography. No obvious access for fire trucks.	
Building Description	Single storey house built at the top of a stone masonry retaining wall (which approximates 2 stories in height). The house is incrementally built in plan with rooms added over time. Foundations of house appear to be stone masonry construction. Possibly reinforced concrete columns with unreinforced concrete block panels. Timber frame roof with metal roofing sheeting.

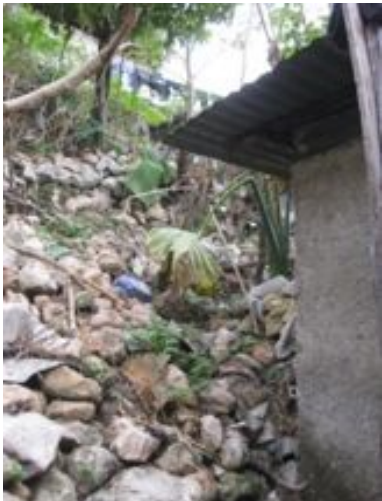
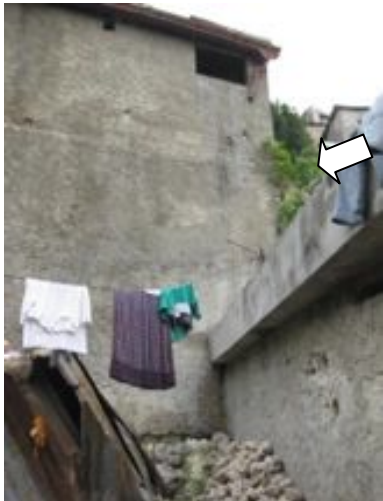
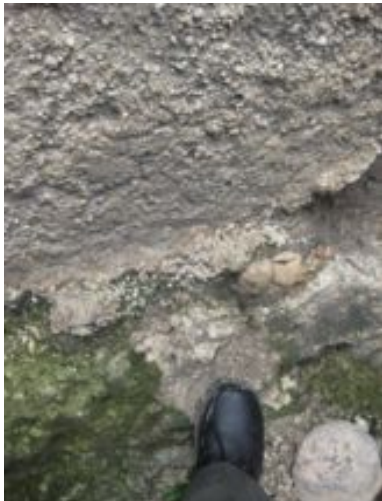
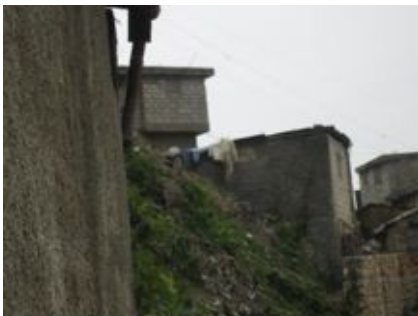
Building Coordinates	Lat: N18° 31.173', Long: W72° 20.662'
Building Name:	Impasse Eddy Prolongé (Owner/Occupier: Destine Charls)
Site	Steep sloping ground. Terraces formed using stone masonry retaining walls. Relatively congested built up area given the steep topography.
Building Description	Single storey house built on terrace. The house is a single room abode. Foundations of house appear to be stone masonry construction. Masonry wall construction. Timber frame roof with metal roofing.
Assessment Findings	<p>There is no apparent damage to this property from the earthquake.</p> <p>There is evidence of a little settlement behind the retaining wall which creates the terrace. The wall does not appear to be fissured however the base is easily undermined.</p> <p>There is evidence from aerial imagery of landslides in the vicinity.</p> <p>Interview with owner/occupier indicates this area prone to runoff from heavy rains draining down the slope - house had previously been destroyed in this manner and has been rebuilt.</p>

Rating	YELLOW (However take into account the recommendations)
Recommendations	<p>Given the hazards of the site, and, in particular, the uncertainty of the stability of the slope and retaining wall which forms the terraces, this property maybe founded on very weak foundations. Whilst in the immediate short term the property may be considered for usage, until a slope stability assessment is carried out it will not be known if there is a fundamental slop stability or terrace stability issue that would need to be taken care of.</p> <p>The retaining wall in question should be examined further. Investigations should include establishment of the base of wall. Remedial measures may be required to strengthen the wall and ensure its stability. This may include introduction of drainage through the wall etc.</p> <p>Drainage routing around the property needs to also be considered.</p> <p>Once the slope stability checked and retaining wall has been passed as OK this building can be rated as GREEN.</p> <p>It is possible that the studies establish problems with the site and the terraces and the risk of continuing living in this property would need to be re-evaluated.</p>

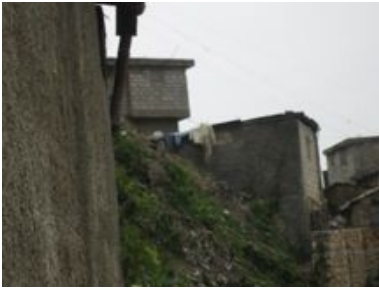
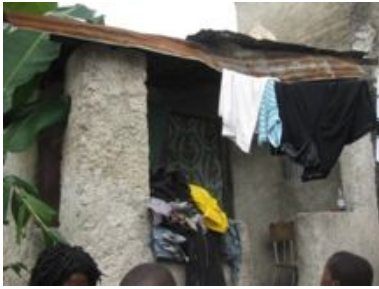
<p>View of houses on slope adjacent.</p>	<p>View of front elevation of house</p>	<p>Evidence of minor cracking in the house.</p>
<p>Building Coordinates</p>		<p>Lat: N18° 31.170', Long: W72° 20.655'</p>
<p>Building Name:</p>	<p>Not available</p>	
<p>Site</p>	<p>Steep sloping ground. Terraces formed using stone masonry retaining walls. Relatively congested built up area given the steep topography.</p>

<p>Building Description</p>	<p>Single storey house built at the base of a stone masonry retaining wall (which approximates 2 stories in height). The house is a single room abode with front covered area. Foundations of house appear to be stone masonry construction. Unreinforced concrete masonry panels. Timber frame roof with metal roofing.</p>	
<p>Assessment Findings</p>	<p>There is apparent settlement of the ground behind the retaining wall (evident in property at top of the wall). Retaining wall does not appear to be fissured however the base is easily undermined.</p> <p>There is evidence from aerial imagery of landslides in the vicinity.</p> <p>Interview with owner/occupier in terrace above indicates this area prone to runoff from heavy rains draining down the slope (neighbours house had previously been destroyed in this manner and has been rebuilt.)</p> <p>Minor cracking in one wall panel.</p>

<p>Rating</p>	<p>YELLOW</p>	
<p>Recommendations</p>	<p>Given the hazards of the site, and, in particular, the uncertainty of the stability of the slope and retaining wall which forms the terraces, this property maybe founded on very weak foundations. Whilst in the immediate short term the property may be considered for usage, until a slope stability assessment is carried out it will not be known if there is a fundamental slope stability or terrace stability issue that would need to be taken care of.</p> <p>The retaining wall in question should be examined further. Investigations should include establishment of the base of wall. Remedial measures may be required to strengthen the wall and ensure its stability. This may include introduction of drainage through the wall etc.</p> <p>Drainage routing around the property needs to also be considered.</p> <p>Once the slope stability checked and retaining wall has been passed as OK this building can be rated as GREEN.</p> <p>It is possible that the studies establish problems with the site and the terraces and the risk of continuing living in this property would need to be re-evaluated.</p>

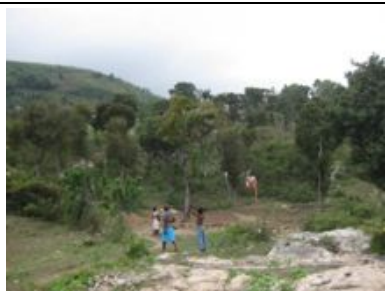
View at bottom of hill leading up to Pacot

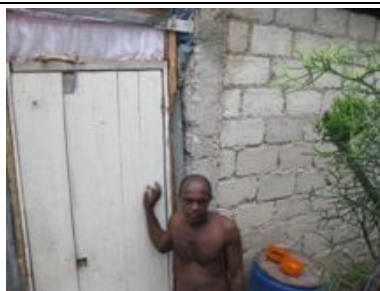
House 1 in the compound (south west elevation)

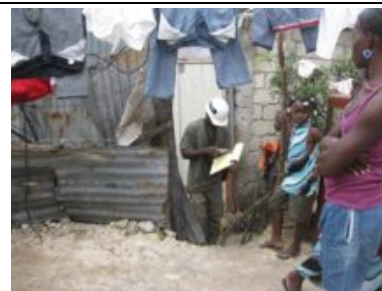
House 1 in the compound (south west elevation)

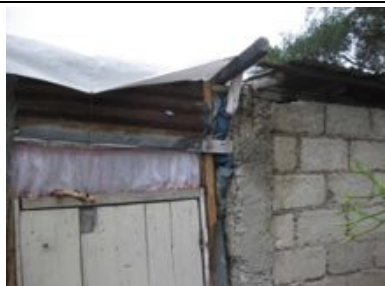
House 1 in the compound. (South west elevation with detail of roof to column connection.)

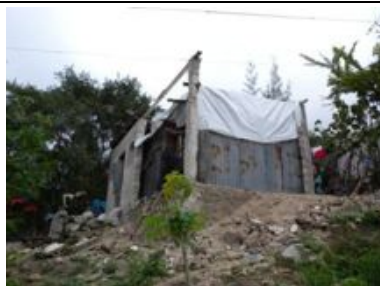
House 1 in the compound. View of the north side of house. Masonry infill panels have failed and collapsed.

Assessment Findings	<p>Both Houses 1 and 2 have suffered critical failures. With collapse of perimeter walls and roof structure. Remaining walls are unstable. Foundations appear to be unaffected.</p> <p>It was evident that the owners have been proactive in building new shelters. With much of the original buildings having been tidied up by completing demolishing or similar. Nevertheless there are still risks associated with the remaining bits we were able to observe.</p> <p>Better hand tools would be of great help to this community who also have the benefit of having open land around their homes to make necessary adjustments</p>	
Rating	<p>YELLOW for what we have seen – See recommendations</p> <p>Whilst the buildings might be strictly a RED, given the options these people have, saying to them that they cannot use any parts of their remaining properties is unlikely to be of help and at odds with their realities and desire to make the best out of what they do have.</p> <p>This does however leave them vulnerable to the effects of aftershocks or similar.</p>

Recommendations	<p>For houses 1 and 2 unstable masonry panels should be removed (or stabilised)</p> <p>This may mean the complete demolition of structure, as some concrete ring beams and concrete columns are fully embedded in the masonry panels and/or are too slender to support themselves.</p> <p>An alternative might be to provide temporary shoring to enable the remaining portions of the properties to be better supported against future lateral loads.</p> <p>Clearly, repairing these houses will be hard and it is likely that building new homes will be the best option for this community.</p> <p>However, the need for shelter is forcing them into using as much of the existing buildings they have. The issue is that to build a shelter people either need timber or some other type of structural member all of which are in very short supply. This is forcing people to reuse as much of the remaining poor quality reinforced concrete members as is possible.</p> <p>These houses do clearly demonstrate the difficulties of applying developed world standards to an environment where it is likely that even before the earthquake the houses may have been judged to be unsafe, though this is also hard to tell.</p>

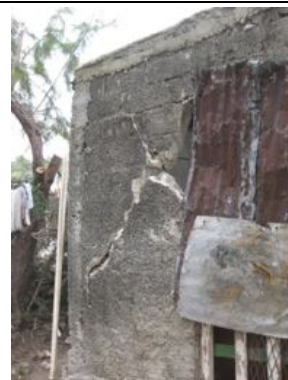
House 1 in the compound. View of South east of the house showing severe cracking in the masonry infill panel

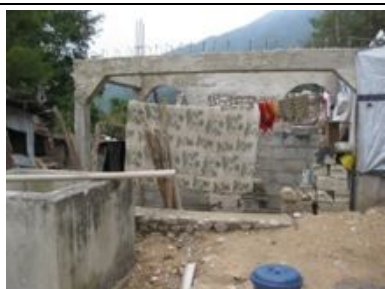
House 2 in the compound. Apparently under construction

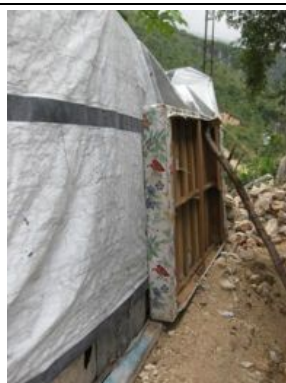
House 2 in the compound. Masonry walls which had been constructed collapsed. Temporary "walls" installed.

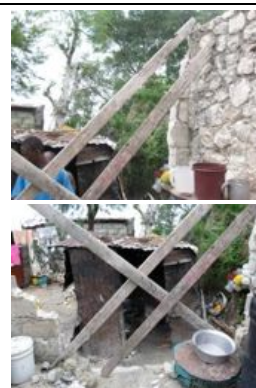
House 2 in the compound. Masonry walls failed. Two images showing the timber members resting against (and not propping) still standing stone masonry wall. (Corrugated iron structure in background still standing.)

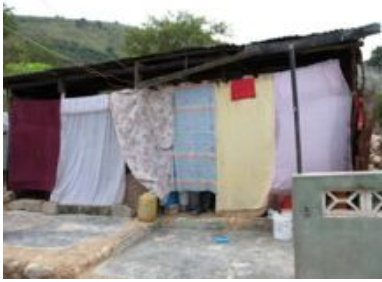
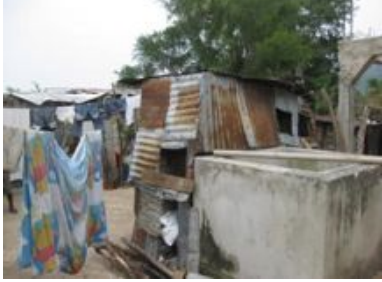
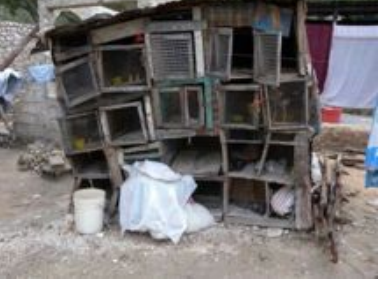
House 3 in the compound: no masonry walls	Other structures in the compound include a water tank which is relatively unscathed and corrugated iron chicken coup which is still being used.	
Building Coordinates	Lat: N18° 31.179', Long: W72° 20.656'	
Building Name:	Rue Pacot Prolongéen, Haut Vieux Kay (Owner/Occupier: Oscar Pierre)	
Site	Hillside semi rural community. Sloping ground with rocky outcrops.	
Building Description	<p>House 1: Built in 2003 according to the owner/occupier. Single storey 1-2 room house. Built on stone masonry foundations. Basic reinforced concrete columns unreinforced concrete masonry infill panels. Light weight timber frame roof with metal sheeting.</p> <p>House 2: Single storey house partially constructed. Evidence projecting reinforcement indicates possible plan to extend upwards in the future. Built on stone masonry foundations which are, according to the owner, built onto the rock. Reinforced concrete columns and reinforced concrete beams in places. Infill panels are a combination of either stone masonry or block masonry.</p> <p>House 3: Not inspected</p>

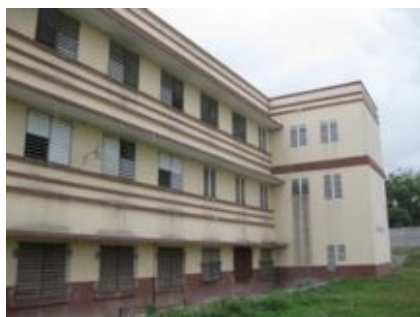
Rear view of Main Building #1 (3 storey). Stairwell (on right) added after construction of original building. Some minor cracking at junction between two constructions.

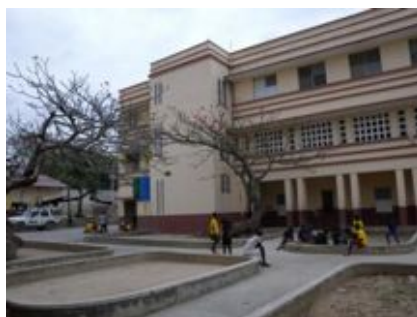
View of Main Building #2 (3 storey block) from central courtyard.

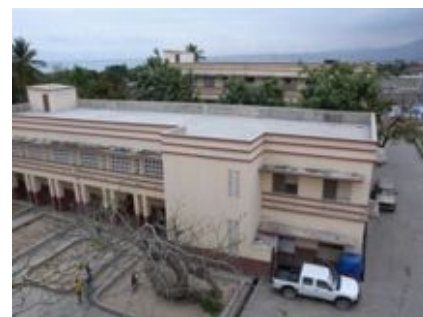
View of Main Building #3 (2 storey block) (Main Building #4 in background)

Note the significant horizontal reinforced concrete ring beam / sunshade to all the windows and the horizontal bands

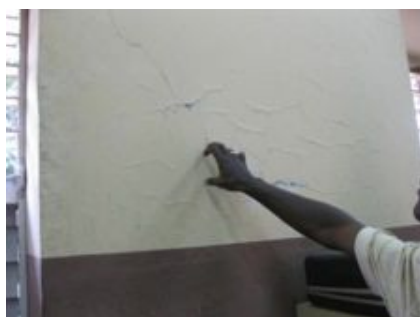
Cracking in plaster of thick masonry wall. Seen typically at the ground floor levels for all Main Buildings.

Assessment Findings	Minor cracking to majority of masonry piers /panels in the exterior facade at ground floor level of main buildings. Some cracking of internal masonry walls. Damage to connection between one storey column and link walkway beam. Good regular shape, floor slab appears to be of solid concrete. Wide sunshade type ring beam above all lines of openings. Many full height masonry walls between classrooms. Concrete quality appears good	
Rating	Main Buildings and Link Building: YELLOW Storage Building: GREEN	
Recommendations	Main Buildings: The main buildings are still standing and evidence of structural damage is limited. However it is noted that the structures will have been weakened by the event which is manifest in the manner of cracking of the masonry walls. The owner should do further investigations into the integrity of the overall structure of the main school buildings. This should include further assessment of the cracking in infill panels by removing plaster. Owner should consider strengthening to lower stories by reinforcing around openings by adding a strong frame and cross bracing for example. Repair/replace damaged internal partitions. Repair damage to column beam connection at link walkway at corner of Main Building #1. Ensure tall furniture and similar are anchored / bolted to walls and egress corridors kept free. Limit all access to the roofs of buildings (parapets are not tall) Link Building: Though the damage to the link building appears to be in the infill masonry panels installed after original construction, the building owner should do further investigations into the integrity of the overall structure of the link building. Repair/replace damaged internal partitions. Storage Buildings: These building appear to have fared well in the earthquake. It would be advisable, in the short term, to use these facilities for any activities that can be feasibly carried out in these buildings until further investigations are carried out on the other buildings in the compound.

Centre d'Accueil de Carrefour – 4 Main Buildings	<p>The main buildings are still standing and evidence of structural damage is limited. However it is noted that the structures will have been weakened by the event which is manifest in the manner of small cracking of the masonry walls. The embedded reinforced concrete frame appears undamaged on the whole.</p> <p>The owner should do further investigations into the integrity of the overall structure of the main school buildings. This should include further assessment of the cracking in infill panels by removing plaster.</p> <p>Owner should consider strengthening to lower stories by reinforcing around openings.</p> <p>Repair/replace damaged internal partitions.</p> <p>Repair damage to column beam connection at link walkway at corner of Main Building #1.</p> <p>Ensure furniture and similar to be braced back to walls and egress corridors kept free.</p> <p>Limit all access to the roofs of buildings.</p>

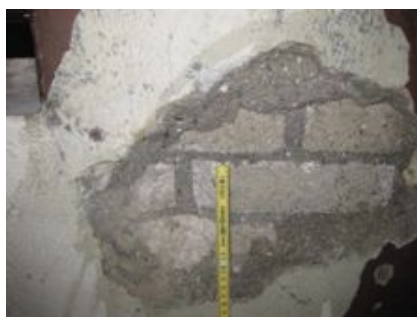
Investigation into composition of thick internal masonry wall (concrete block face dimension 200 mm x 50 mm) – the block/brick appears of solid construction type

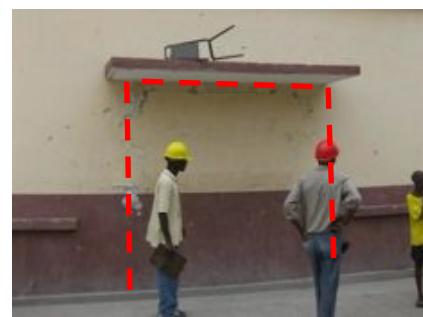
Cracking at junction between infill masonry pannel (apparently installed after original construction) and original structure. (possible original opening highlighted by red dotted line.)

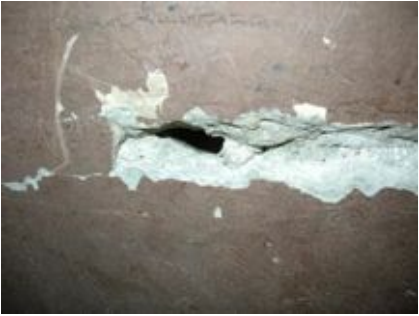
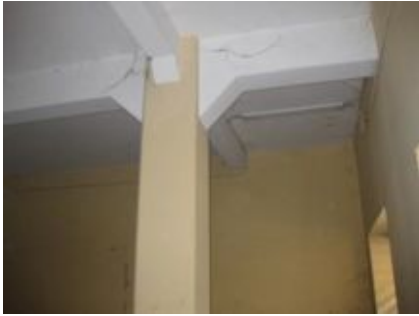
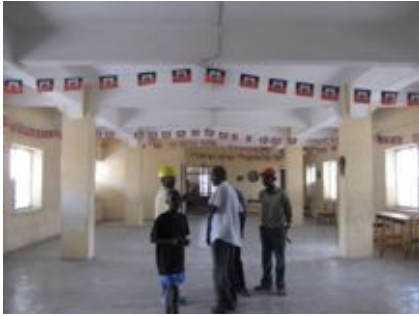
<p>Cracking in masonry infill in stairwell of Main Building #3 (2 storey block). Not sure if this had occurred prior to the earthquake</p>	<p>Typical internal structure in main buildings: concrete floor slab supported by 400 mm square concrete columns. Thick masonry infill walls around the perimeter. No sign of damage to the concrete frame</p>	<p>Inside of hall on top storey of one of the main buildings.</p>

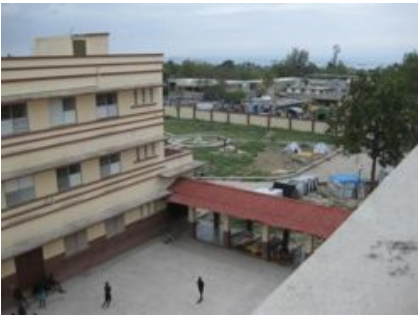
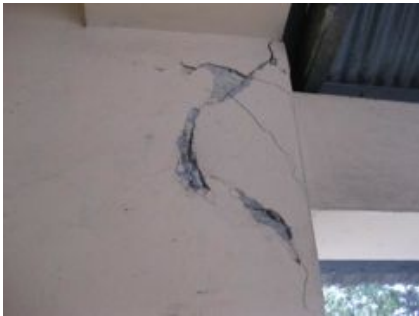
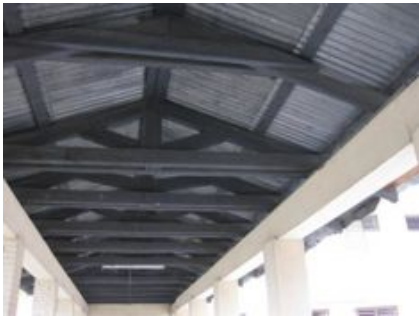
<p>View of building number 1 on left and covered link walkway.</p>	<p>Pull out type of damage at connection between column for single storey lean to and beam for covered link walkway due to differential movement between the building and the walkway cover.</p>	<p>No apparent damage to remainder of covered link walkway. Timber trusses are stock and appear well built</p>

Centre d'Accueil de Carrefour – Single Storey Link building	<p>Though the damage to the link building appears to be in the infill masonry panels installed after original construction, the building owner should do further investigations into the integrity of the overall structure of the link building.</p> <p>Repair/replace damaged internal partitions.</p>
Centre d'Accueil de Carrefour – Single Storey storage buildings	<p>These building appear to have fared well in the earthquake (light roof which appears to be well constructed with generous overhang over ring beams over the top of the masonry block walls.</p> <p>It would be advisable, in the short term, to use these facilities for any activities that can be feasibly carried out in these buildings until further investigations are carried out on the other buildings in the compound.</p>
Lycée de Carrefour – Main Building	<p>The corner classrooms to the eastern side must not be used until repaired. In these locations the corner concrete columns need immediate repair. The following procedure could be adopted:</p> <ul style="list-style-type: none"> • Propping of roof and floor slabs and providing temporary bracing, • Removal of damaged block work panels, • Increasing the size of foundations for columns • Breaking out damaged concrete and cover concrete providing a new reinforcement cage around the old one (tied into the improved foundation), • Casting new (larger) column around old and de-propping once new column has reached adequate strength. <p>Remove locally damaged masonry and replace with undamaged blocks.</p> <p>Secure block work which is not sufficiently restrained.</p> <p>Cordon off area around east side of building which need urgent attention.</p> <p>Owner should consider detailed structural review of rest of moment frame structure for strength and apply retrofit strengthening.</p> <p>Ensure furniture and similar is braced back to walls and egress corridors kept free.</p>

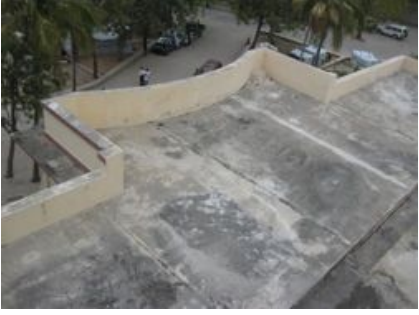
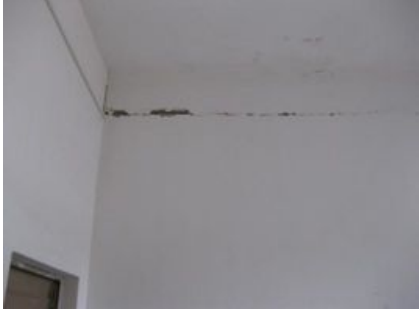
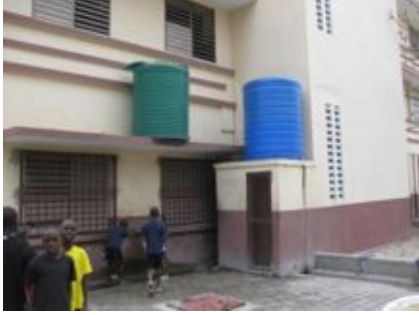
<p>Roof of single storey link building – no apparent damage.</p>	<p>Cracking at junction between infill block masonry wall and concrete beam in link building. Infill panels put in after original construction for subdivision of rooms</p>	<p>Water tanks on one of the main buildings. The blue one was in same position before the Earthquake, the green one is new.</p>

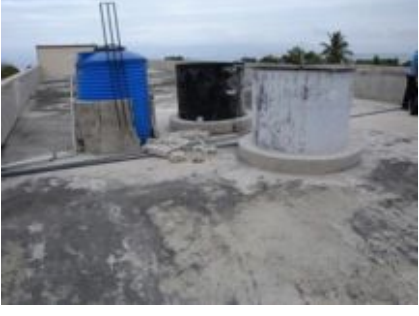
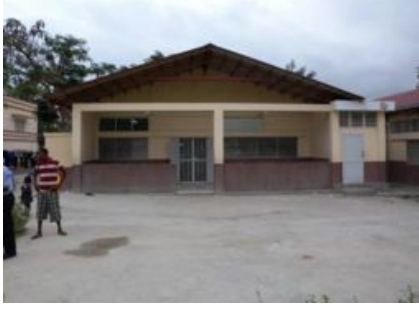
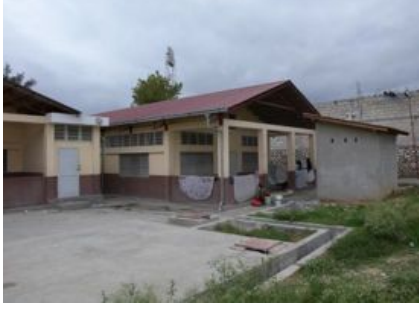
<p>Water tanks at roof level of Main Building #2. Some damage to non structural blockwork around blue tank.</p>	<p>Single storey storage buildings. (Building number 1.)</p>	<p>Single storey storage buildings. (Building number 2.)</p>
