Oxfam GB

Haiti Earthquake Response

Arup Assignment Report

May 2010

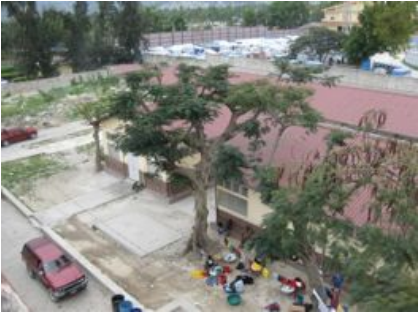
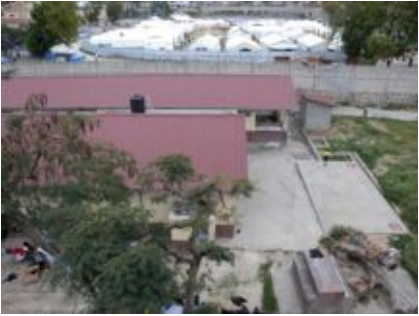
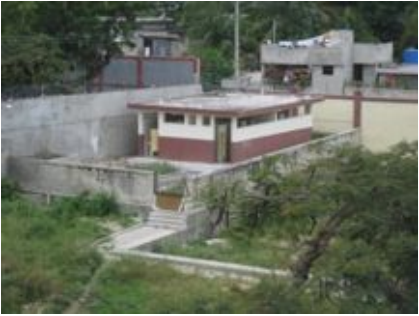
<p>Water tanks at roof level of Main Building #2. Some damage to non structural blockwork around blue tank.</p>	<p>Single storey storage buildings. (Building number 1.)</p>	<p>Single storey storage buildings. (Building number 2.)</p>

View of the 2 single storey storage buildings from above. No visible damage.	Another view of single storey storage buildings. No visible damage. Note tall perimeter fence with stone masonry base, reinforced concrete columns and horizontal bandbeams at half and full concrete block wall portion.	Toilet block not inspected as shut because of failure to foul drainage. From distance no apparent structural failure.
Compound Coordinates	Lat: N18°32.234 , Long: W72°24.387	
Compound Name:	Centre D'Accueil de Carrefour (School – Orphanage and Oxfam facility for storage and cutting of plastic sheeting)	
Site	Level ground in walled compound. 4 main school buildings linked by covered walkway and single storey link building. 2 single storey storage buildings. Outside toilet block and small out structures.	
Building Description	Main Buildings (3 No 3 storey and 1 No 2 storey): Foundations (not visible), Reinforced concrete frame building with concrete slab and thick unreinforced solid masonry piers / infill. (the masonry looked of the solid variety) Link Building: Foundations (not visible), Single storey, reinforced concrete frame with concrete roof and unreinforced block work panels. Storage buildings: Single storey concrete frame buildings, block work infill panels with lightweight steelwork roof (Toilet Block: Not inspected in detail -Closed as foul drainage had failed. Other out buildings also not inspected)

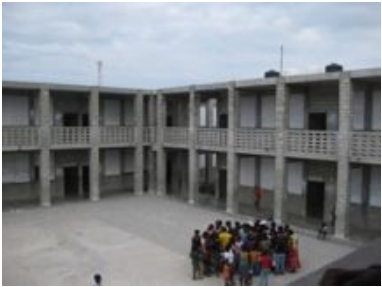
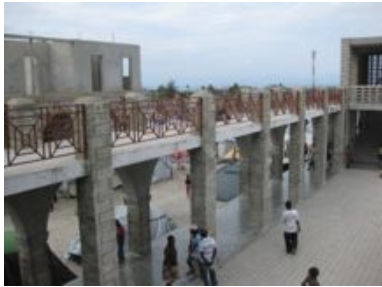
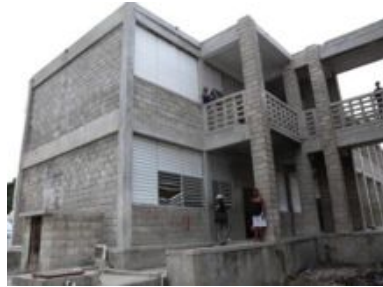
View of central courtyard from south classroom block	View of wester link walkway	Eastern end of the south classroom block with covered link on right of photo.

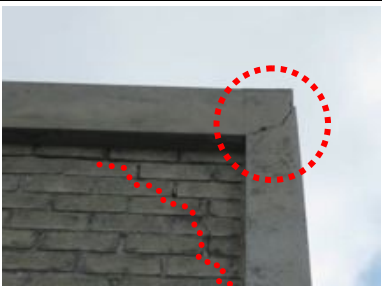
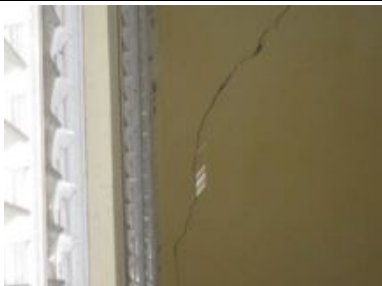
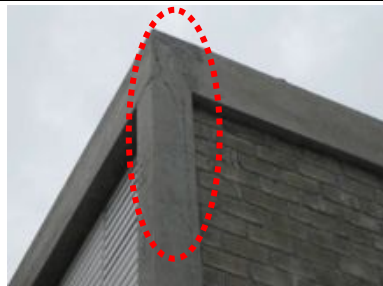
Shearing of top of corner column on east end of south block. Cracking in the infill masonry panel.	View of masonry cracking from inside of classroom	Similar cracking of concrete in corner column of north block
Columns are relatively small in size. Reasonable possibility that the masonry infill wall acted as a strut and was stronger than the column / beams. Observed construction practice means that the beam column joint probably does not have any confinement reinforcement and was particularly vulnerable to the forces imparted by the masonry struts.

<p>Assessment Findings</p>	<p>Cracking evident in moment frame in top storey, particularly at the eastern corners of the classroom blocks. In these areas evidence of cracking infill masonry panels. Regular cracking in non-structural masonry panels adjacent to entrances to classrooms due to poor detailing and the existence of unanticipated load paths.</p>	
<p>Rating</p>	<p>YELLOW (with RED for the corner classrooms on east side)</p>	
<p>Recommendations</p>	<p>The corner classrooms to the eastern side must not be used until repaired. In these locations the corner concrete columns need immediate repair. The following procedure could be adopted:</p> <ul style="list-style-type: none"> • propping of roof and floor slabs and providing temporary bracing, • removal of damaged blockwork panels, • increasing the size of foundations for columns • breaking out damaged concrete and cover concrete providing a new reinforcement cage around the old one (tied into the improved foundation), • casting new (larger) column around old and de-propping once new column has reached adequate strength. <p>Remove locally damaged masonry and replace with undamaged blocks. Secure blockwork which is not sufficiently restrained.</p> <p>Cordon off area around east side of building which need urgent attention.</p> <p>Owner should consider detailed structural review of rest of moment frame structure for strength and apply retrofit strengthening.</p> <p>Ensure furniture and similar is braced back to walls and egress corridors kept free.</p>

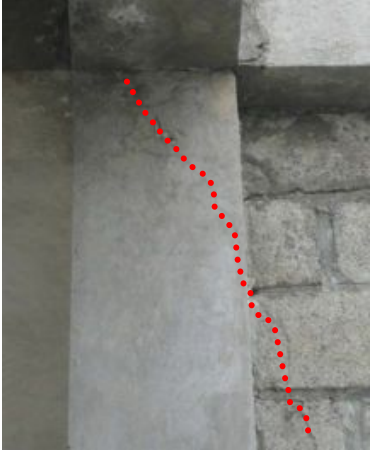
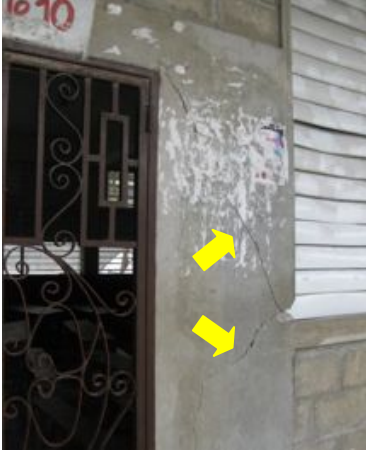
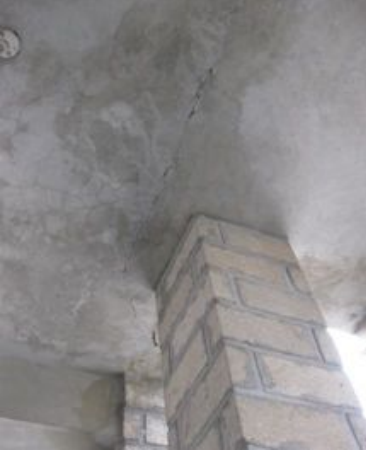
<p>Hairline crack propagating through column and block work. (Indicated by red dotted line.)</p>	<p>Cracking in non-structural masonry panels caused by stress concentration at sill level occurring adjacent to most class entrances.</p>	<p>Cracking in concrete slab at junction between covered link and class block</p>

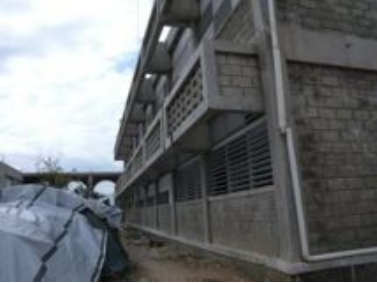
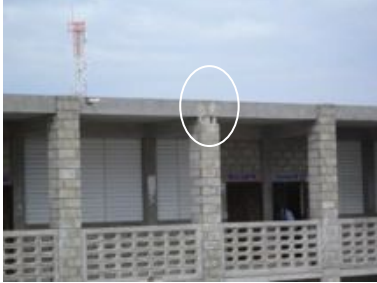
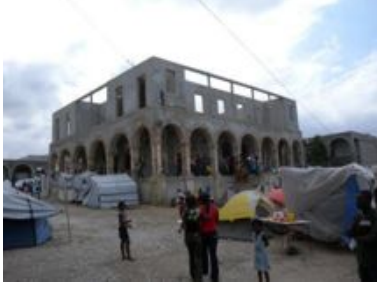
<p>View of "brise soleil" (?) structures on south facade of south classroom block appear undamaged. Unclear if down pipe was damaged during earthquake.</p>	<p>Block cladding to column fell off exposing concrete column.</p>	<p>View of historic building which was being restored and extended before the earthquake.</p>
<p>Building Coordinates</p>	<p>Lat: N18°32.474 , Long: W72°24.422</p>	
<p>Building Name</p>	<p>Lycée de Carrefour</p>	
<p>Site</p>	<p>Located on relatively level ground.</p>	
<p>Building Description</p>	<p>Main School Building: Foundations appear to be stone masonry – founding level not apparent. Superstructure is 2 stories and consists of reinforced concrete slabs and roof supported by reinforced concrete moment frame with infill block masonry wall panels. (Other buildings in compound were not accessed but appeared to be generally of concrete and masonry construction.)</p>

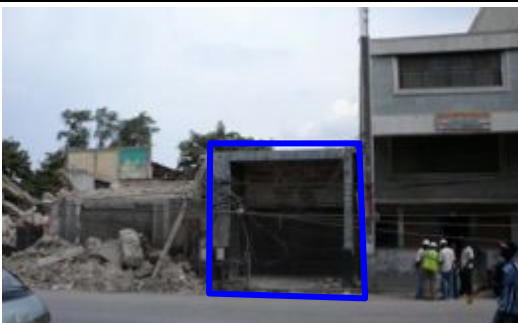
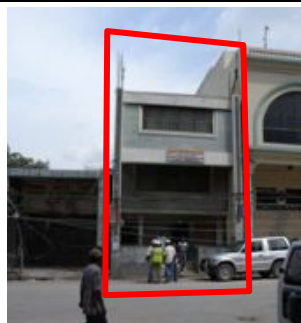
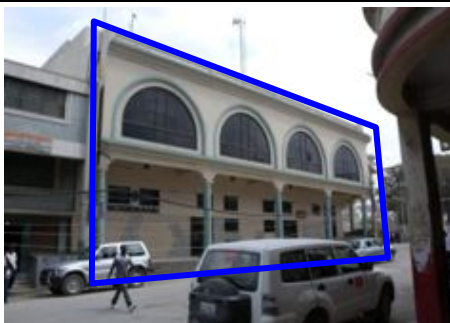
Small adjacent building posing pounding hazard albeit a lighter structure.	COZPAN offices in the 1 st floor	Weekend adjacent bank building – poses a pounding hazard beyond what has already occurred.

Site	Level ground in dense urban setting. Low lying power cables at the building entrance pose a hazard to a safe building entry.	
Building Description	Reinforced concrete foundations for a concrete moment frame building with concrete slab and unreinforced block work infill masonry. Flat slab roof with small section of light metal roof with CGI sheets.	
Assessment Findings	Some cracking to non-structural infill partitions near the stairs at the front entrance to the building. 1 st floor (where COZPAN offices are) had corner cracks to the front masonry wall running parallel to the road next due to the large window. Columns and beams did not show any signs of distress. Urban setting so adjacent building adequacy must be considered - though pounding damage appeared minimal.	
Rating	Green (note comment about street cables)	
Recommendations	Recommend that building owner is asked to repair the damaged masonry infill on the first floor Building owner should be in discussions with neighbours about the conditions of the adjacent buildings and any future plans for reparations to and/or demolition of those adjacent buildings Furniture and similar to be braced back to walls and egress corridors kept free Low hanging power and communication cables pose an entry and exit hazard – in normal circumstances this would be reason to post a “Yellow” restricted entry rating.

COZPAN - OFFICE	<p>Recommend that building owner is asked to repair the damaged masonry infill on the first floor</p> <p>Building owner should be in discussions with neighbours about the conditions of the adjacent buildings and any future plans for reparations to and/or demolition of those adjacent buildings</p> <p>Furniture and similar to be braced back to walls and egress corridors kept free</p> <p>Low hanging power and communication cables pose an entry and exit hazard – in normal circumstances this would be reason to post a “Yellow” restricted entry rating.</p>
COZPAN – School/Office	<p>Remove locally damaged masonry and replace with undamaged blocks.</p> <p>Provide ring beam (timber or concrete) to unrestrained masonry blocks to prevent falling hazard.</p> <p>Cordon off area around damaged perimeter walls which needs urgent attention – requires new corner foundation and existing wall portions to be tied in or wall to be demolished and rebuilt.</p> <p>Provide horizontal roof bracing to introduce a diaphragm to enable orthogonal walls to support each other.</p>

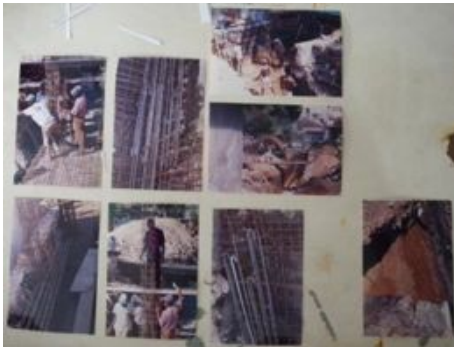
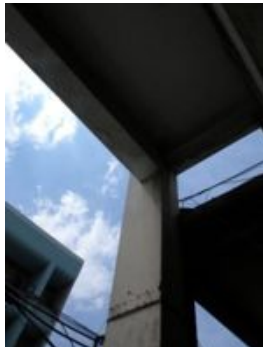
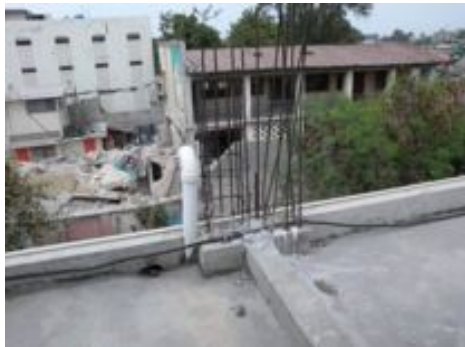
Construction photos made available by the owner showing foundation construction	Beams do not align centrally with the columns introducing additional torsion	Expansion joint with double columns – The gap is only a thermal movement joint and not a seismic Gap joint – but no indication of structural damage at the movement joint location

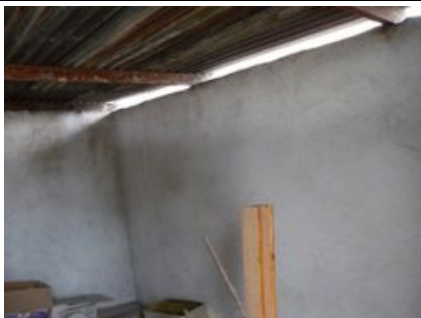
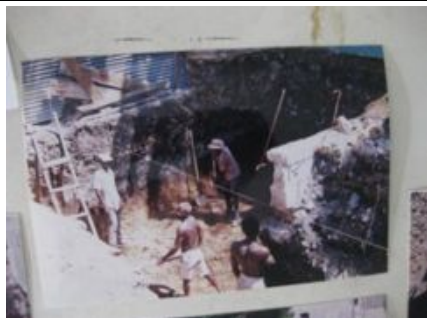
Central staircase with light metal roof in approximately the middle of the building	Cracking in non structural infill over staircase	Foundation construction excavation to competent ground (more than 2m deep excavation)
Building Coordinates	Lat: N18°32.804, Long: W72°20.365	
Building Name:	COZPAN – OFFICE (inspection date 27 Feb 2010)

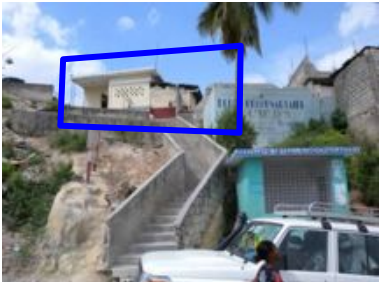
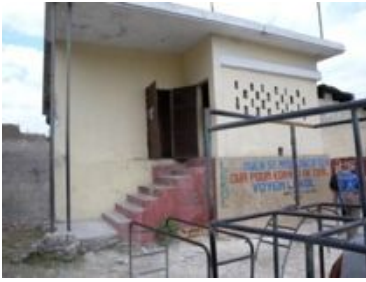
COZPAN Building location	Original construction of reinforced concrete frame and unreinforced block work infill with concrete roof slab	Lean to extension of unreinforced concrete block masonry with light metal roof

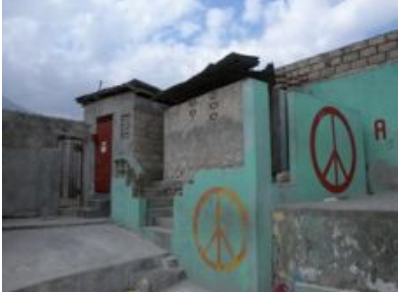
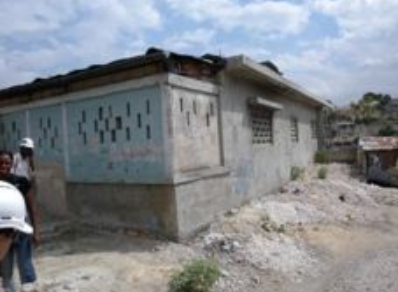
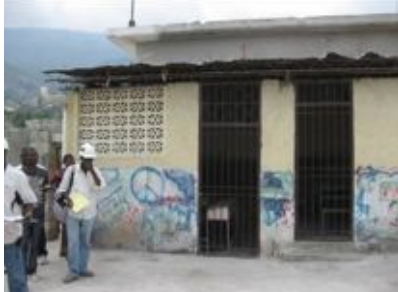
Outside Kitchen and Latrines made of unreinforced blocks next to main building	Rear view to the Building	Elevation of lean to extension view from courtyard

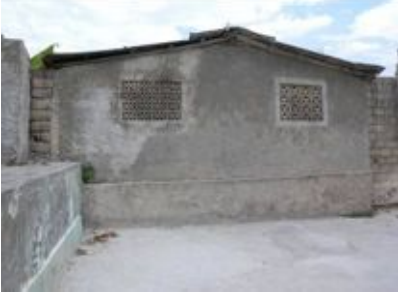
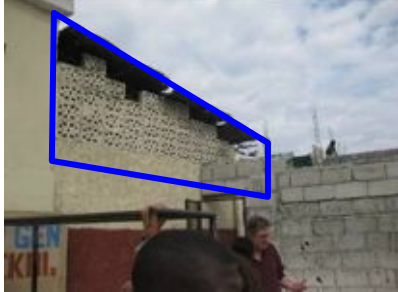
Damaged perimeter wall – corner column was not anchored to and it failed – remaining masonry wall is vulnerable to falling even by pushing it	Neighbours building facing on to the courtyard appearing undamaged from this side	Falling hazard of unrestrained perforated blocks
Building Coordinates	Lat: N18°31.403 ,Long: W72°21.065	
Building Name	COZPAN – School/Office (inspection date 27 Feb 2010)	
Site	Located on steep slope, built with stone masonry terrace walls	
Building Description	Original building constructed on (possibly undressed) stone masonry with reinforced concrete columns, infill block masonry and reinforced concrete roof. Two lean to extensions have been added, the larger one being about 1m lower down, both with light metal roof trusses and CGI sheets. Basic steel trusses appear connected to the blocks with a partial concrete band beam or light steel lative truss

Assessment Findings	RC frame of original part appears undamaged. Lean too structures have small partial diagonal cracks in a few locations over doors.	
Rating	YELLOW (but nominal repairs will enable this building to be reintroduced into use.)	
Recommendations	Remove locally damaged masonry and replace with undamaged blocks. Provide ring beam (timber or concrete) to unrestrained masonry blocks to prevent falling hazard. Cordon off area around damaged perimeter walls which needs urgent attention – requires new corner foundation and existing wall portions to be tied in or wall to be demolished and rebuilt. Provide horizontal roof bracing to introduce a diaphragm to enable orthogonal walls to support each other.

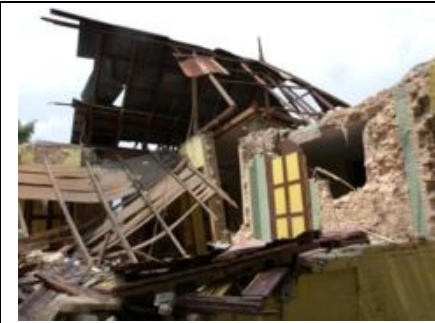
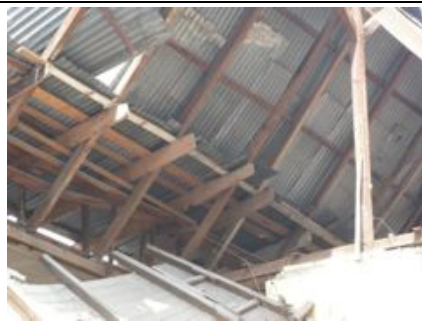
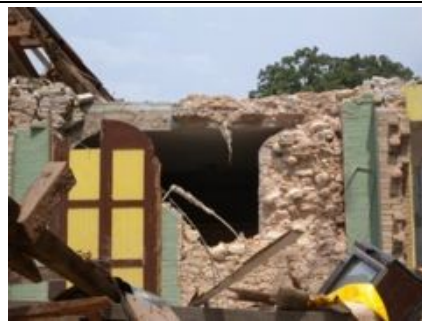
Masonry & timber construction		View of timber framed roof	Rubble stone masonry wall

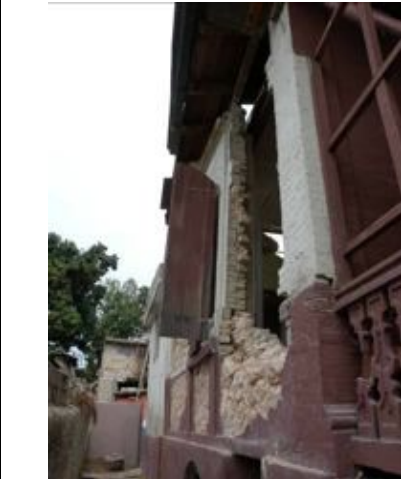
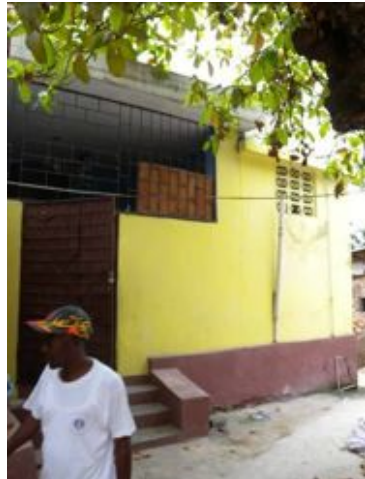
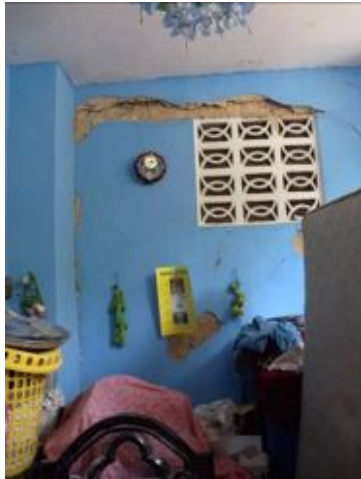
Solid clay brick masonry wall	Lean to extension of reinforced concrete and masonry blocks	Separation of infill and concrete frame with damage to infill

Assessment Findings	Original building is destroyed. Reinforced concrete lean to has infill masonry damage		
Rating	RED (Extension is yellow assuming recommendations are done)		
Recommendations	RED (Extension is yellow assuming recommendations are done)		
	Reinforced lean too can probably be salvaged assuming demolition of old original building is undertaken carefully. Significant amounts of building material could be salvaged (especially timber). Out house – rebuild with lintel / roof level ring beam.

FRIENDSHIP (Rue Marcelin)	<p>Reinforced lean too can probably be salvaged assuming demolition of old original building is undertaken carefully. Significant amounts of building material could be salvaged (especially timber).</p> <p>Out house – rebuild with lintel / roof level ring beam.</p>
JEZI MuHAMED BILAL	<p>All activities within this building are to be stopped with immediate effect. Removal of furniture or similar to be done with utmost caution given the circumstances. All tents or similar below the building within the grounds to be moved as there is a real possibility of the building collapsing and falling and rolling towards them.</p>
OCHAN	<p>Demolish remaining structure – salvage material and ensure that a proper foundation is built.</p> <p>(existing columns are poor quality and should not be relied up on)</p>
APROSIFA	<p>It would be sensible to remove the screed on the first floor and apply a thinner but properly made screed to reduce the weight of the building. The cracked tiles are a source of dirt and replacing these would be a prudent measure anyway.</p> <p>Damaged masonry can be readily repaired.</p> <p>Steel rebar on spalled column should be cleaned and patched with high quality sand cement mix.</p> <p>Under no circumstances should any additional floors be added in the future</p> <p>Garage, stub beam next to main building can be cut to create a seismic gap – this will avoid future pounding issues.</p> <p>Small side house, separating walls to be stitched together. Ring beam required at the top of the walls. Prior to attaching the roof structure.</p> <p>Neighbouring, taller building could pose a hazard – discussions should be help with them as their structure, especially the last floor appears of poor quality and is nearly over the inspected building. There may be a benefit on the neighbour removing the most recent top extension on their building.</p>

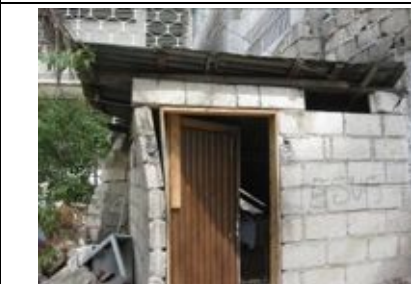
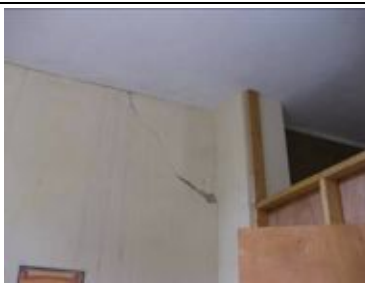
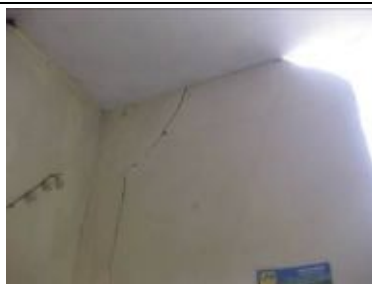
Out house with unstable wall	Internal corner cracks in the lean too extension	Internal corner cracks in the lean too extension	
Building Coordinates	Lat: N18°32.143, Long: W72°20.075		
Building Name	Friendship (Rue Marcelin) (inspection date 27 Feb 2010)		
Site	Level ground in predominantly residential area with garden.		
Building Description	Original building is unreinforced stone and solid brick masonry with timber trusses. Probably 2 storeys with loft space. Lean too is reinforced concrete frame and unreinforced block masonry – not bonded to original structure. Unreinforced block work with light metal roof, 1 storey

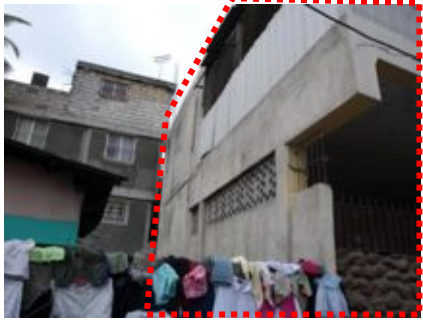
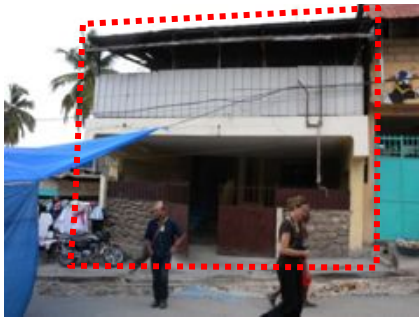
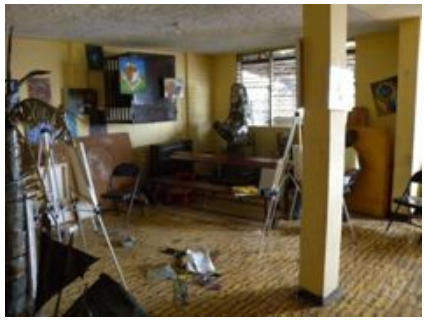
<p>General side view</p>	<p>Front view showing independent concrete frame car port structure with infill masonry in one direction only</p>	<p>General view on the first floor indicating walls and columns</p>

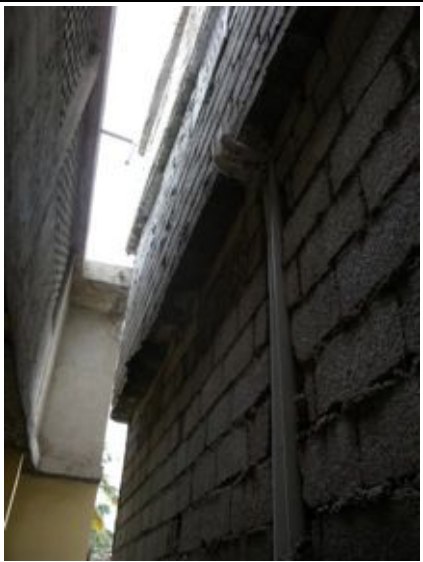
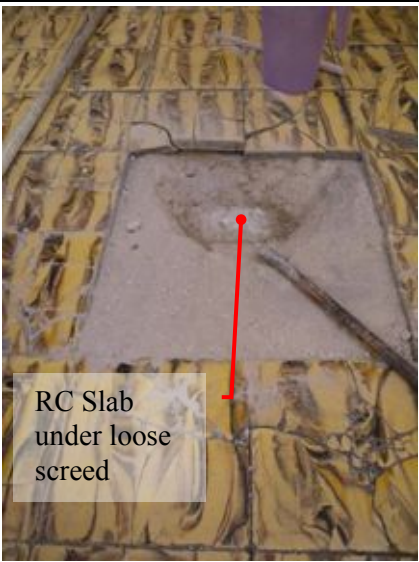
<p>RC Slab under loose screed</p>

Rating	GREEN for the main Building and garage structure. YELLOW for the small side house
Recommendations	<p>It would be sensible to remove the screed on the first floor and apply a thinner but properly made screed to reduce the weight of the building. The cracked tiles are a source of dirt and replacing these would be a prudent measure anyway.</p> <p>Damaged masonry can be readily repaired.</p> <p>Steel rebar on spalled column should be cleaned and patched with high quality sand cement mix.</p> <p>Under no circumstances should any additional floors be added in the future</p> <p>Garage, stub beam next to main building can be cut to create a seismic gap – this will avoid future pounding issues.</p> <p>Small side house, separating walls to be stitched together. Ring beam required at the top of the walls. Prior to attaching the roof structure.</p> <p>Neighbouring, taller building could pose a hazard – discussions should be help with them as their structure, especially the last floor appears of poor quality and is nearly over the inspected building. There may be a benefit on the neighbour removing the most recent top extension on their building.</p>

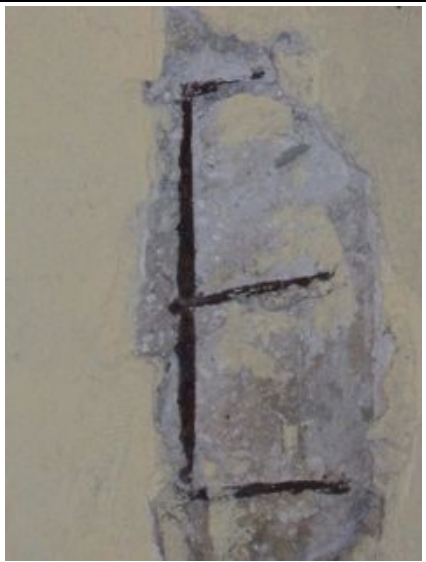
<p>Proximity of neighbouring house. Which has been built incrementally upwards – although very close in places there was no visual evidence of any pounding between the buildings</p>	<p>Reinforced concrete slab under the screed which is effectively loose sand, gravel and small pebbles.</p>	<p>Spalling of concrete on one column. Reinforcement looks as if it has rusted, indicating possible long term exposure. Bars or links do not appear damaged</p>

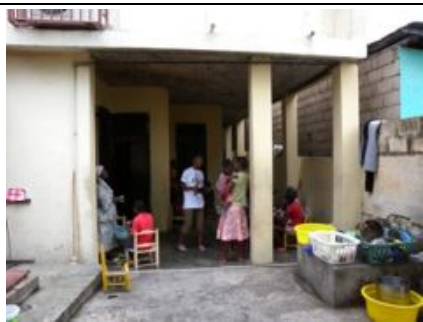
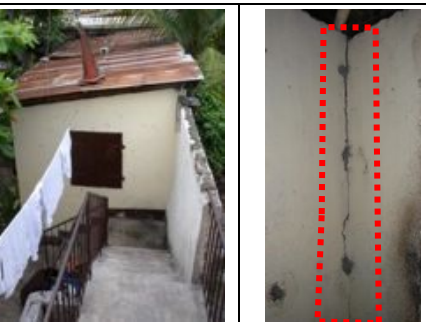
<p>Back of the main building with covered space – Soft storey appearance is limited what is shown on the photo</p>	<p>Pounding damage between the garage and the main building structure. Stub end of garage to be cut</p>	<p>Small, two room hollow block masonry structure with light roof– walls have not been bonded and are coming apart – repair possible</p>

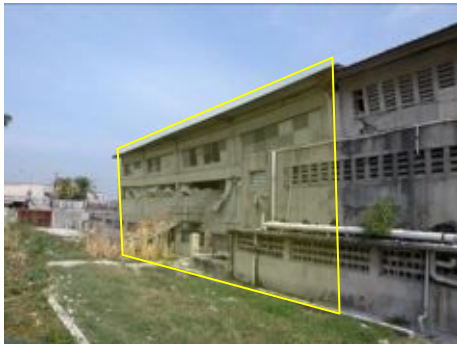
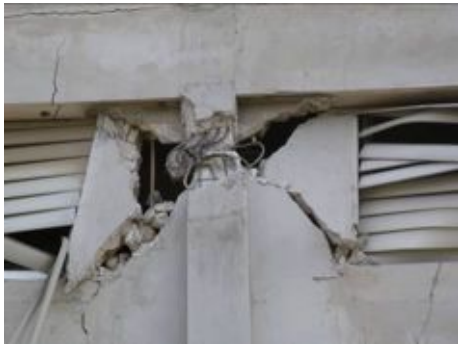
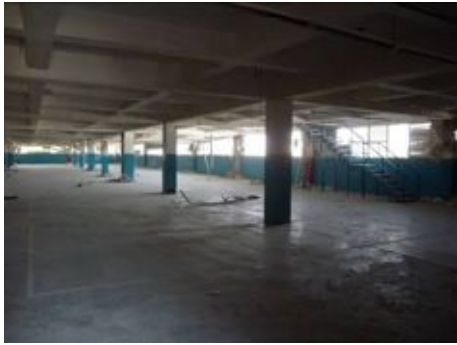
Short column effects have severely damaged the vertical load carrying capacity of the building.	
Figure 4 Near total collapse Part 1 of the warehouse, Assessment = RED

The warehouse building has suffered damage due to the earthquake and it has been weekend. Part 1 of the warehouse has suffered extensive damage and is probably best demolished. A summary of the assessments are shown in the Table 1.

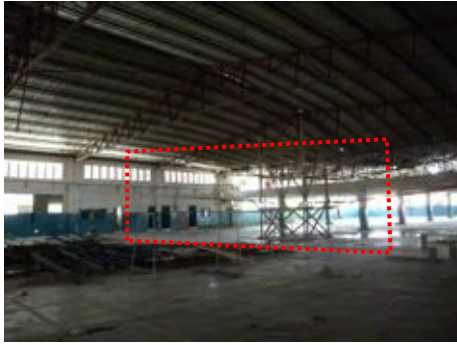
The roof is continuous across Parts 1 to 3 of the warehouse.
Figure 5 Part 2 of the warehouses with significant damage to columns due to partial collapse of Part 1, Assessment = RED

- Strap the double columns at the joint between parts 2 and 3 to take benefit of the two columns.
- Roof bracing to be tightened/ strengthened.
- All false ceiling straps, hangers to be removed to reduce the mass acting on the roof trusses.
- Central columns to be repaired around the base and at the connection with the gutter beam by an appropriate method. This may include the installation of epoxy grouted reinforcement into the ground slab and the gutter beam or similar. As a minimum it is suggested that partial jacketing is installed to improve the ductility of the column to a future earthquake event.
- Oxfam staff should not go into the formal office spaces as long as the infill masonry walls are damaged.

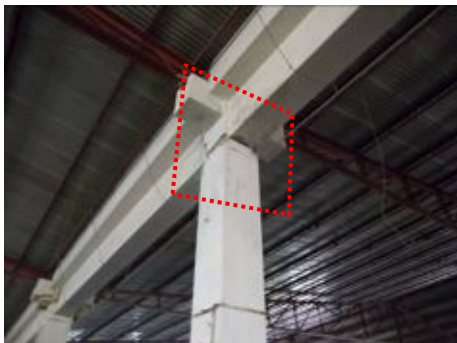
<p>Slightly buckled main column reinforcement</p>
<p>Figure 6 Part 3 of the warehouse with damage to the top and bottom of the central columns in the direction of the gutter beam, Assessment = YELLOW</p>

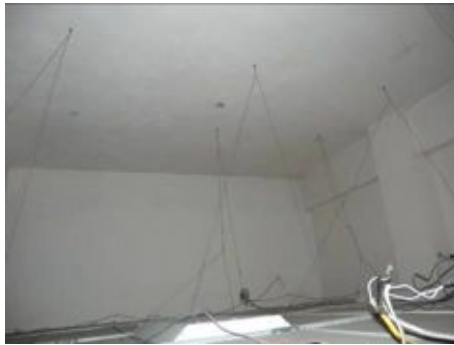
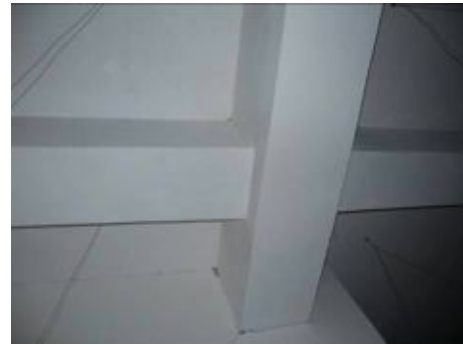
Figure 7 Part 4, single storey reinforced concrete frame with unreinforced masonry infill.

The concrete frame appears undamaged. However, there are significant cracks in the infill.

It is not known if the single storey office part is attached to the warehouse perimeter columns.

Assessment = YELLOW

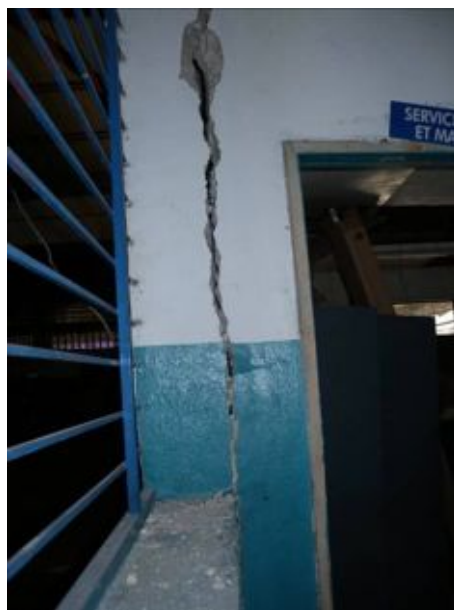
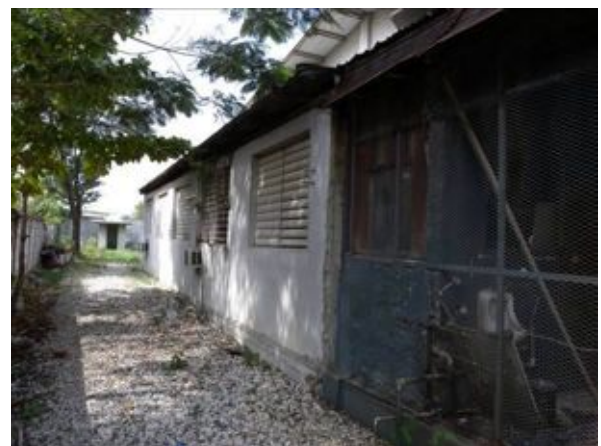
Figure 8 Part 5, single storey unreinforced masonry construction with light timber roof with metal roof sheeting.

Separation has occurred between the warehouse and the masonry part along the movement joint (which had been plastered over) however, there did not appear to be any other significant damage.

Pounding damage to the warehouse columns does not appear to have been done due to the light weight roof of the single storey side building.

Assessment = GREEN but nobody from Oxfam needs to use this space.

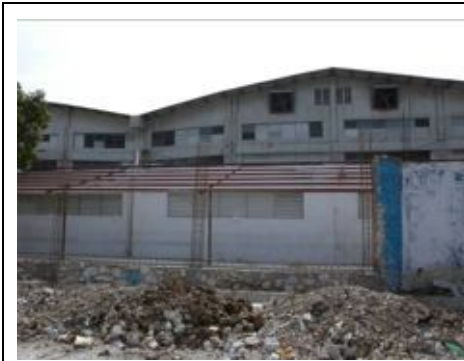
Figure 9 Perimeter wall being repaired to secure the warehouse site.

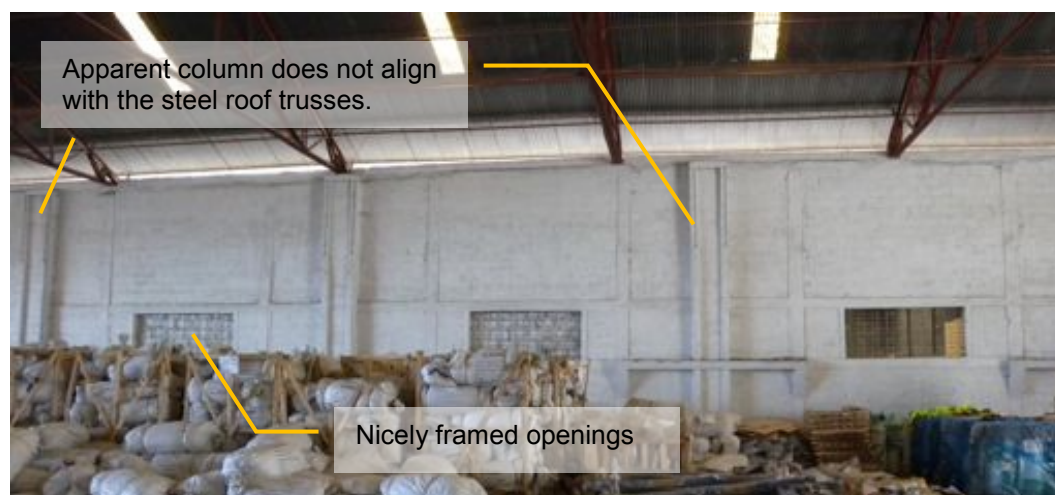
Orthogonal reinforced concrete frame between B4 and B5 warehouses. Large columns are thought to contain concrete columns that have been clad with block work. Note the apparent concrete band beams and intermediate vertical concrete columns within the framing. Note that the large columns do not align with the roof trusses. Openings are nicely framed.

Figure 4 Observations on the perimeter concrete frames to warehouse B4

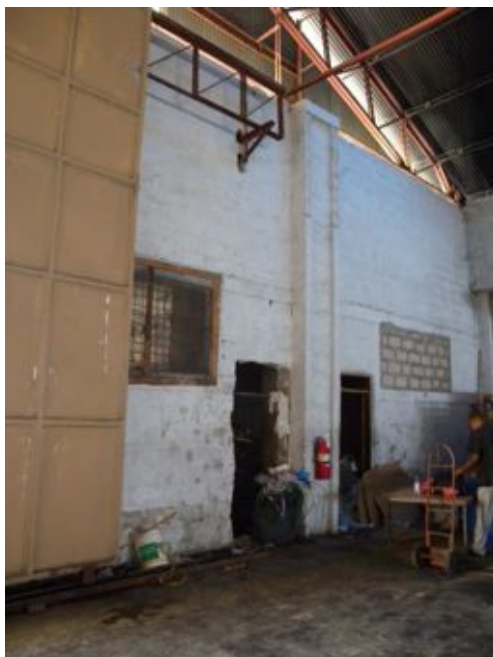
Reinforced concrete frame and hollow block masonry infill end wall at the warehouse loading level.

Columns are most likely cantilevering for which they are unlikely to have been designed.

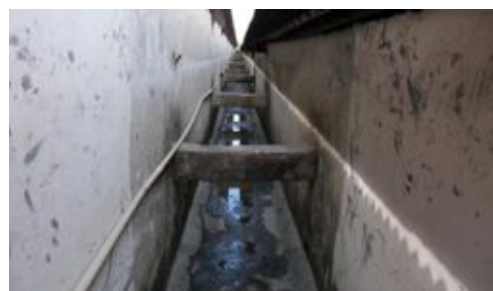
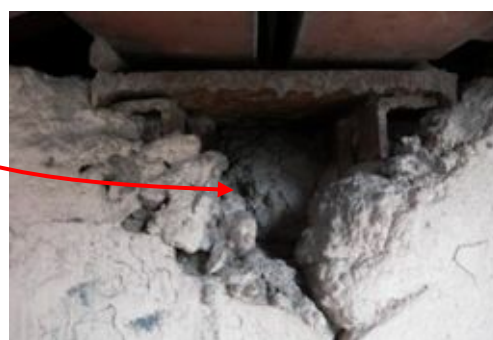
View along the length of the gutter beam showing concrete props between gutter beam vertical faces

Figure 9 Gutter beam details and typical roof truss to concrete connection (taken from either warehouse B2 or B3 due to easier access at those locations).

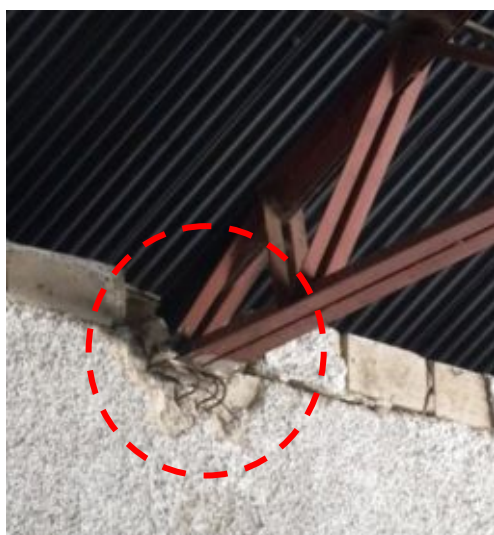
Near total failure of the steel roof truss to top of concrete U-Shaped gutter beam connection.

Confinement reinforcement is missing or has failed.

Figure 10 Steel to concrete connection

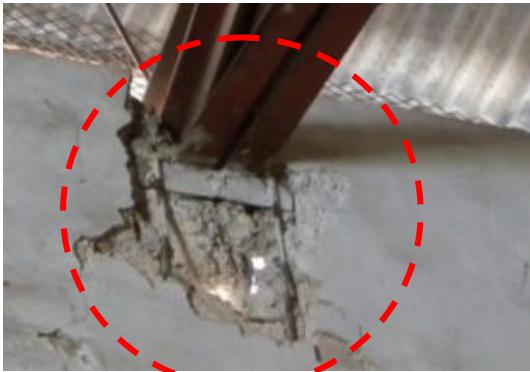
Near total failure of the steel roof truss to top of concrete U-Shaped gutter beam connection.

Confinement reinforcement is missing or has failed.

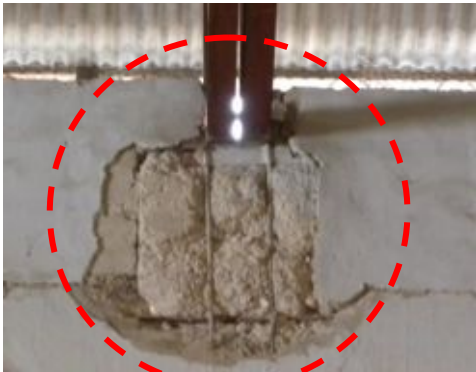
Column bars have been pulled out and severely buckled.

THIS NEEDS URGENT REPAIRING / RETROFITTING

- Extend roof truss ends by welding on angles and brackets so as to create a “hook” for the roof trusses to prevent them from being pulled off their support points.
- Provide confinement to the gutter beam stub columns that are supporting the roof trusses so that the roof trusses can't just pull out leading to their collapse.
- Disconnected collapsed portions of the warehouses from the roof trusses to stop pulling the trusses down. Demolish the remaining portion safely so that it no longer poses a falling hazard.
- Do not allow any use of the facility within the height of the front and back walls.
- Tighten existing loose tension only bracing within the roof.
- It is expected that these steps can be undertaken within 30 to 45 days by the current building owner.

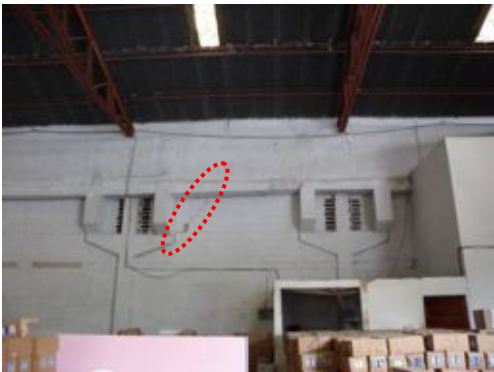
Near total failure of the steel roof truss to top of concrete U-Shaped gutter beam connection.

Confinement reinforcement is missing or has failed.

Column bars have been pulled out and severely buckled.

THIS NEEDS URGENT REPAIRING / RETROFITTING

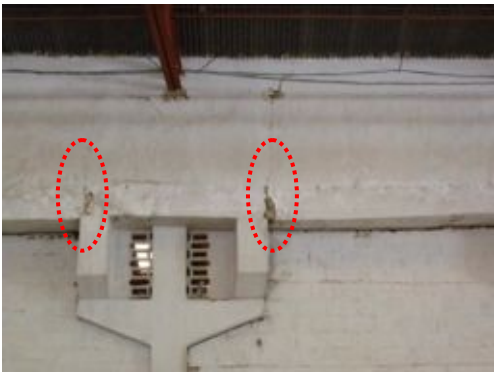
Figure 13 Damage to longitudinally running gutter beams, infill masonry and the steel roof truss to reinforced concrete connections.

Modest levels of damage to the masonry infill.

Damage to gutter beams due to the awkward detailing of this beam.
