EERI/PEER/FHWA Bridge Team Report

Performance of Highway and Railway
Structures during the February 27,
2010 Maule Chile Earthquake

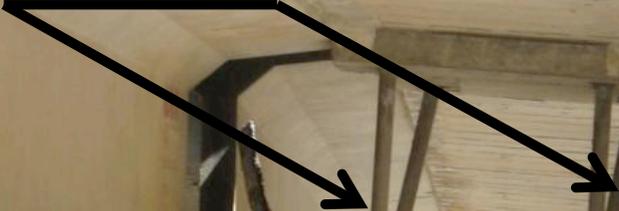
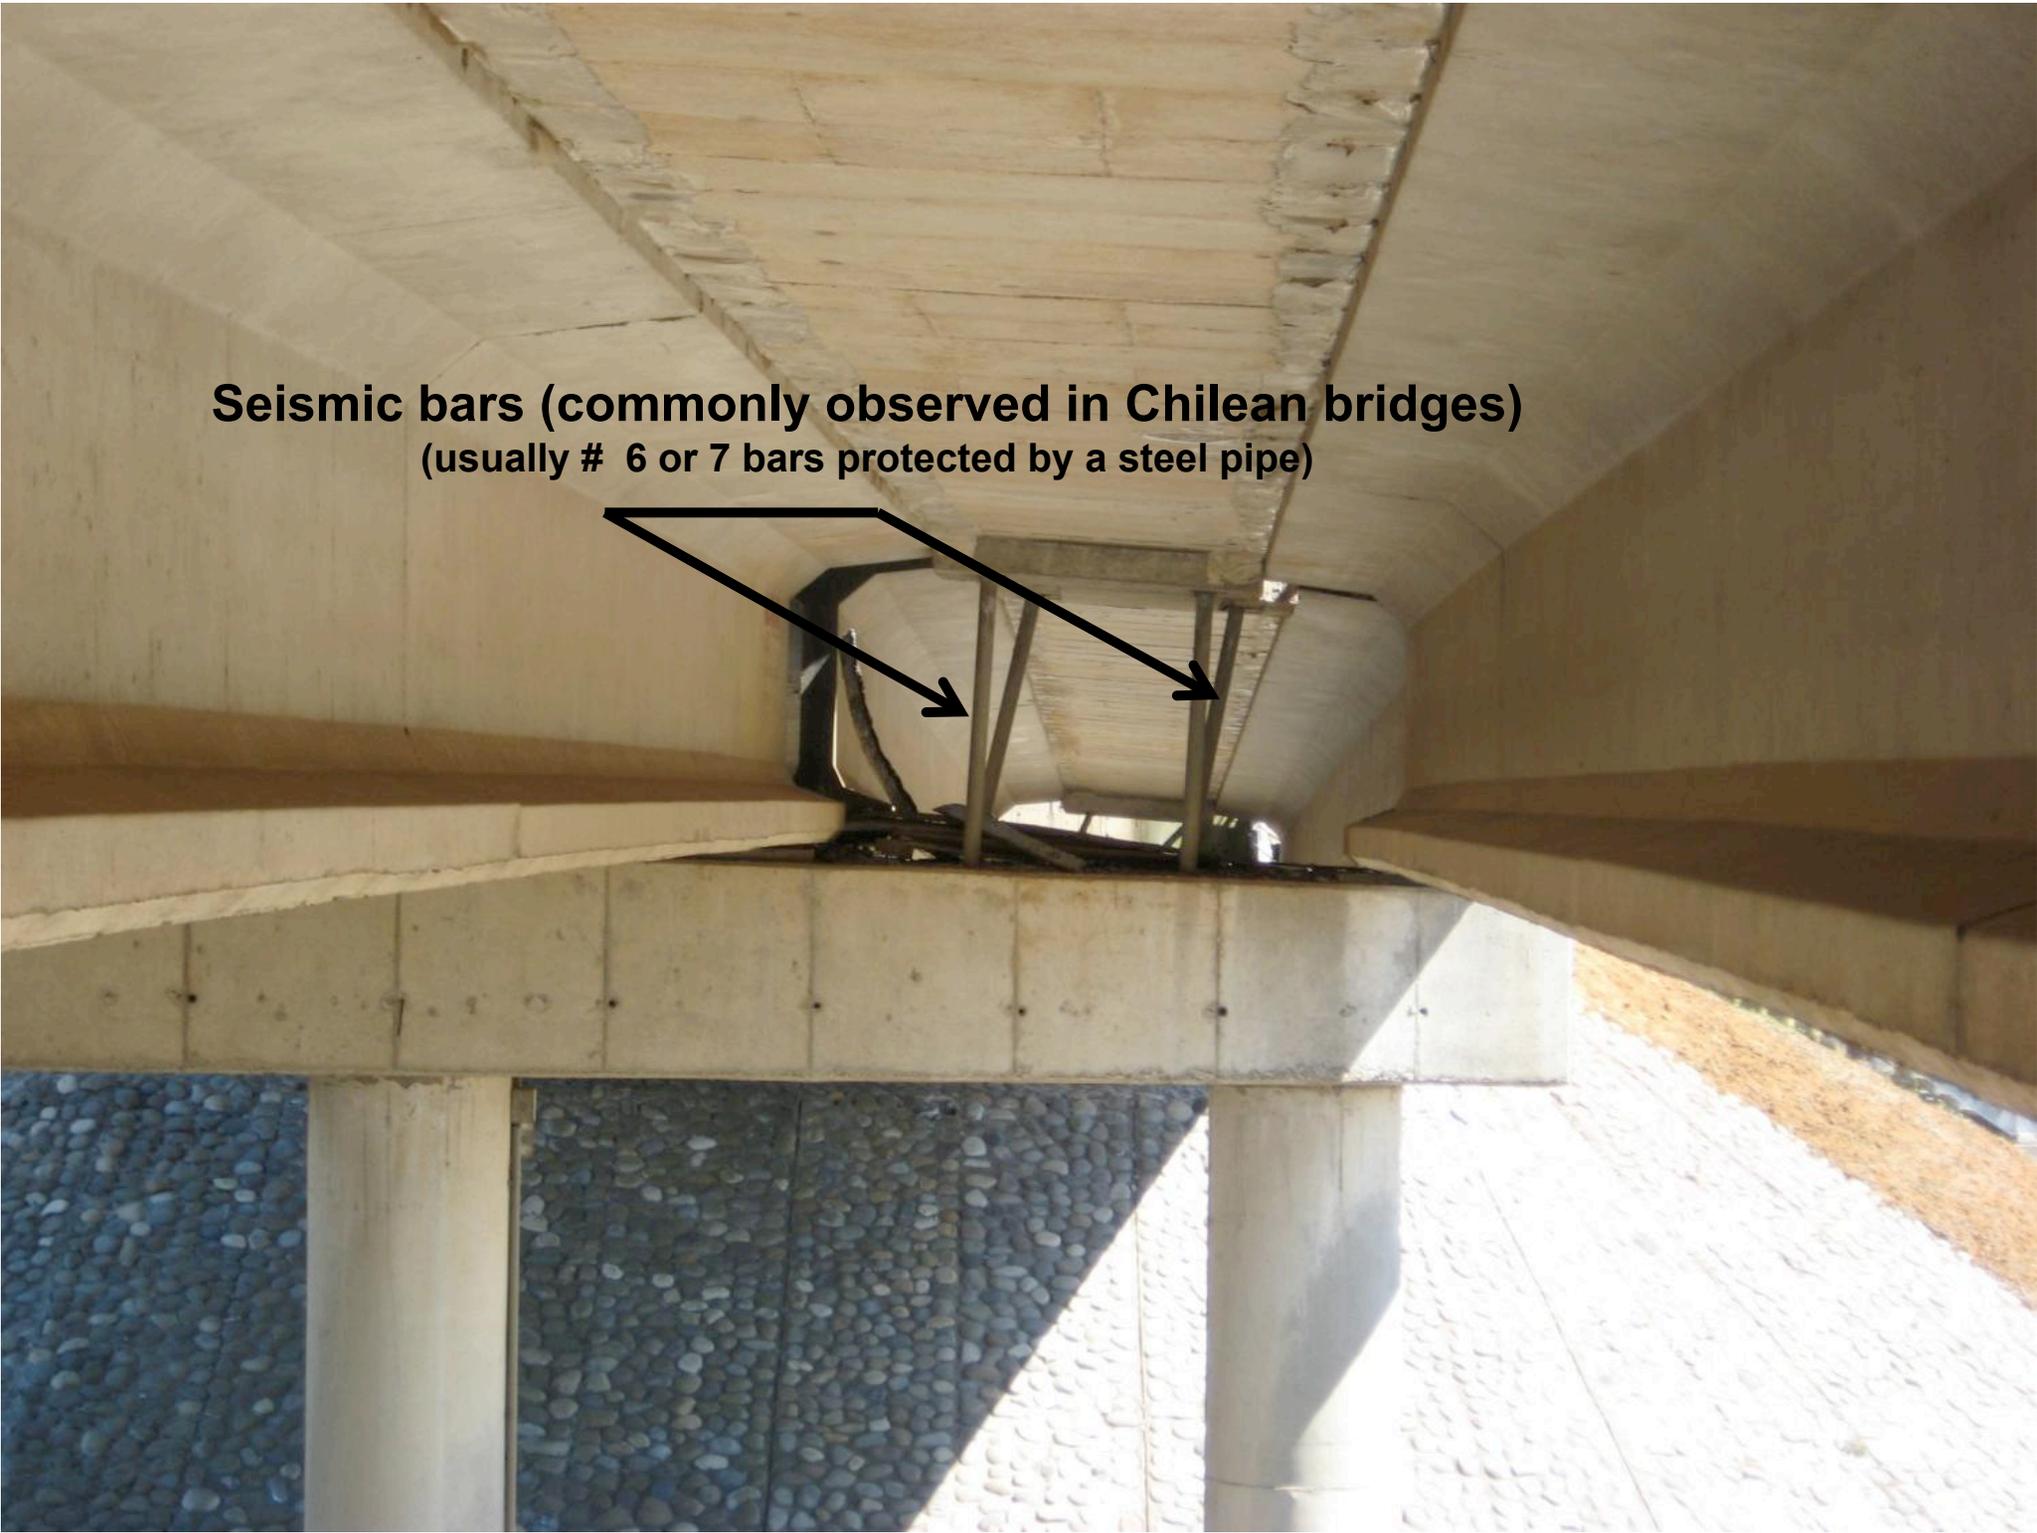
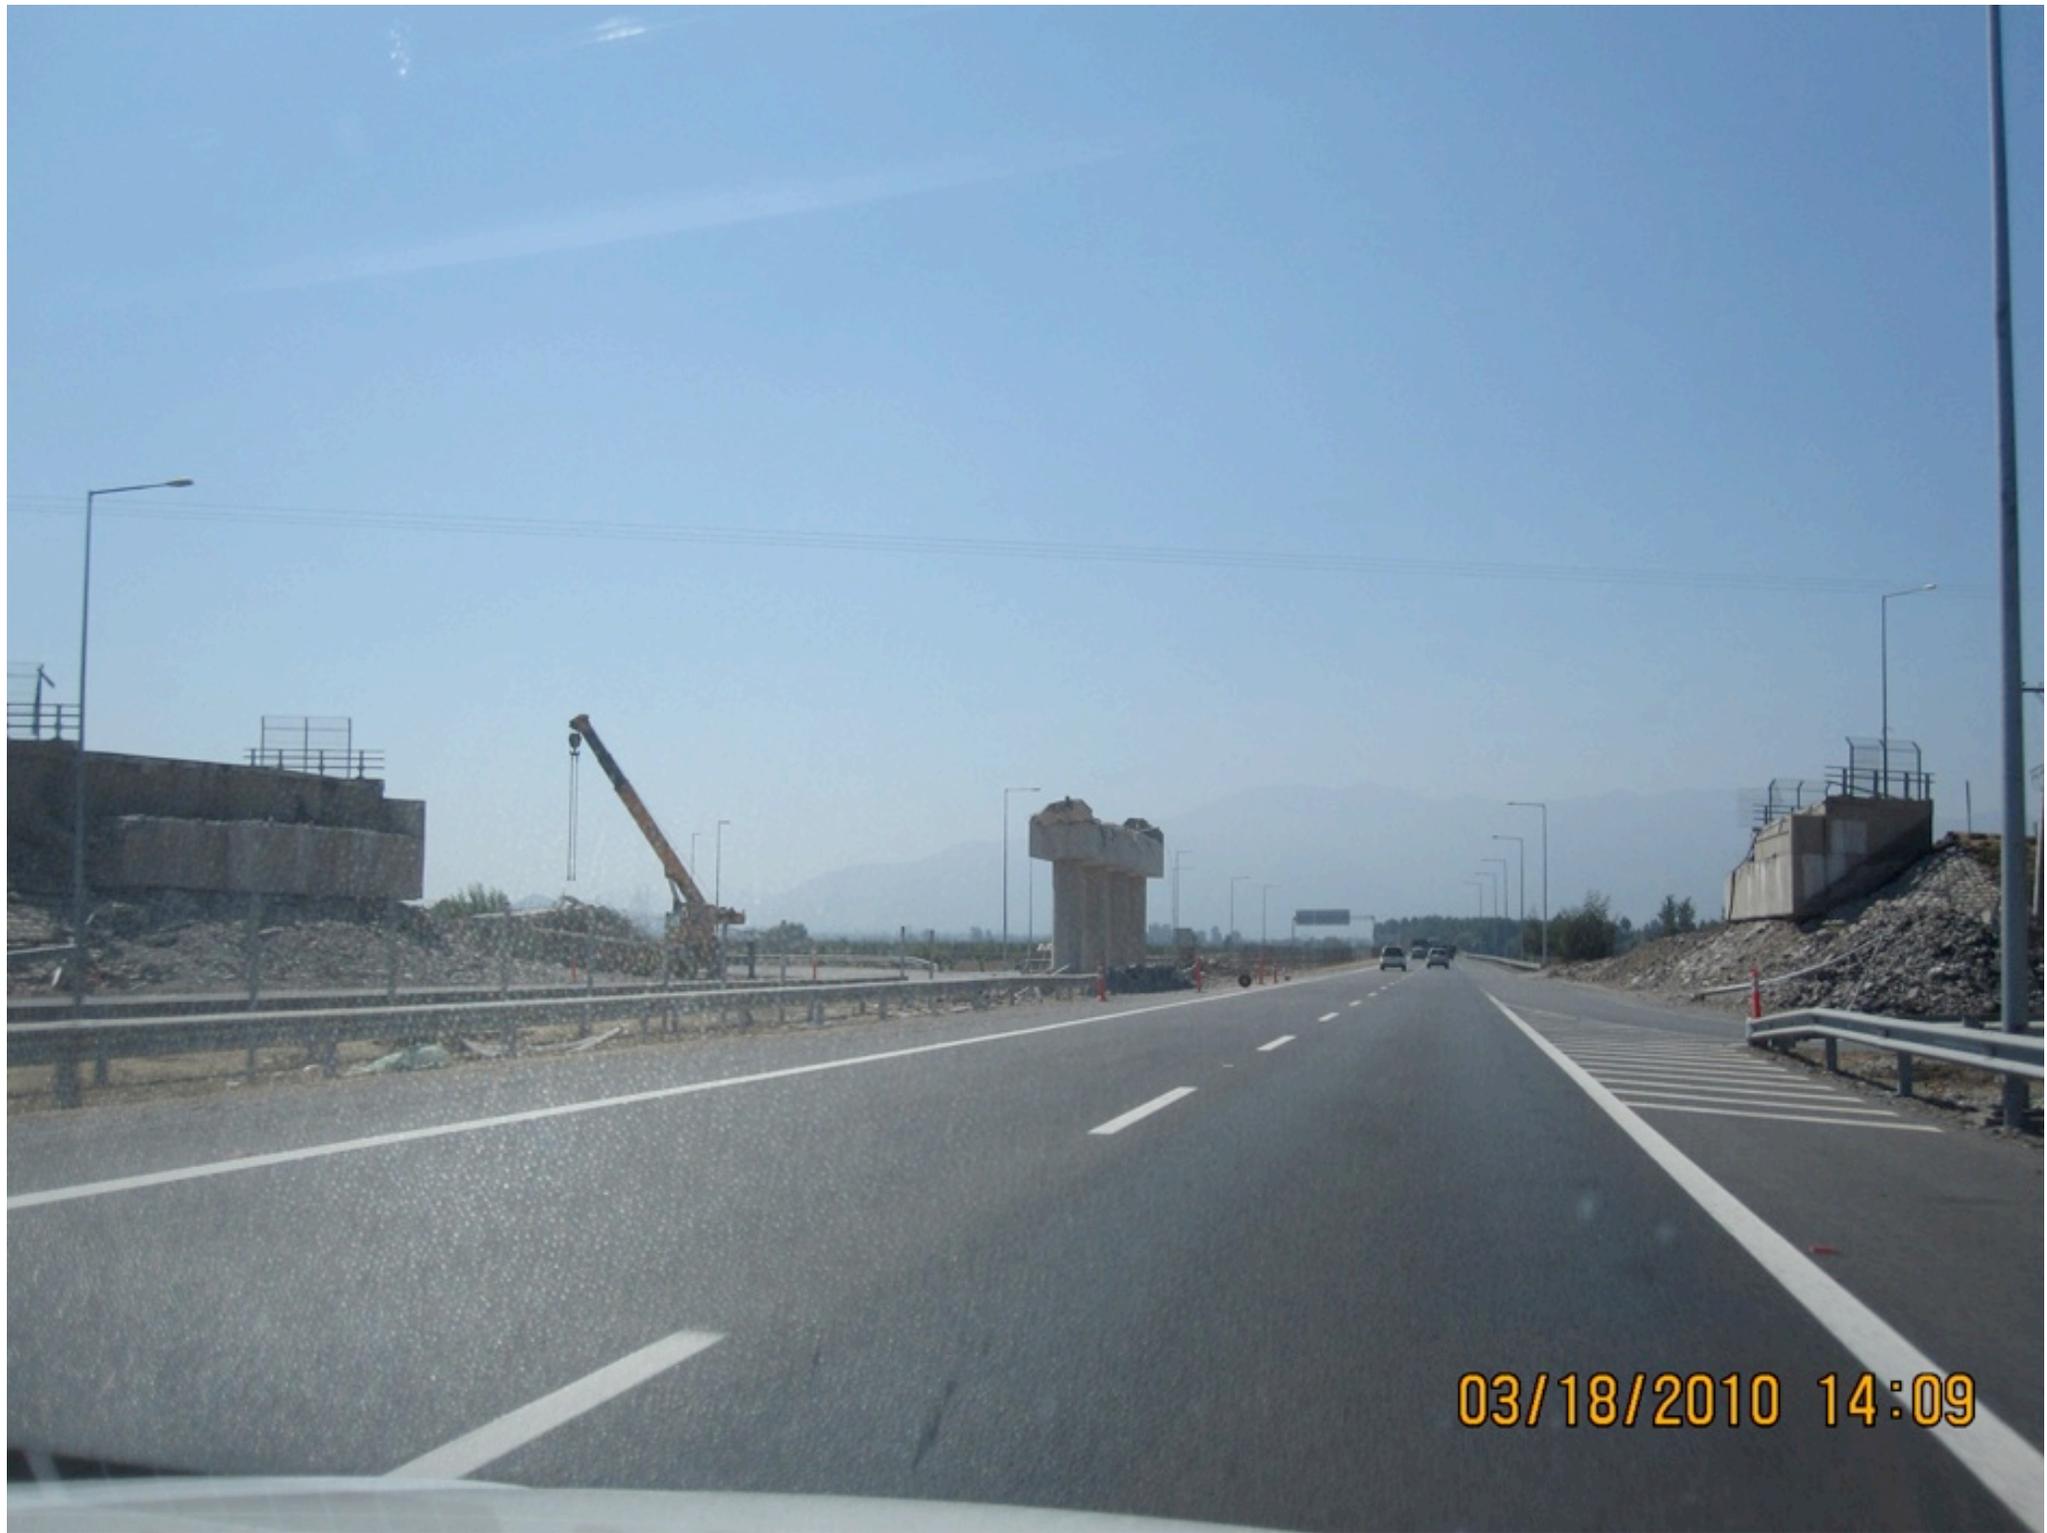
Exterior beams were heavily damaged in some O/C's with stronger and stiffer shear keys and without end diaphragms

Seismic bars (commonly observed in Chilean bridges)
(usually # 6 or 7 bars protected by a steel pipe)

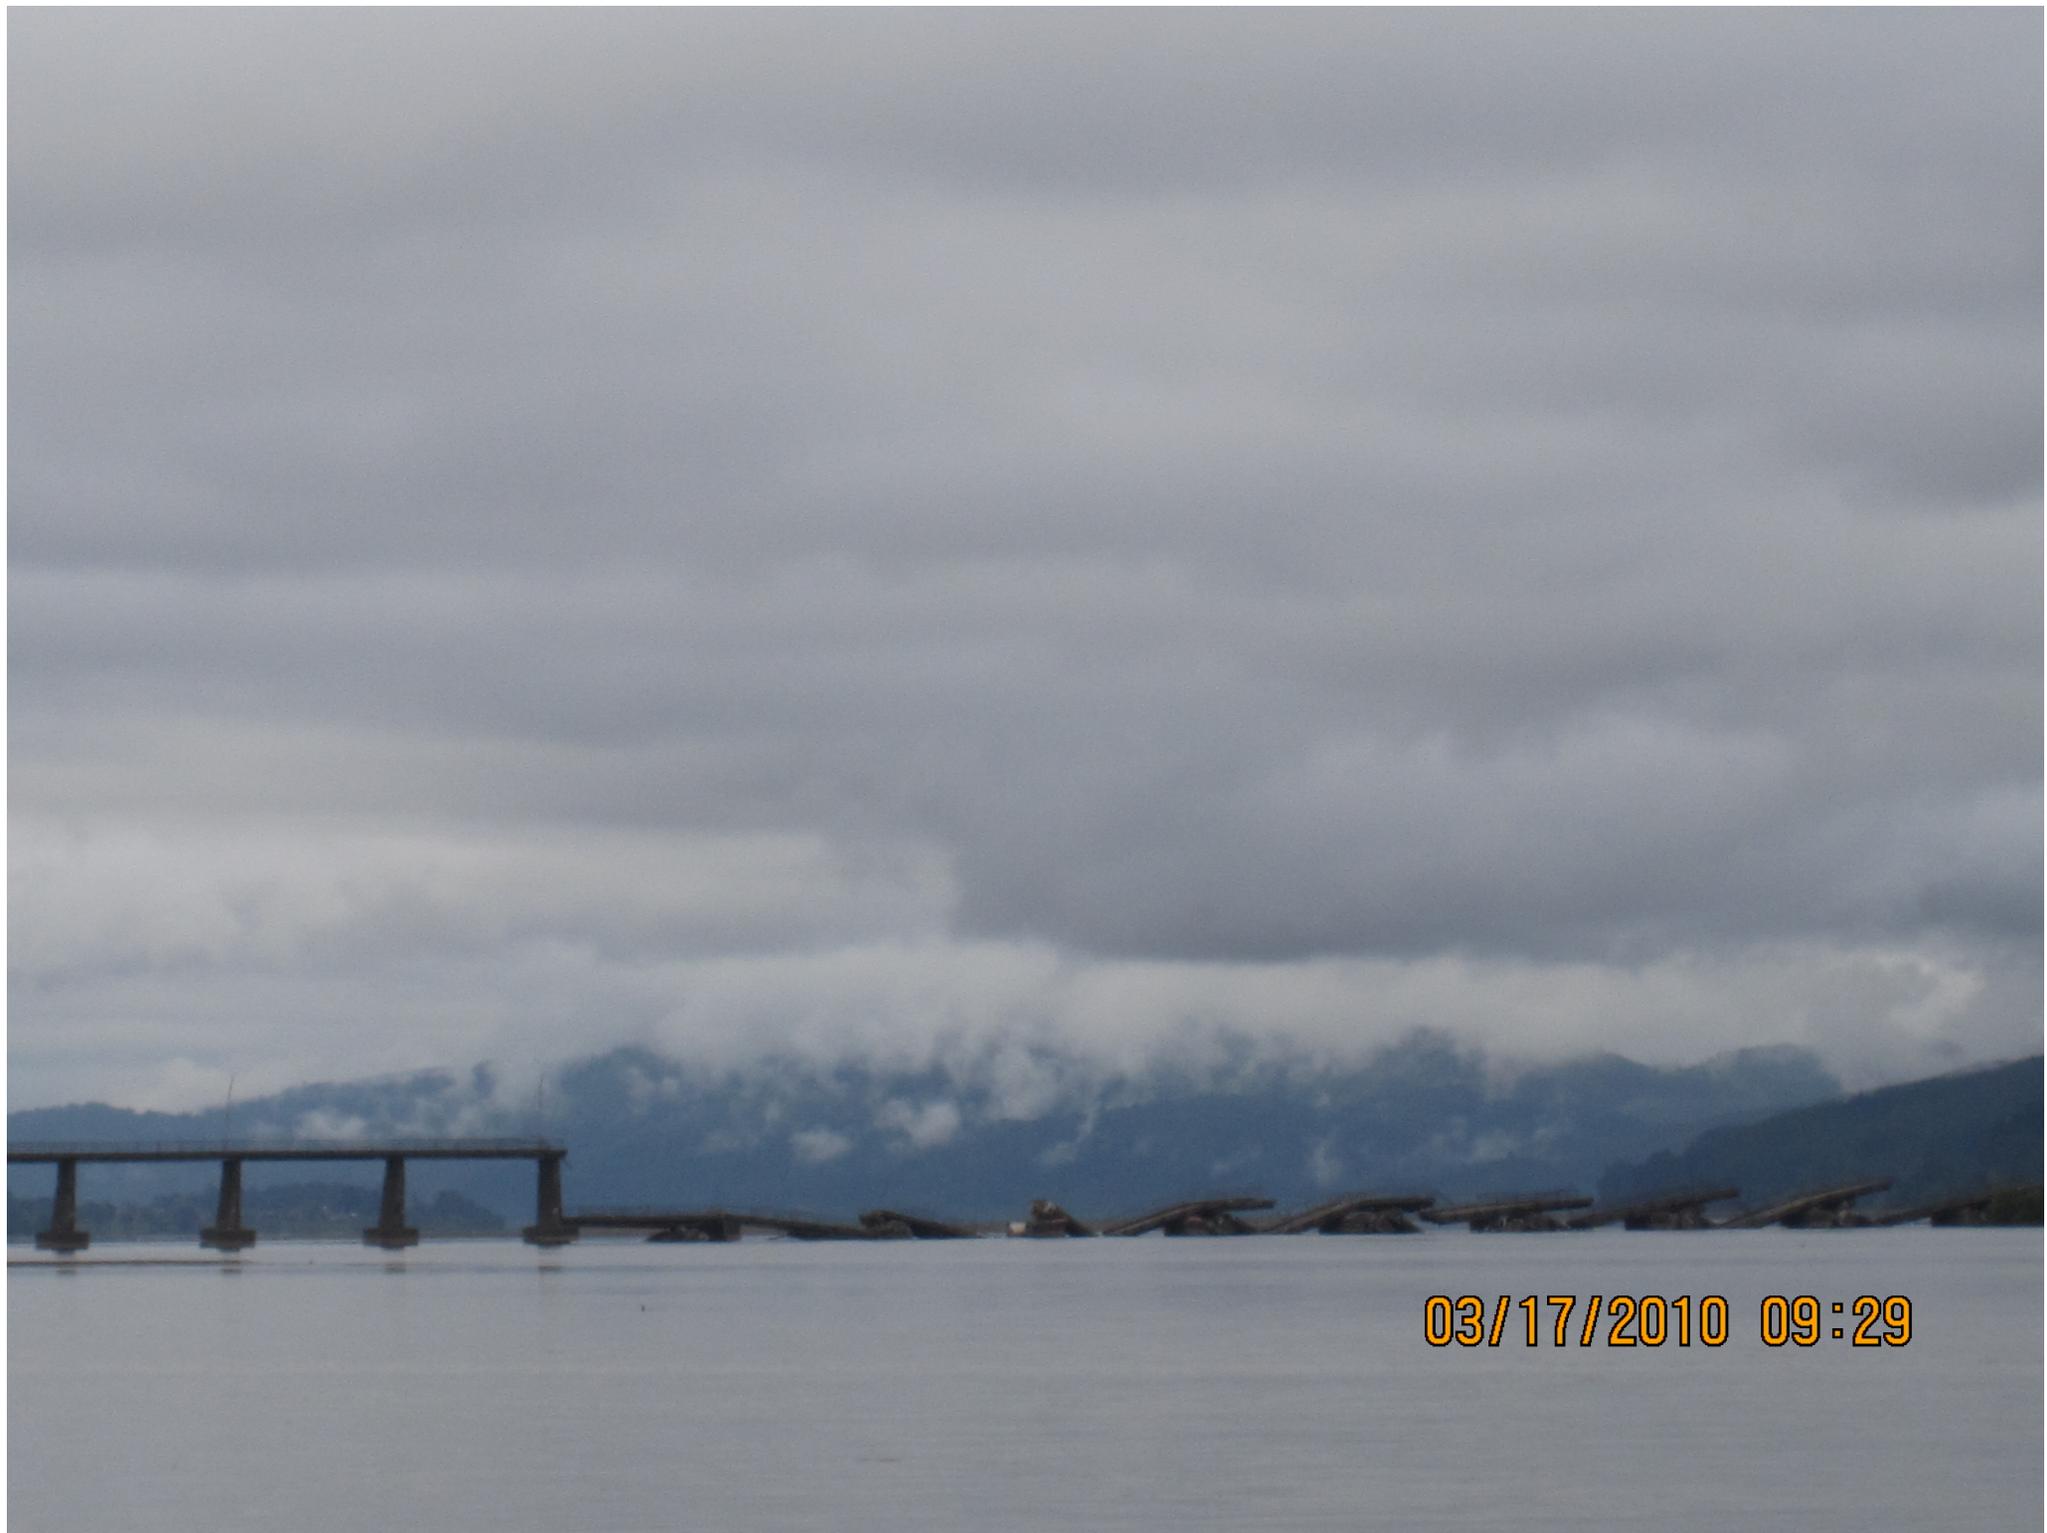
The Bridge had been closed before the EQ. It consists of several short span simply supported steel girders resting on pier walls with short a seating width. Collapsed can be attributed to unseating of the beams

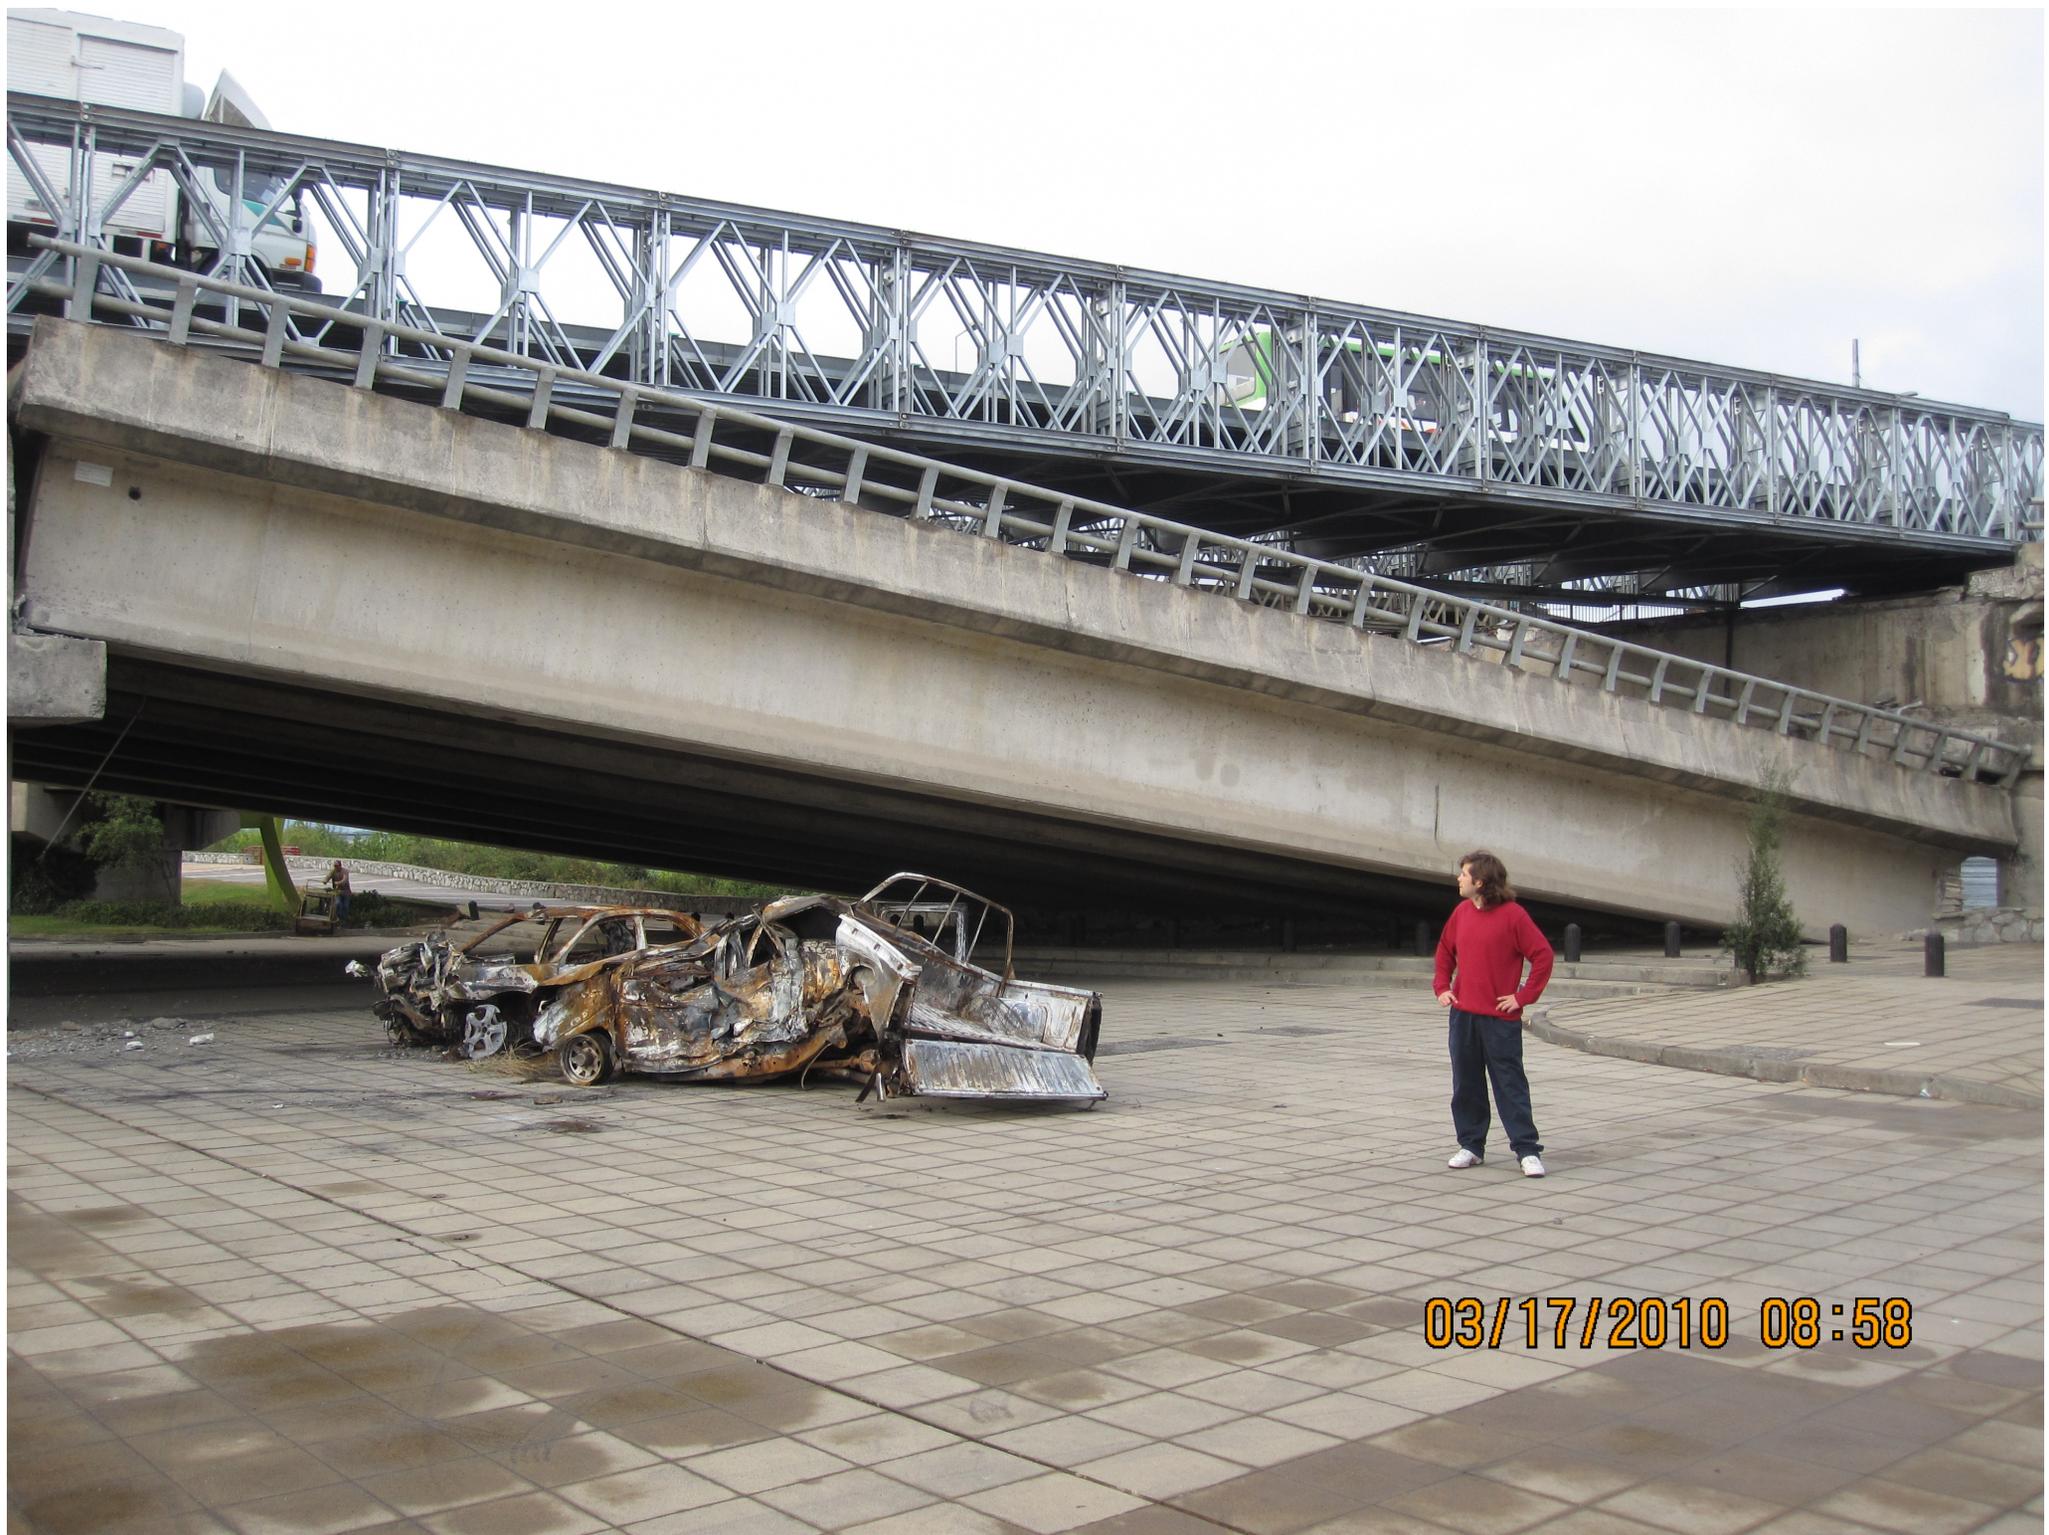
This bridge was poorly balanced. It had a variety of structures with different stiffness all coming together at a huge super-bent. All the different elements needed to be designed with similar stiffness to prevent catastrophic damage.
