EERI/PEER/FHWA Bridge Team Report

Performance of Highway and Railway
Structures during the February 27,
2010 Maule Chile Earthquake

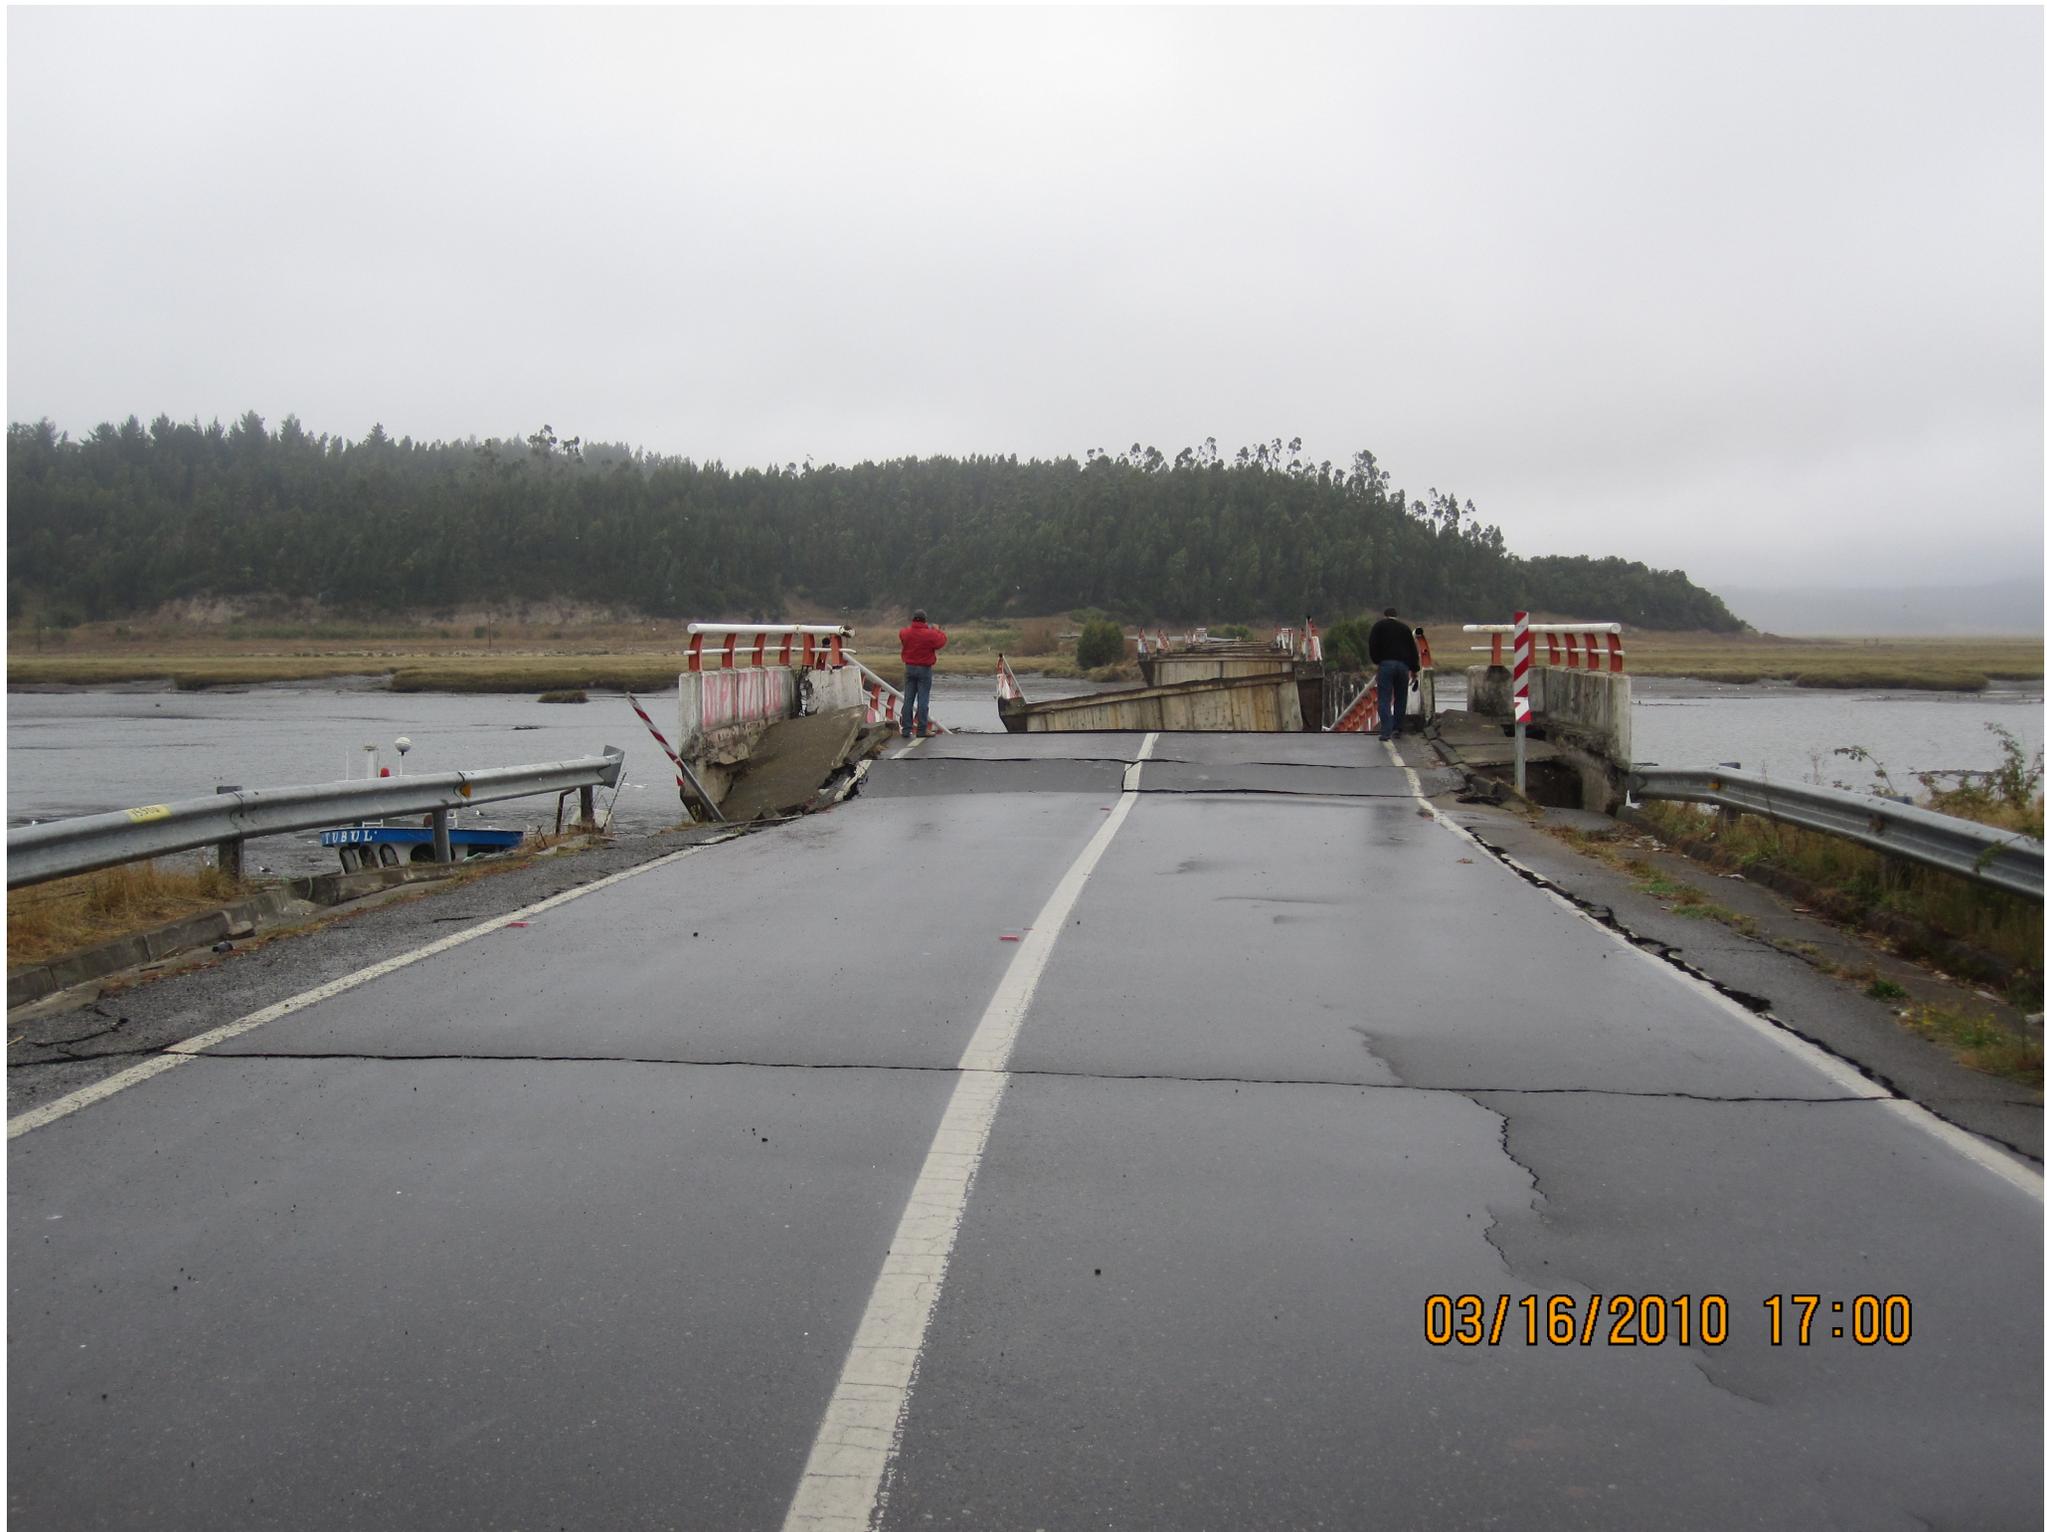
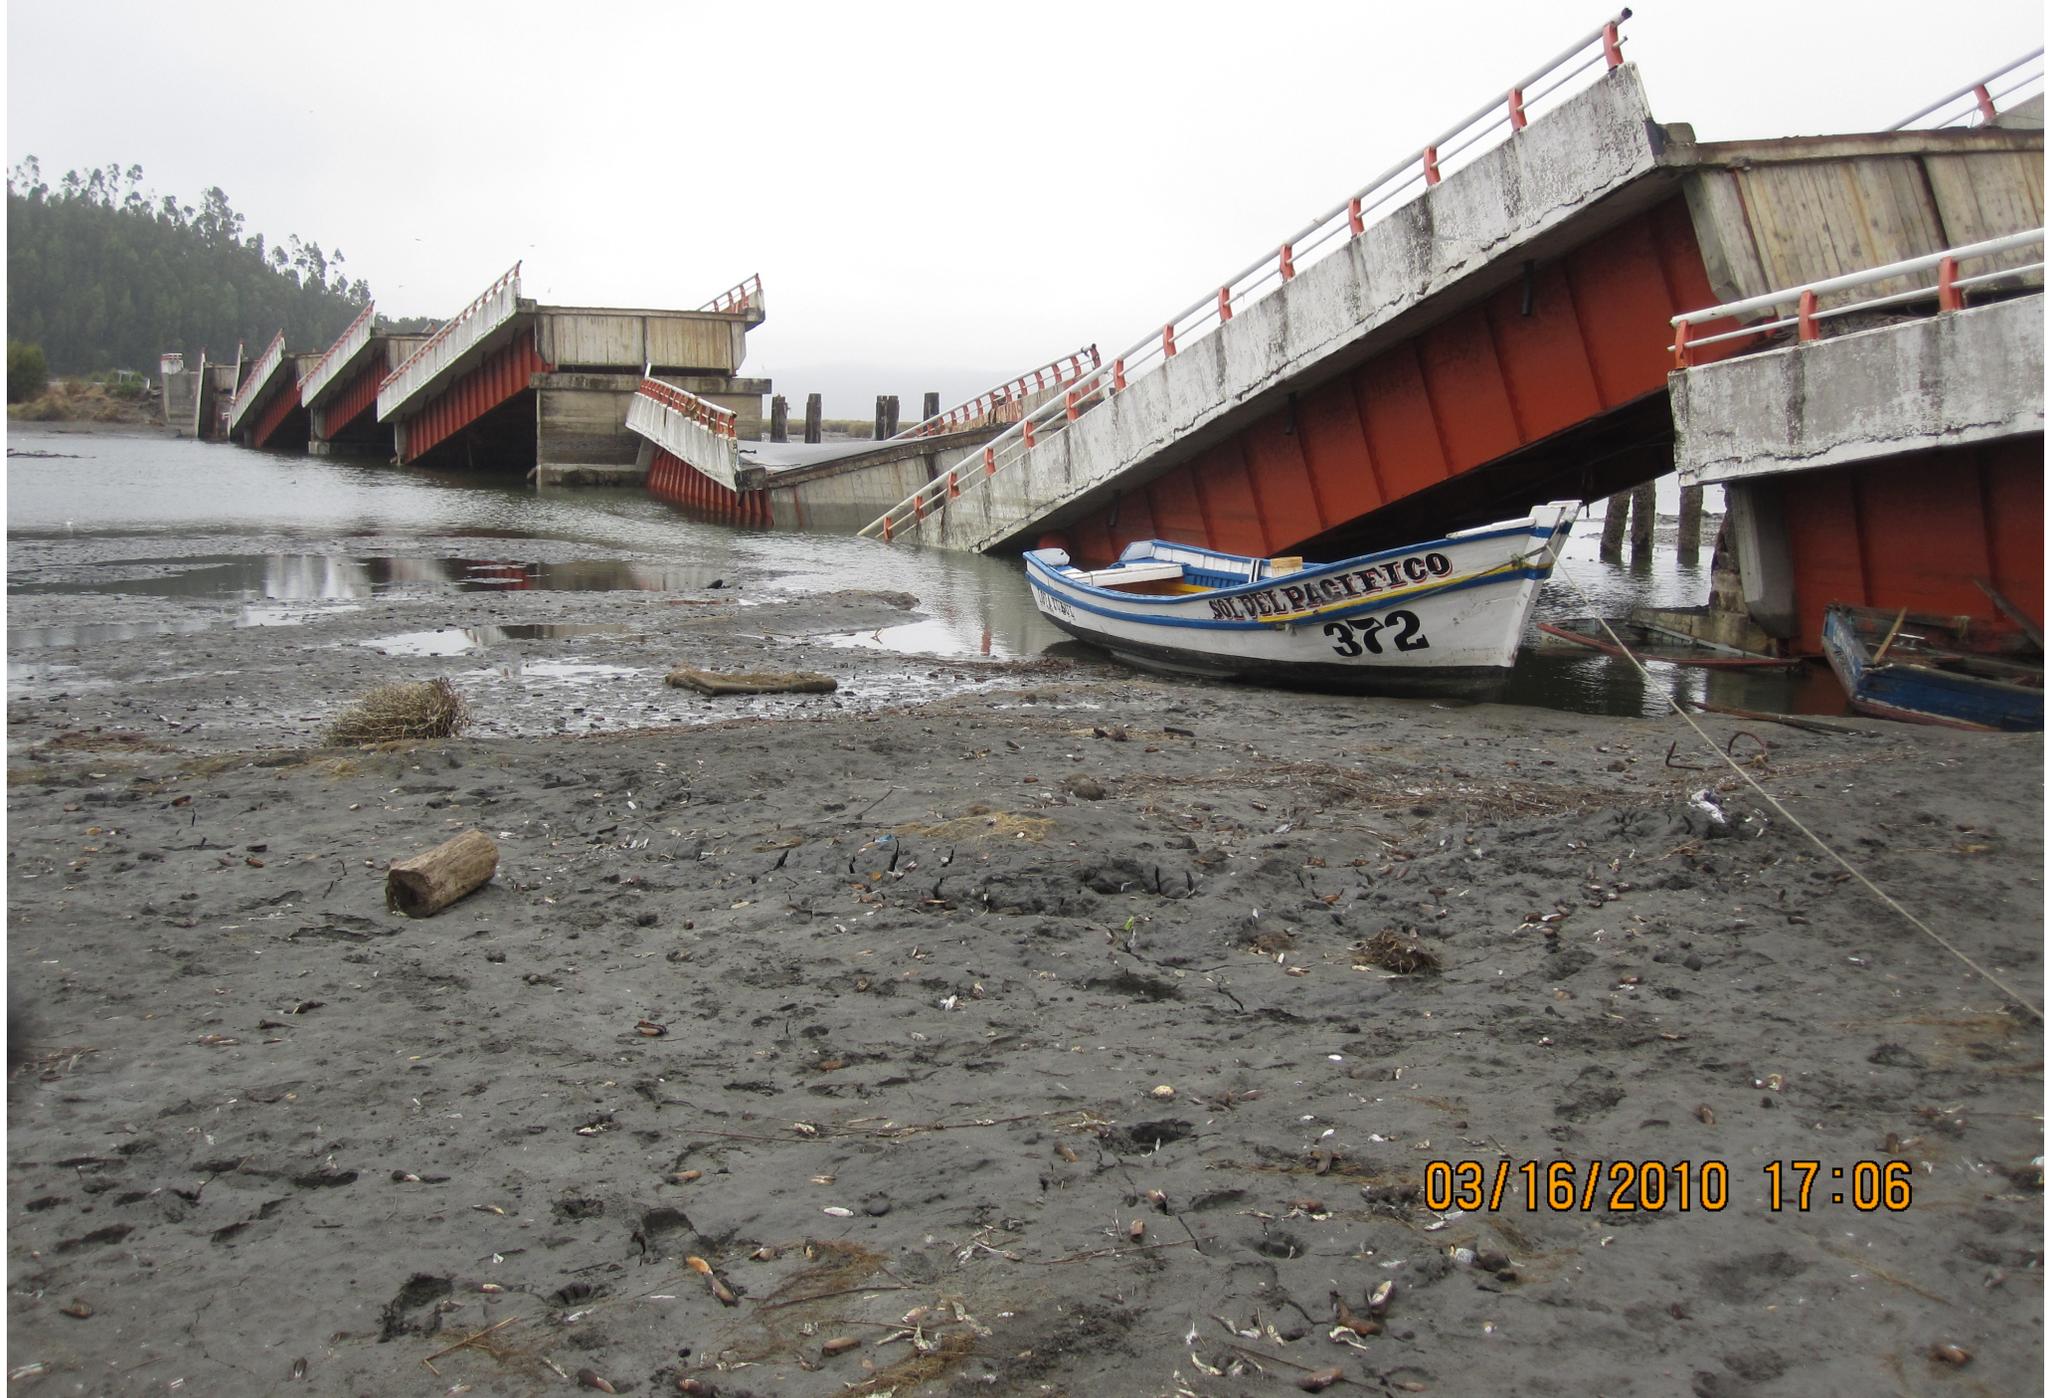
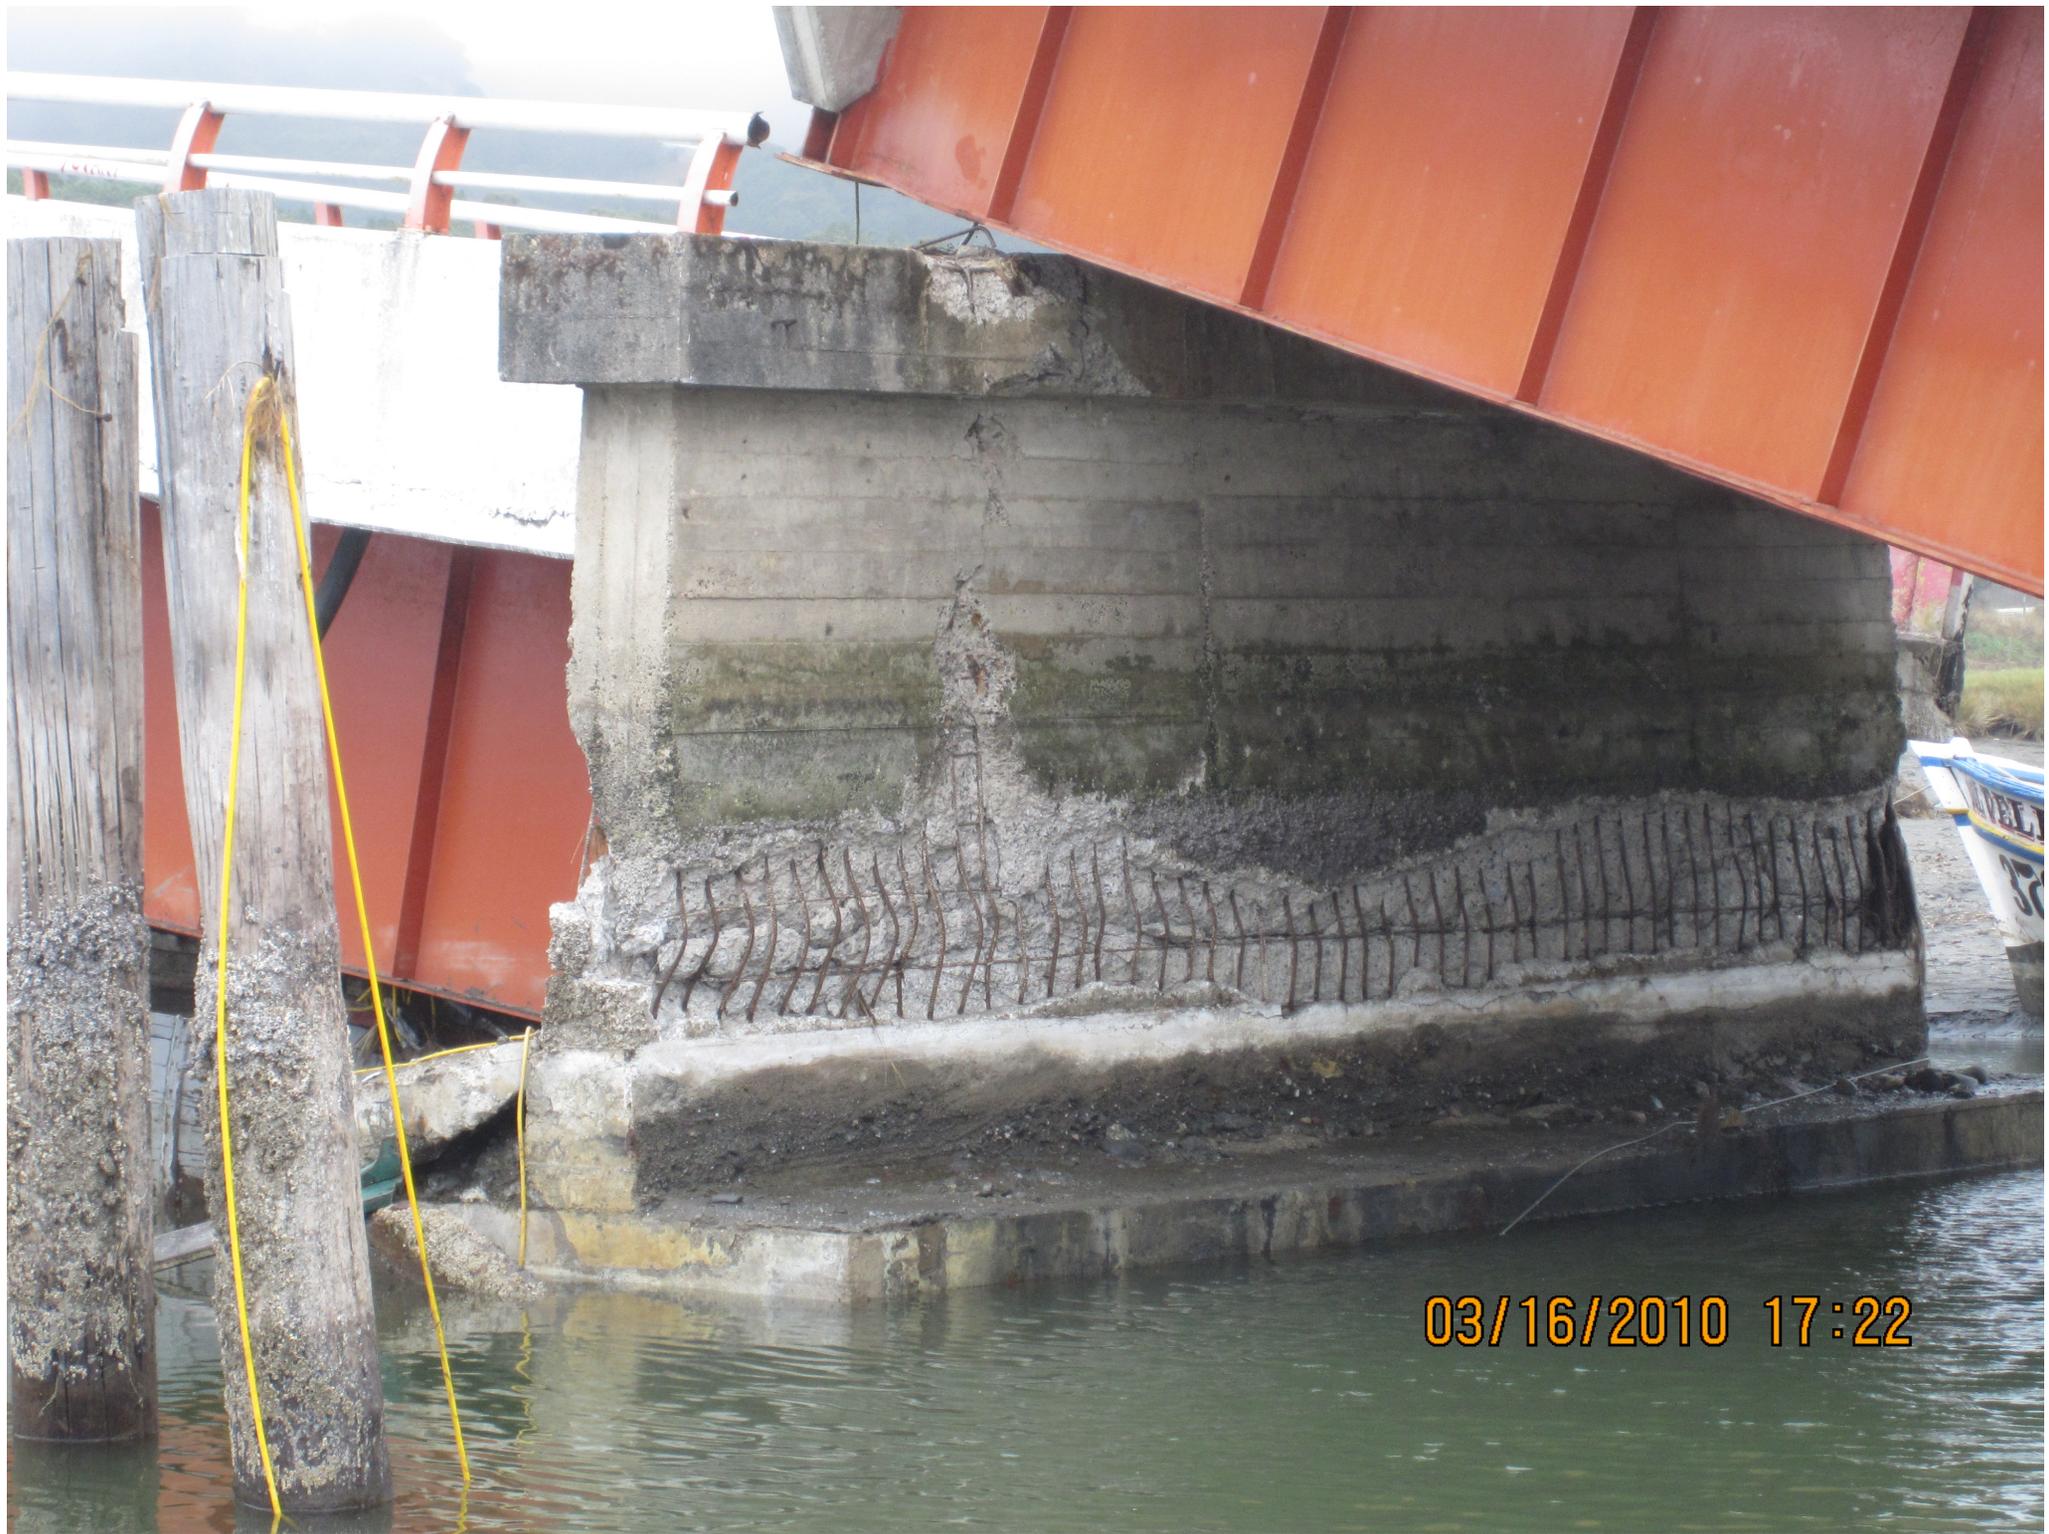
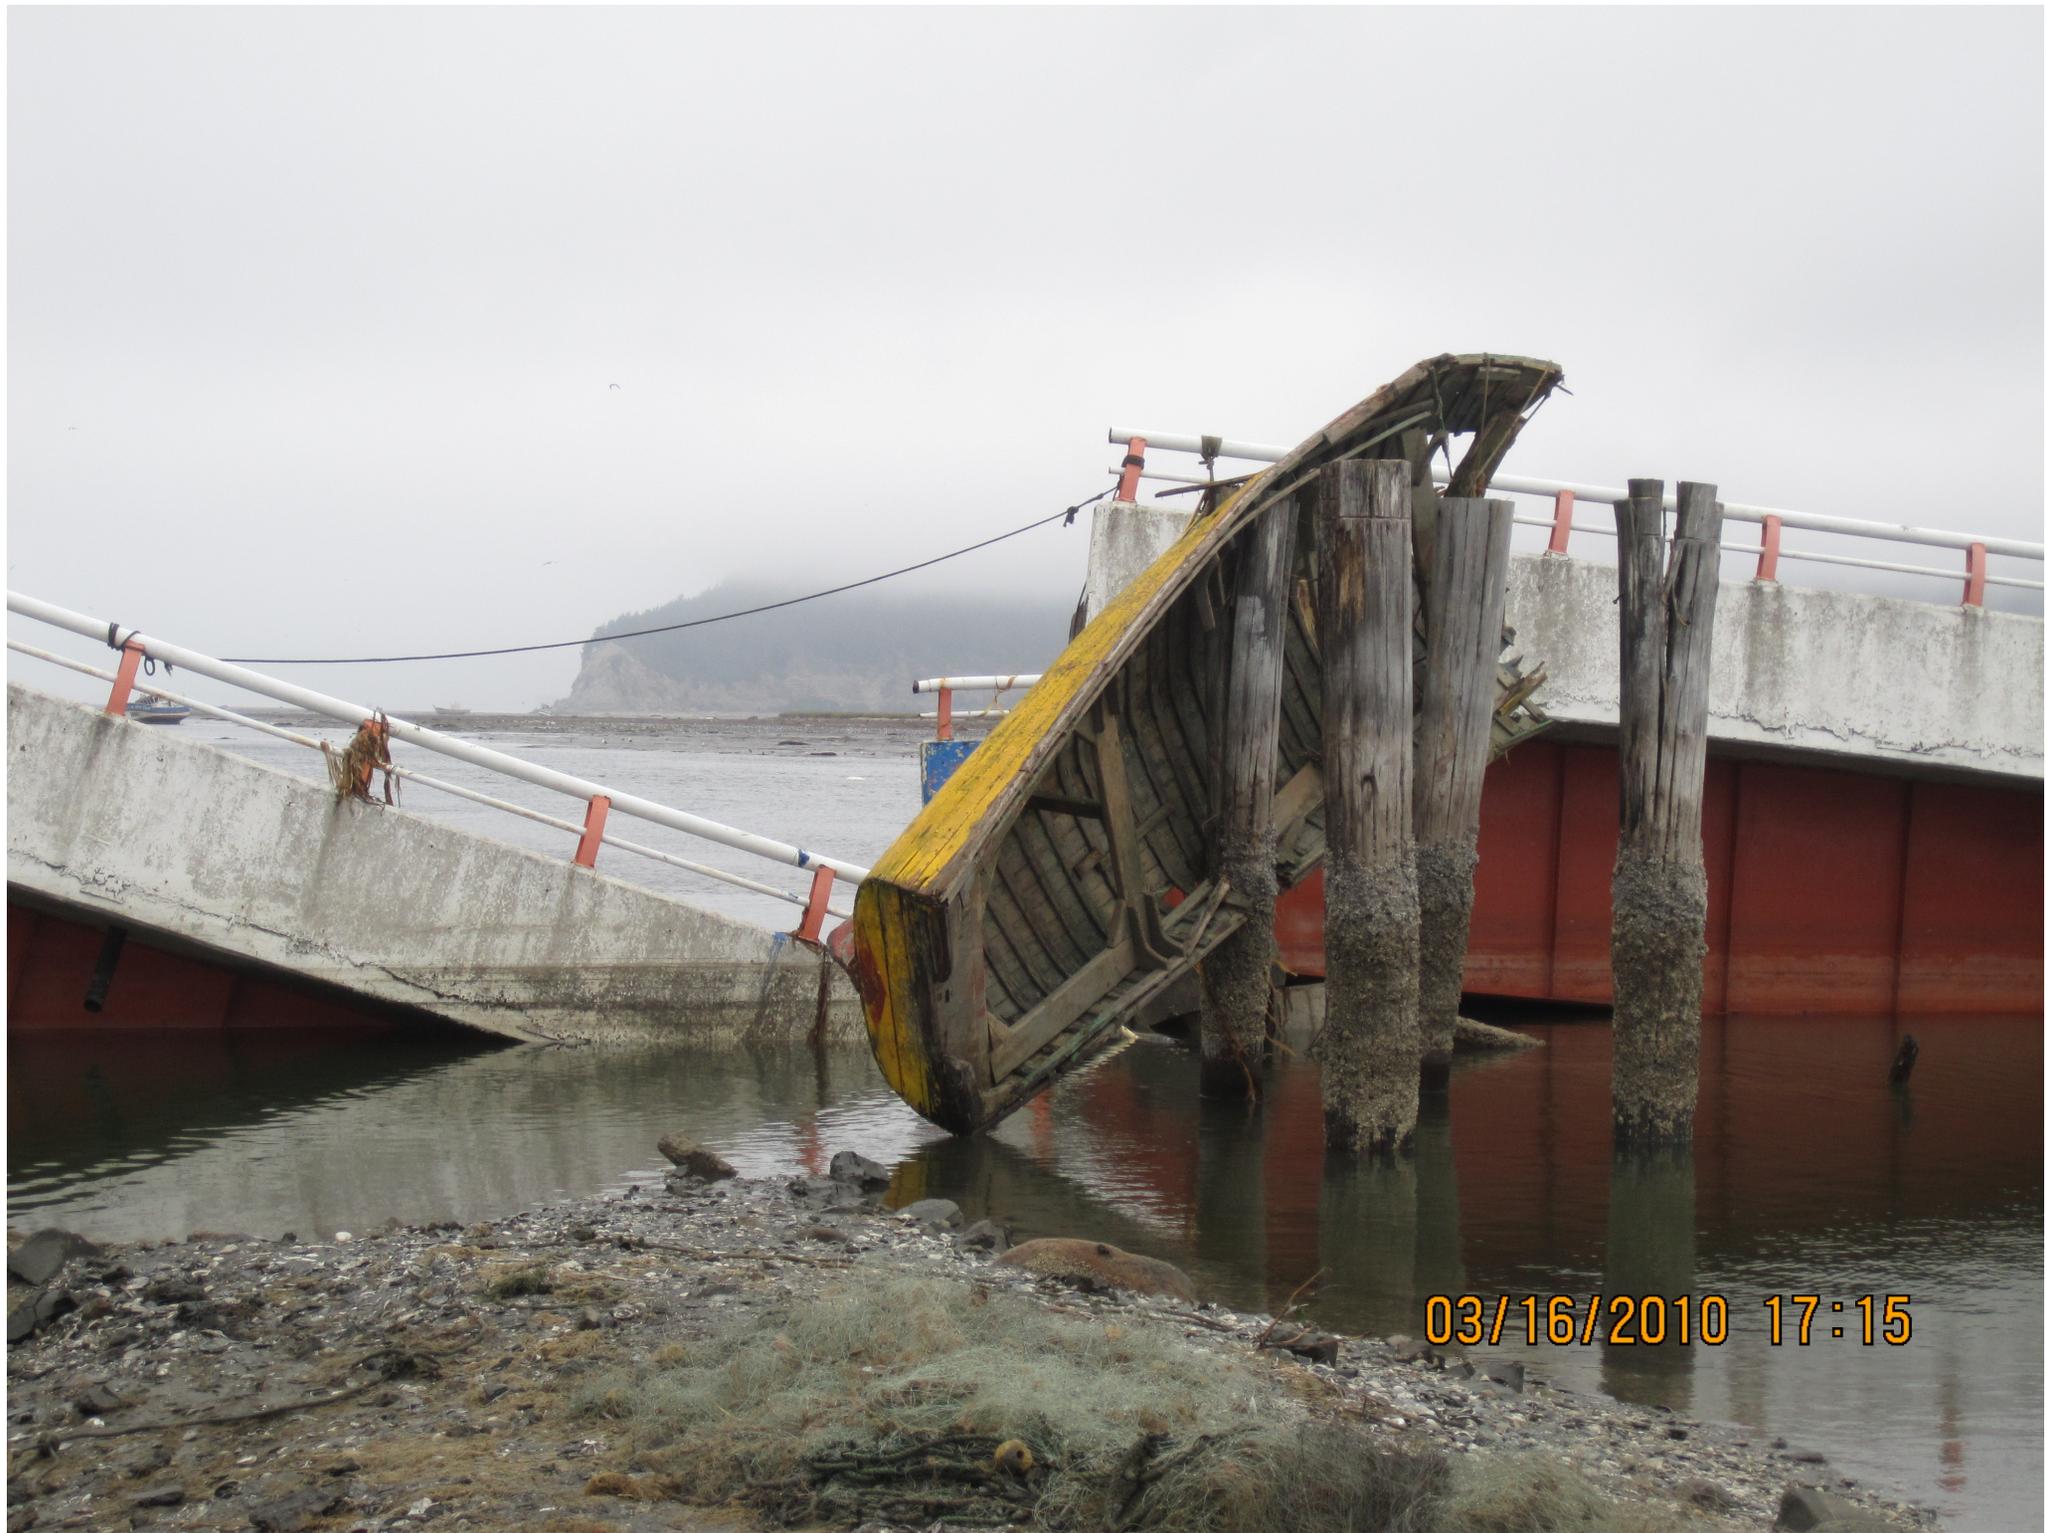
Puente Tubul

This was the southernmost location of a complete bridge collapse. A landslide made for a long detour over a dirt road to reach this bridge. When we first came to the site, we weren't sure if the damage was due to tsunami, lateral spreading, or strong shaking. However, the residents (mostly living in tents and still awaiting the government's assistance after the earthquake) said the damage was definitely the result of ground shaking (Scott, our geotechnical engineer said he later heard that the relatively small tsunami wave had erased the evidence of lateral spreading). However, it is apparent that the bridge experienced a strong longitudinal jolt that caused the pier walls to move (and for one pier wall to break) and causing all eight steel girder superstructures to become unseated.
