EERI/PEER/FHWA Bridge Team Report

Performance of Highway and Railway
Structures during the February 27,
2010 Maule Chile Earthquake

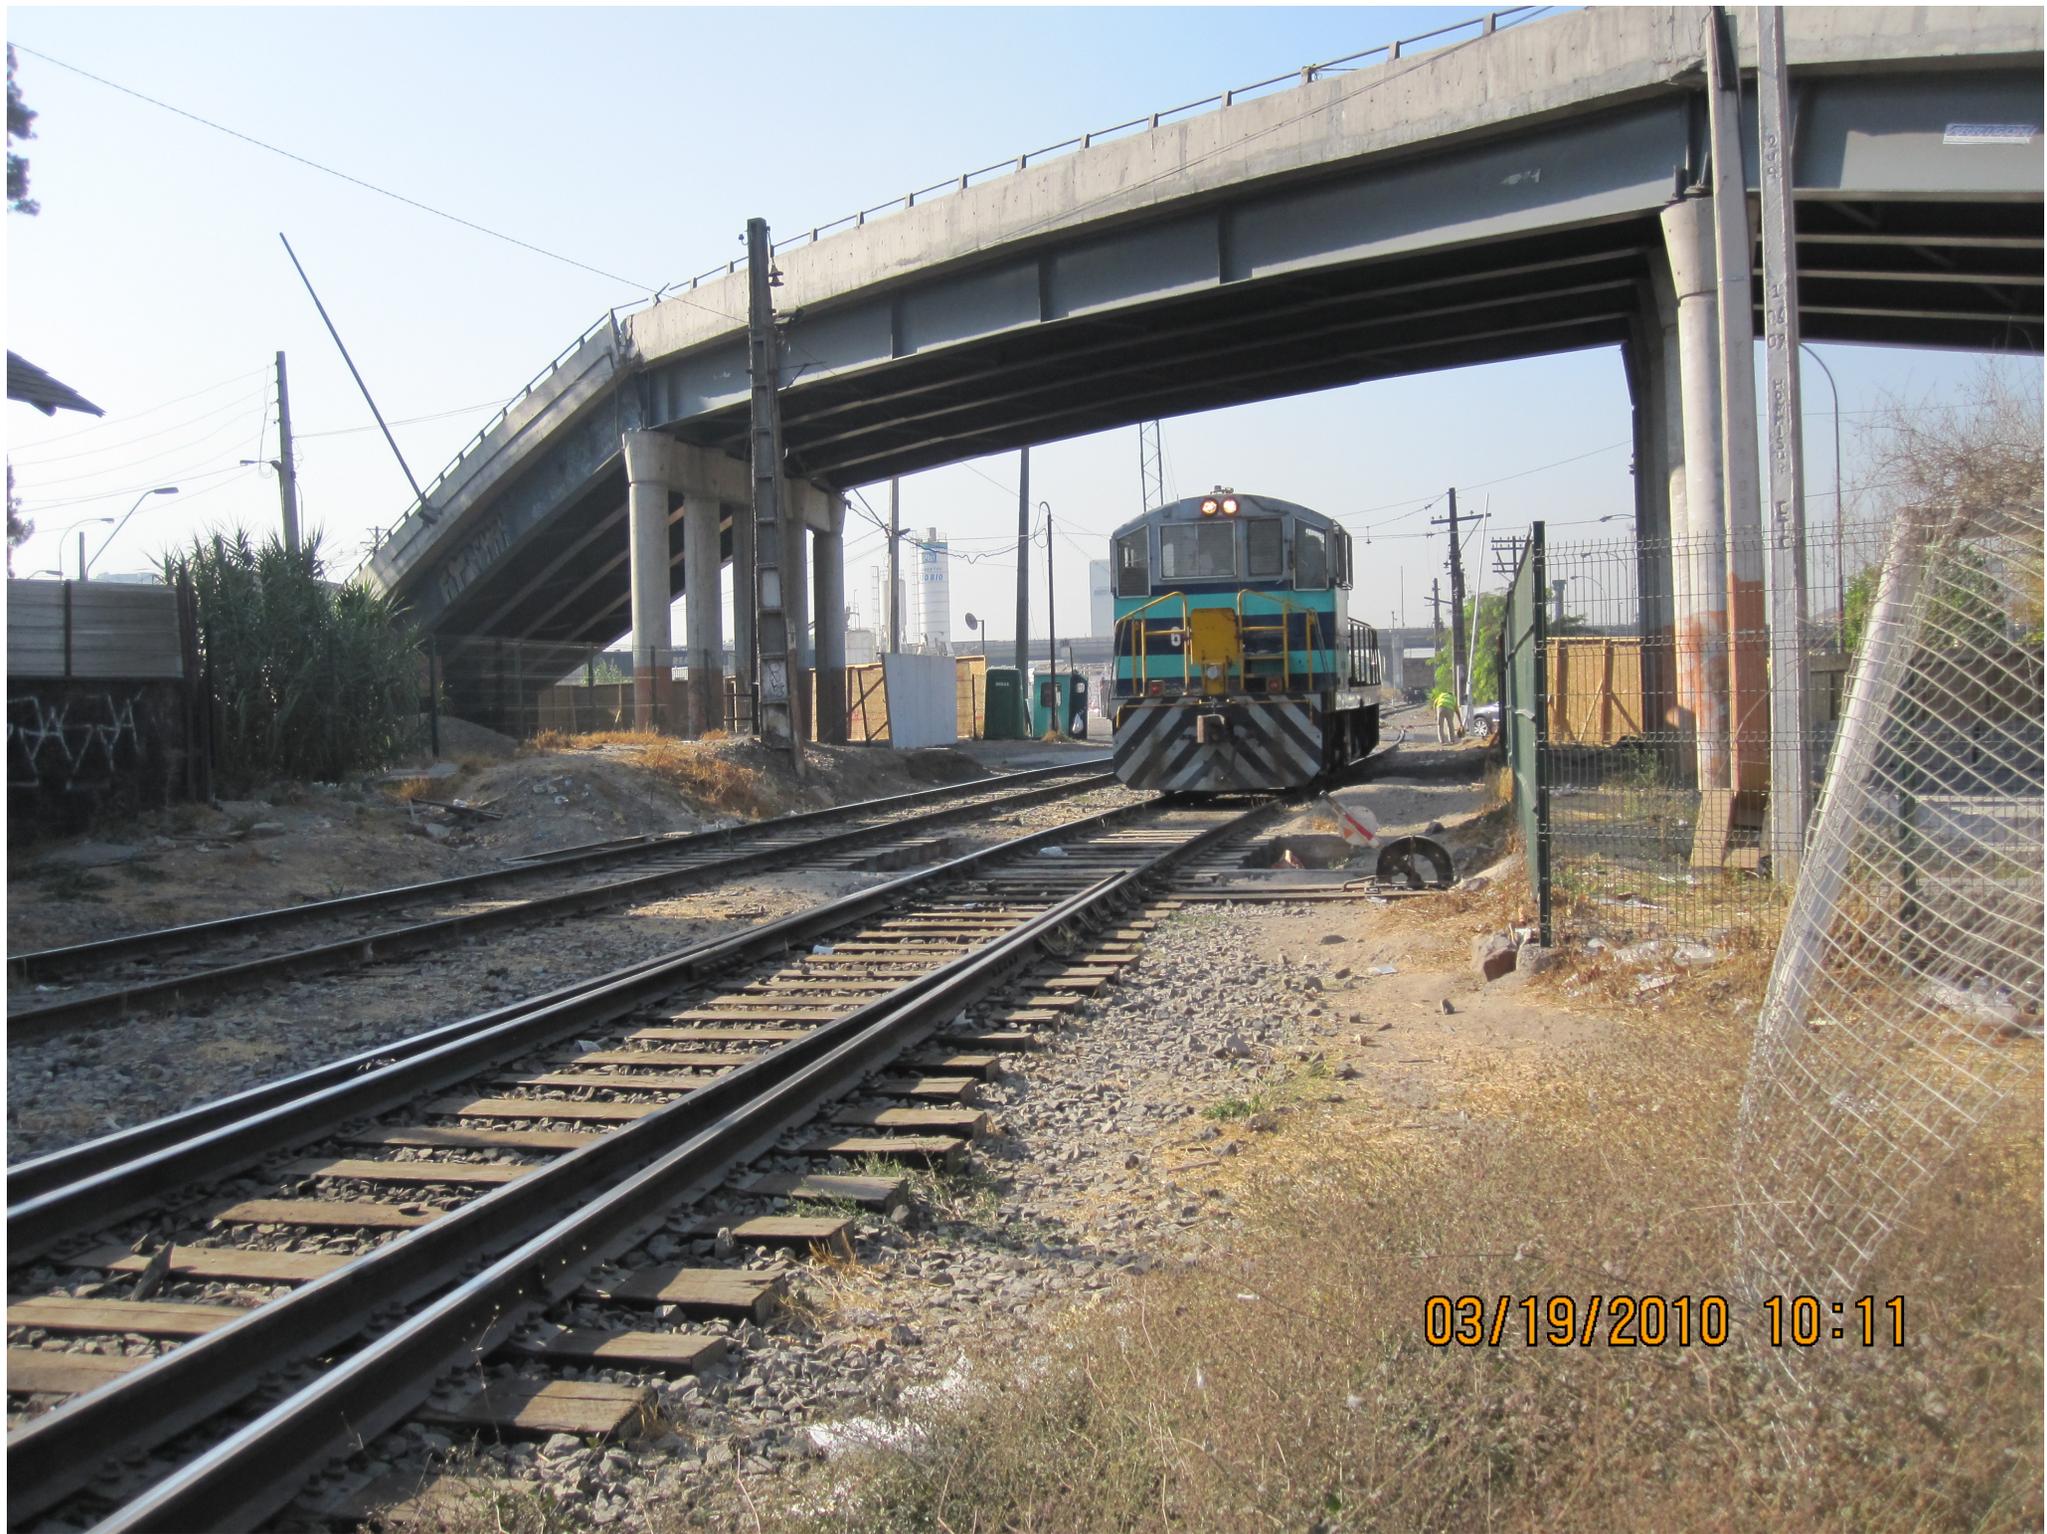
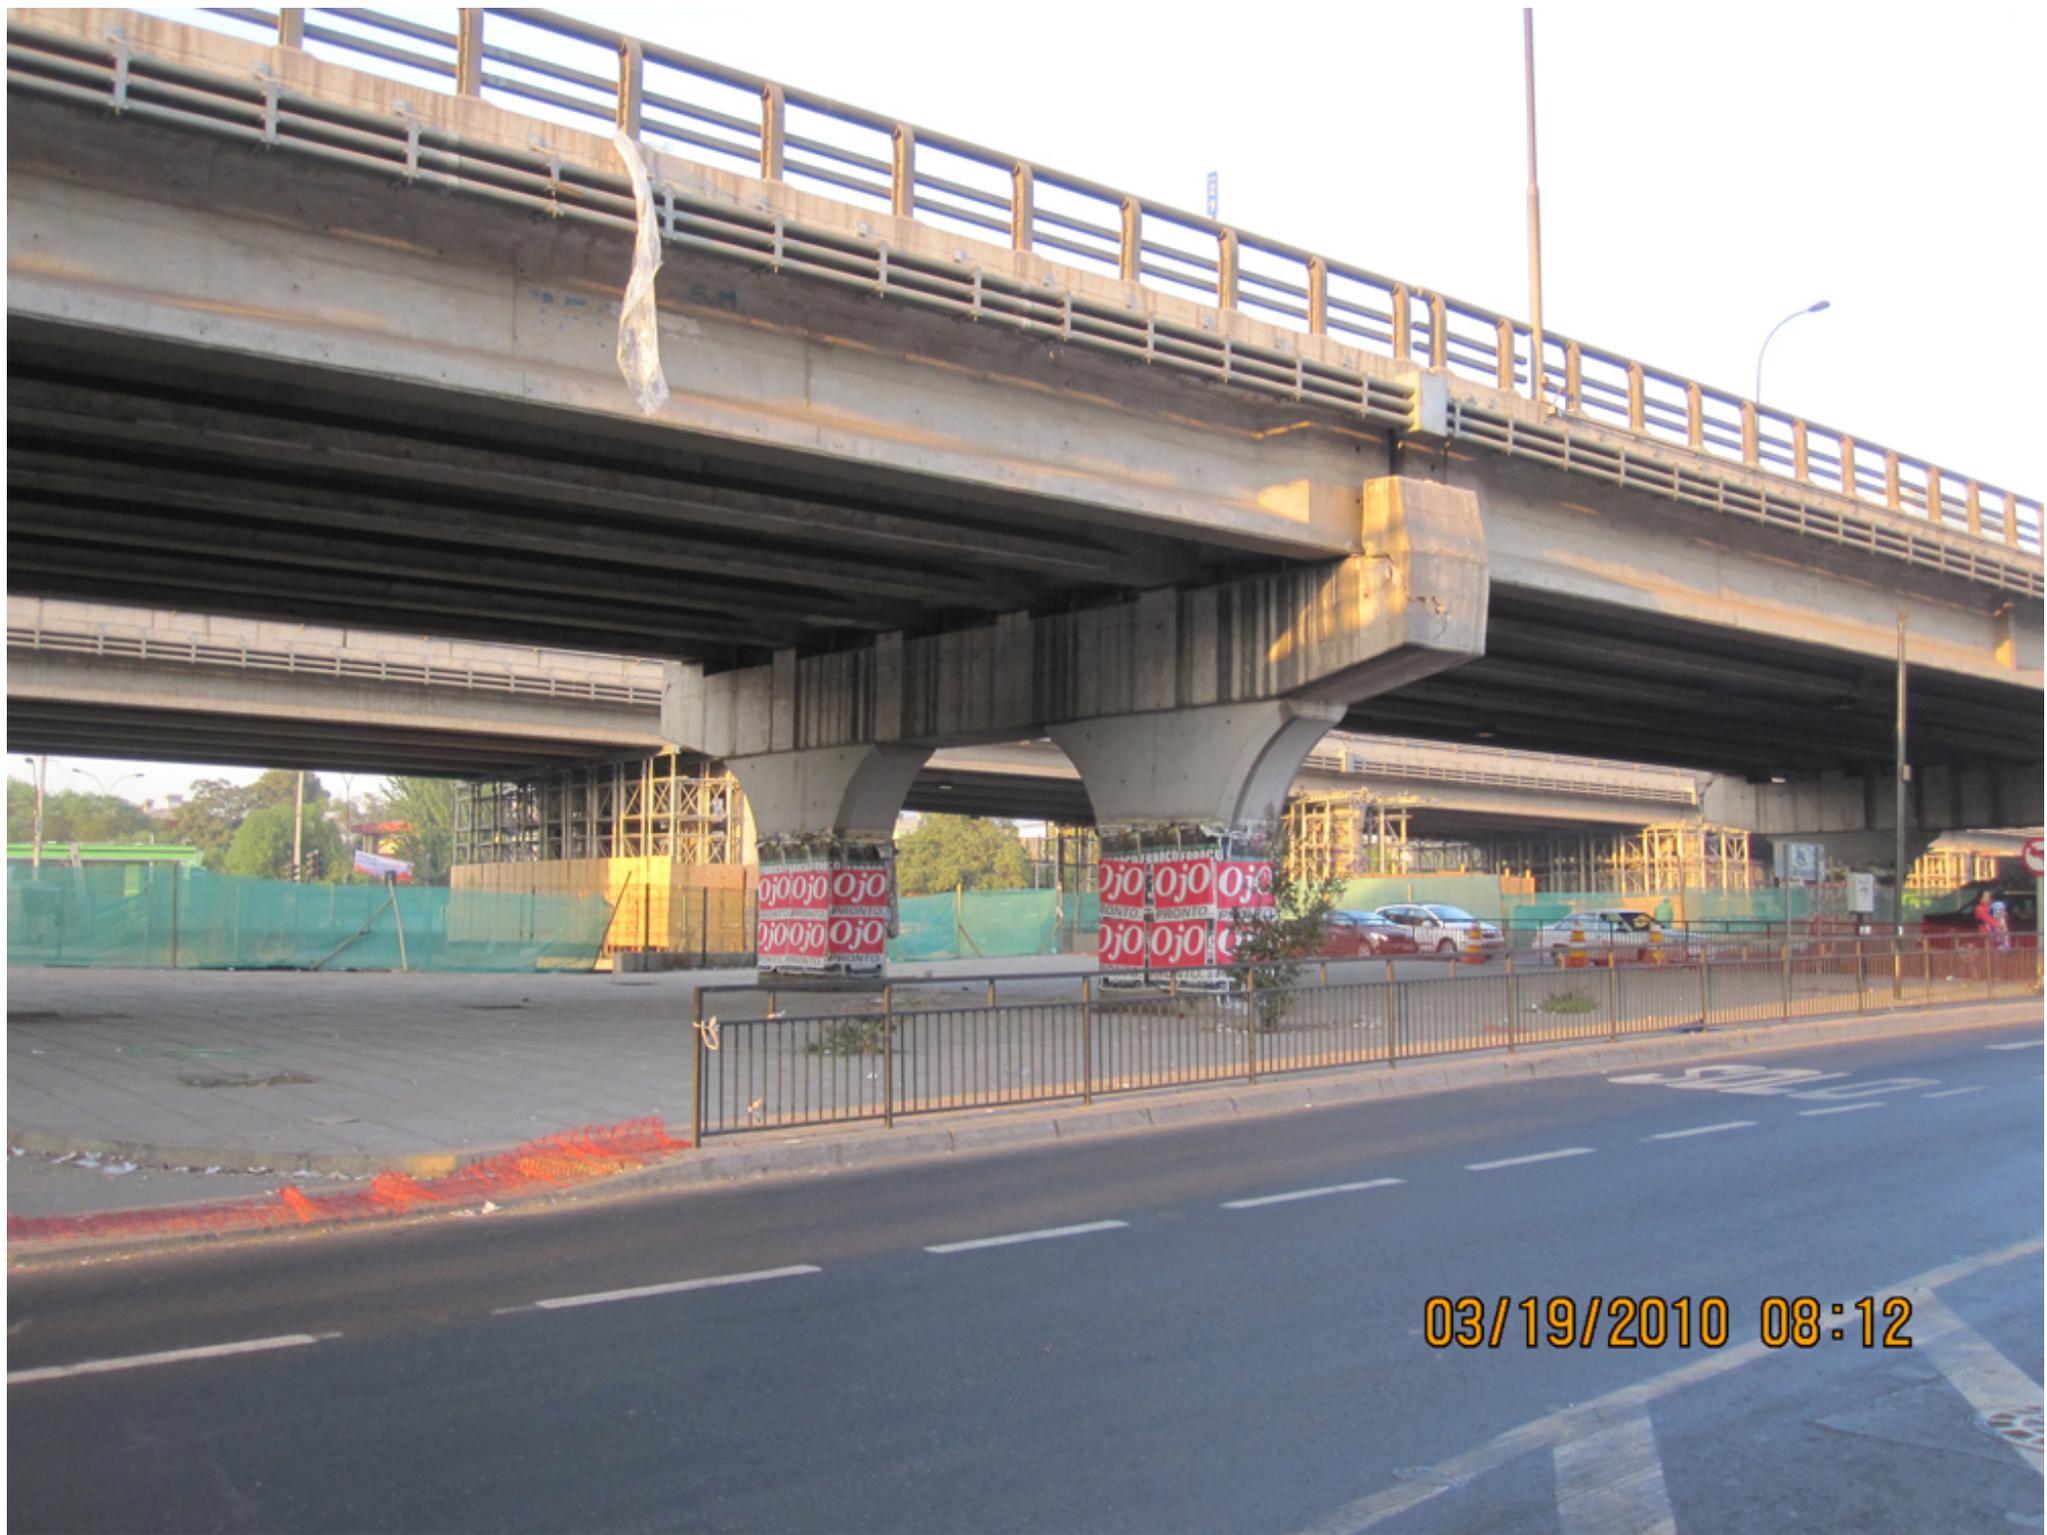
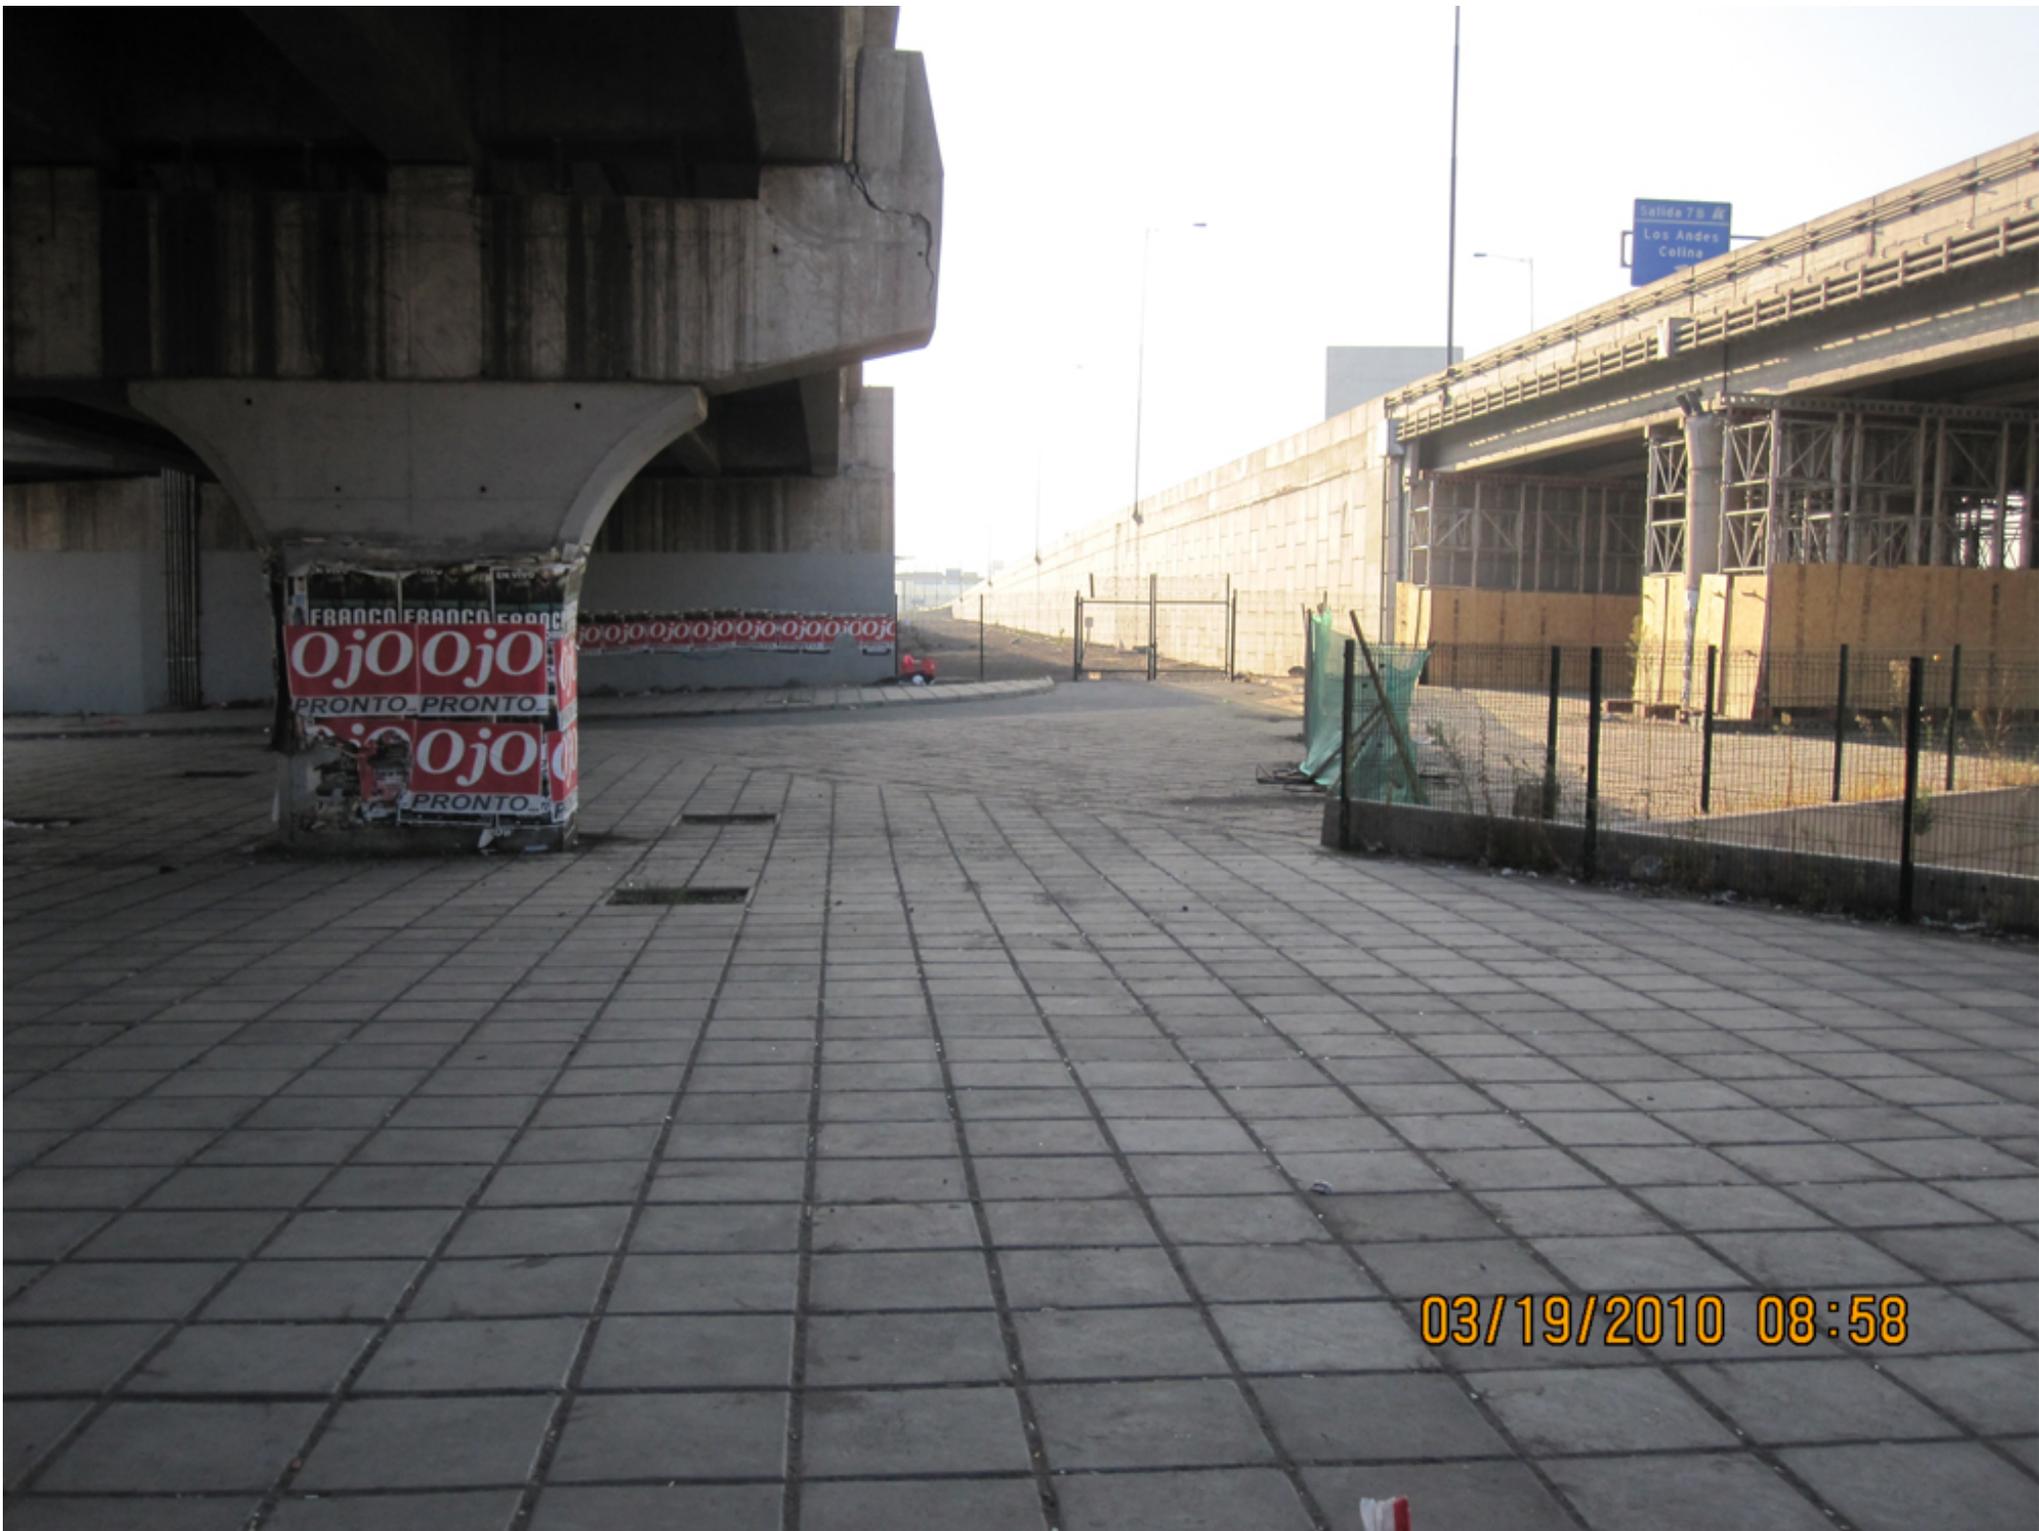
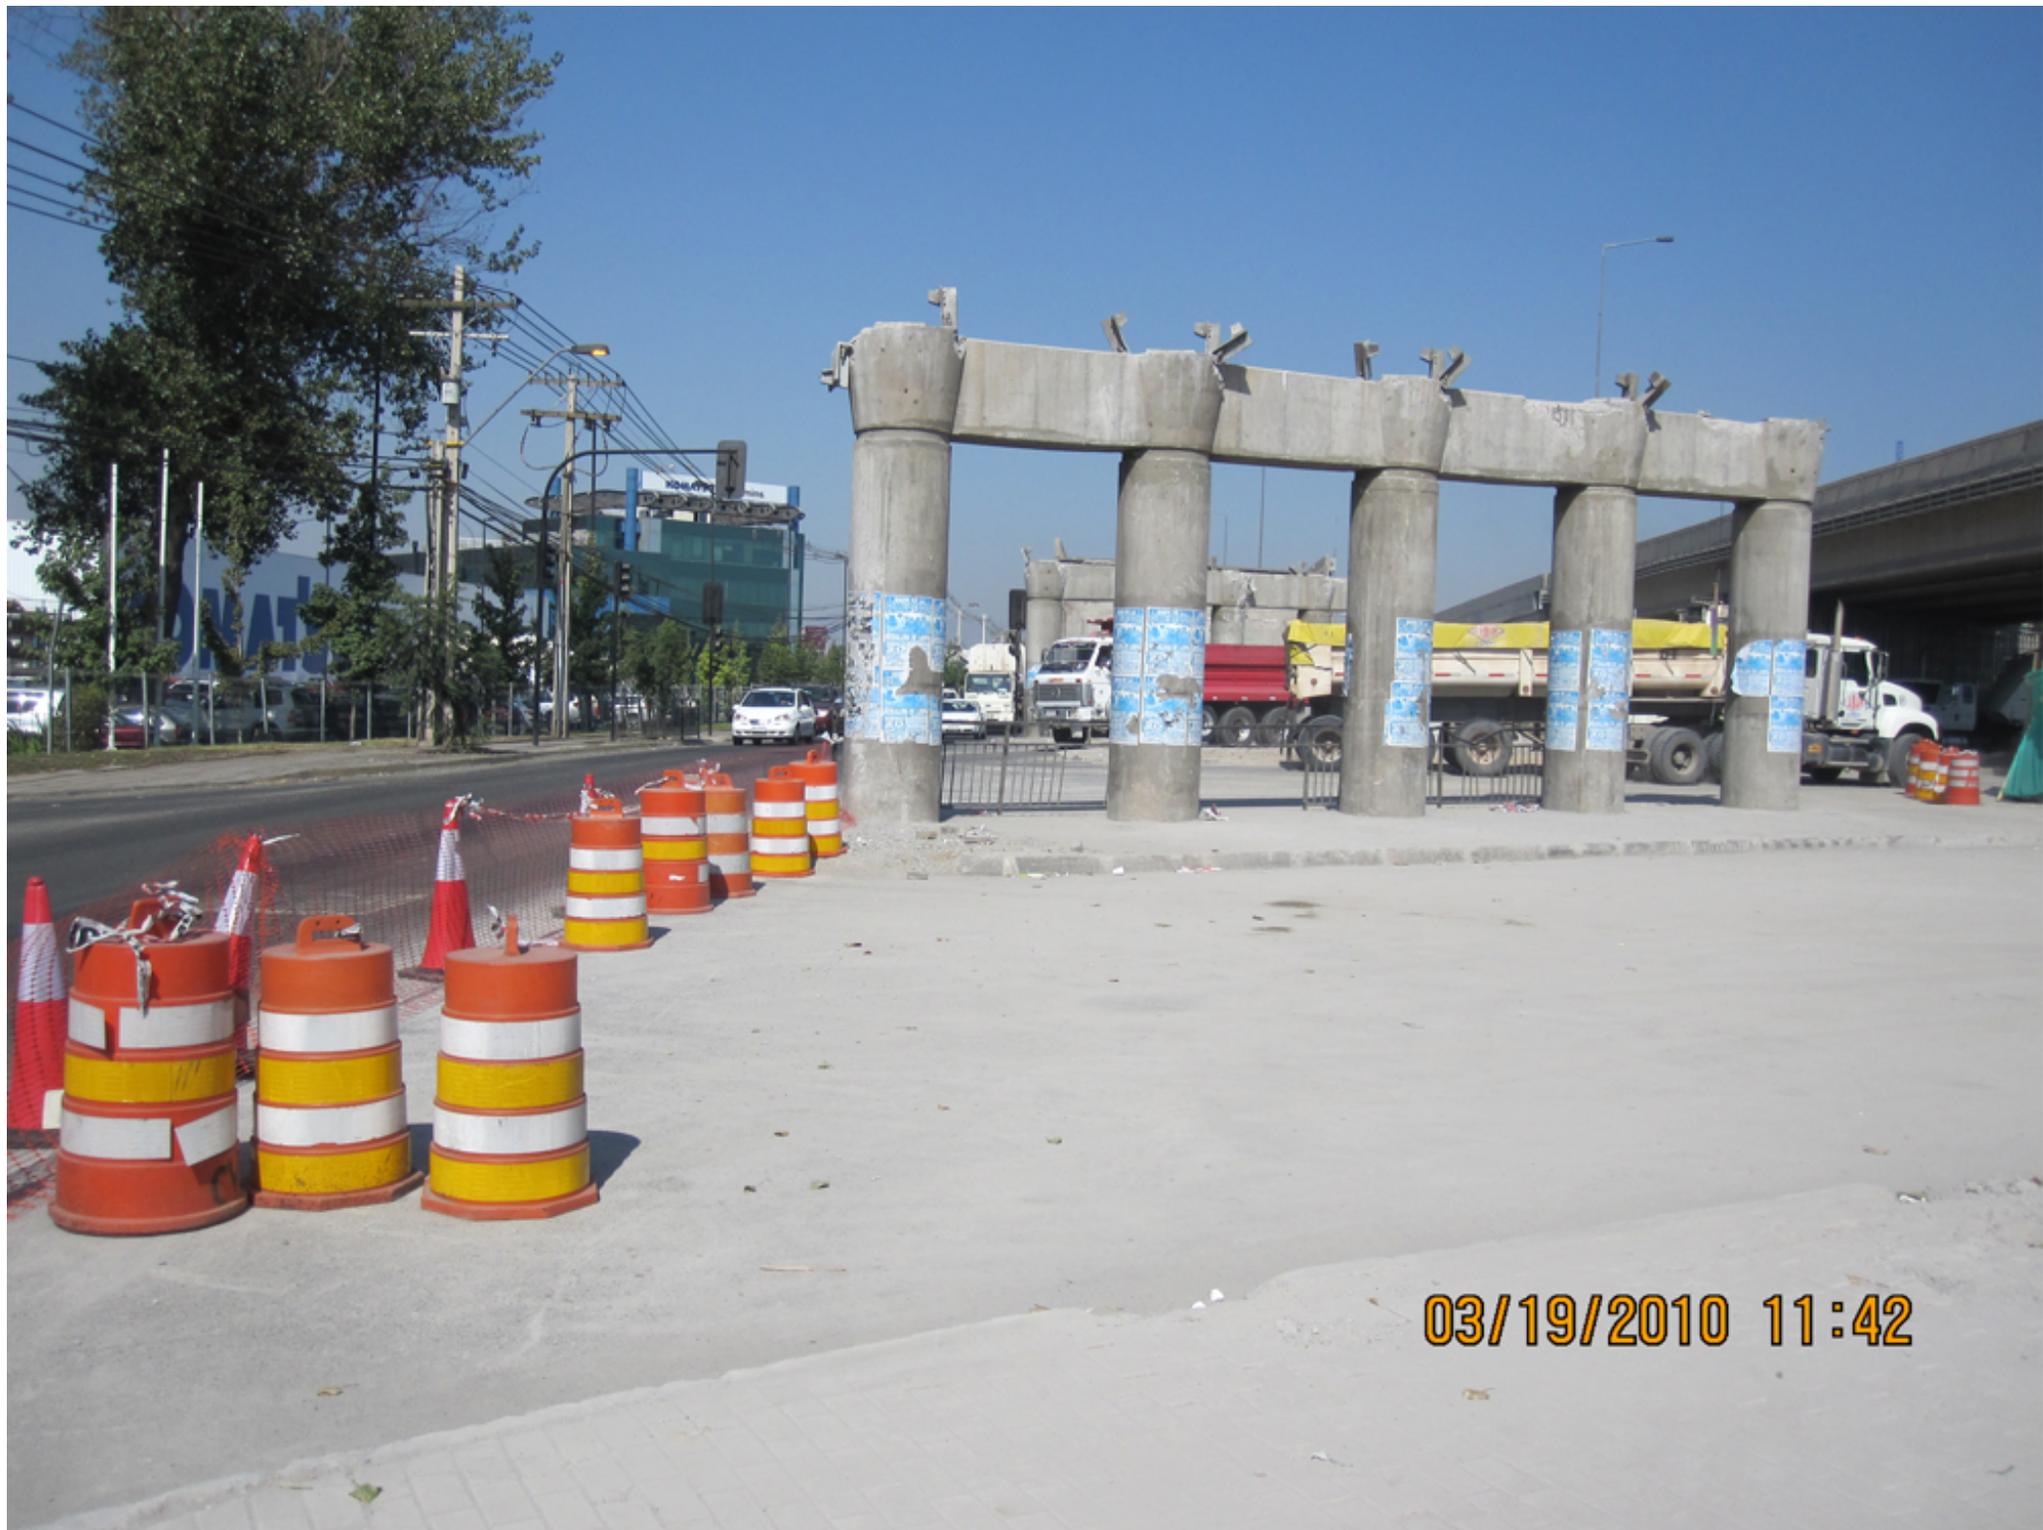
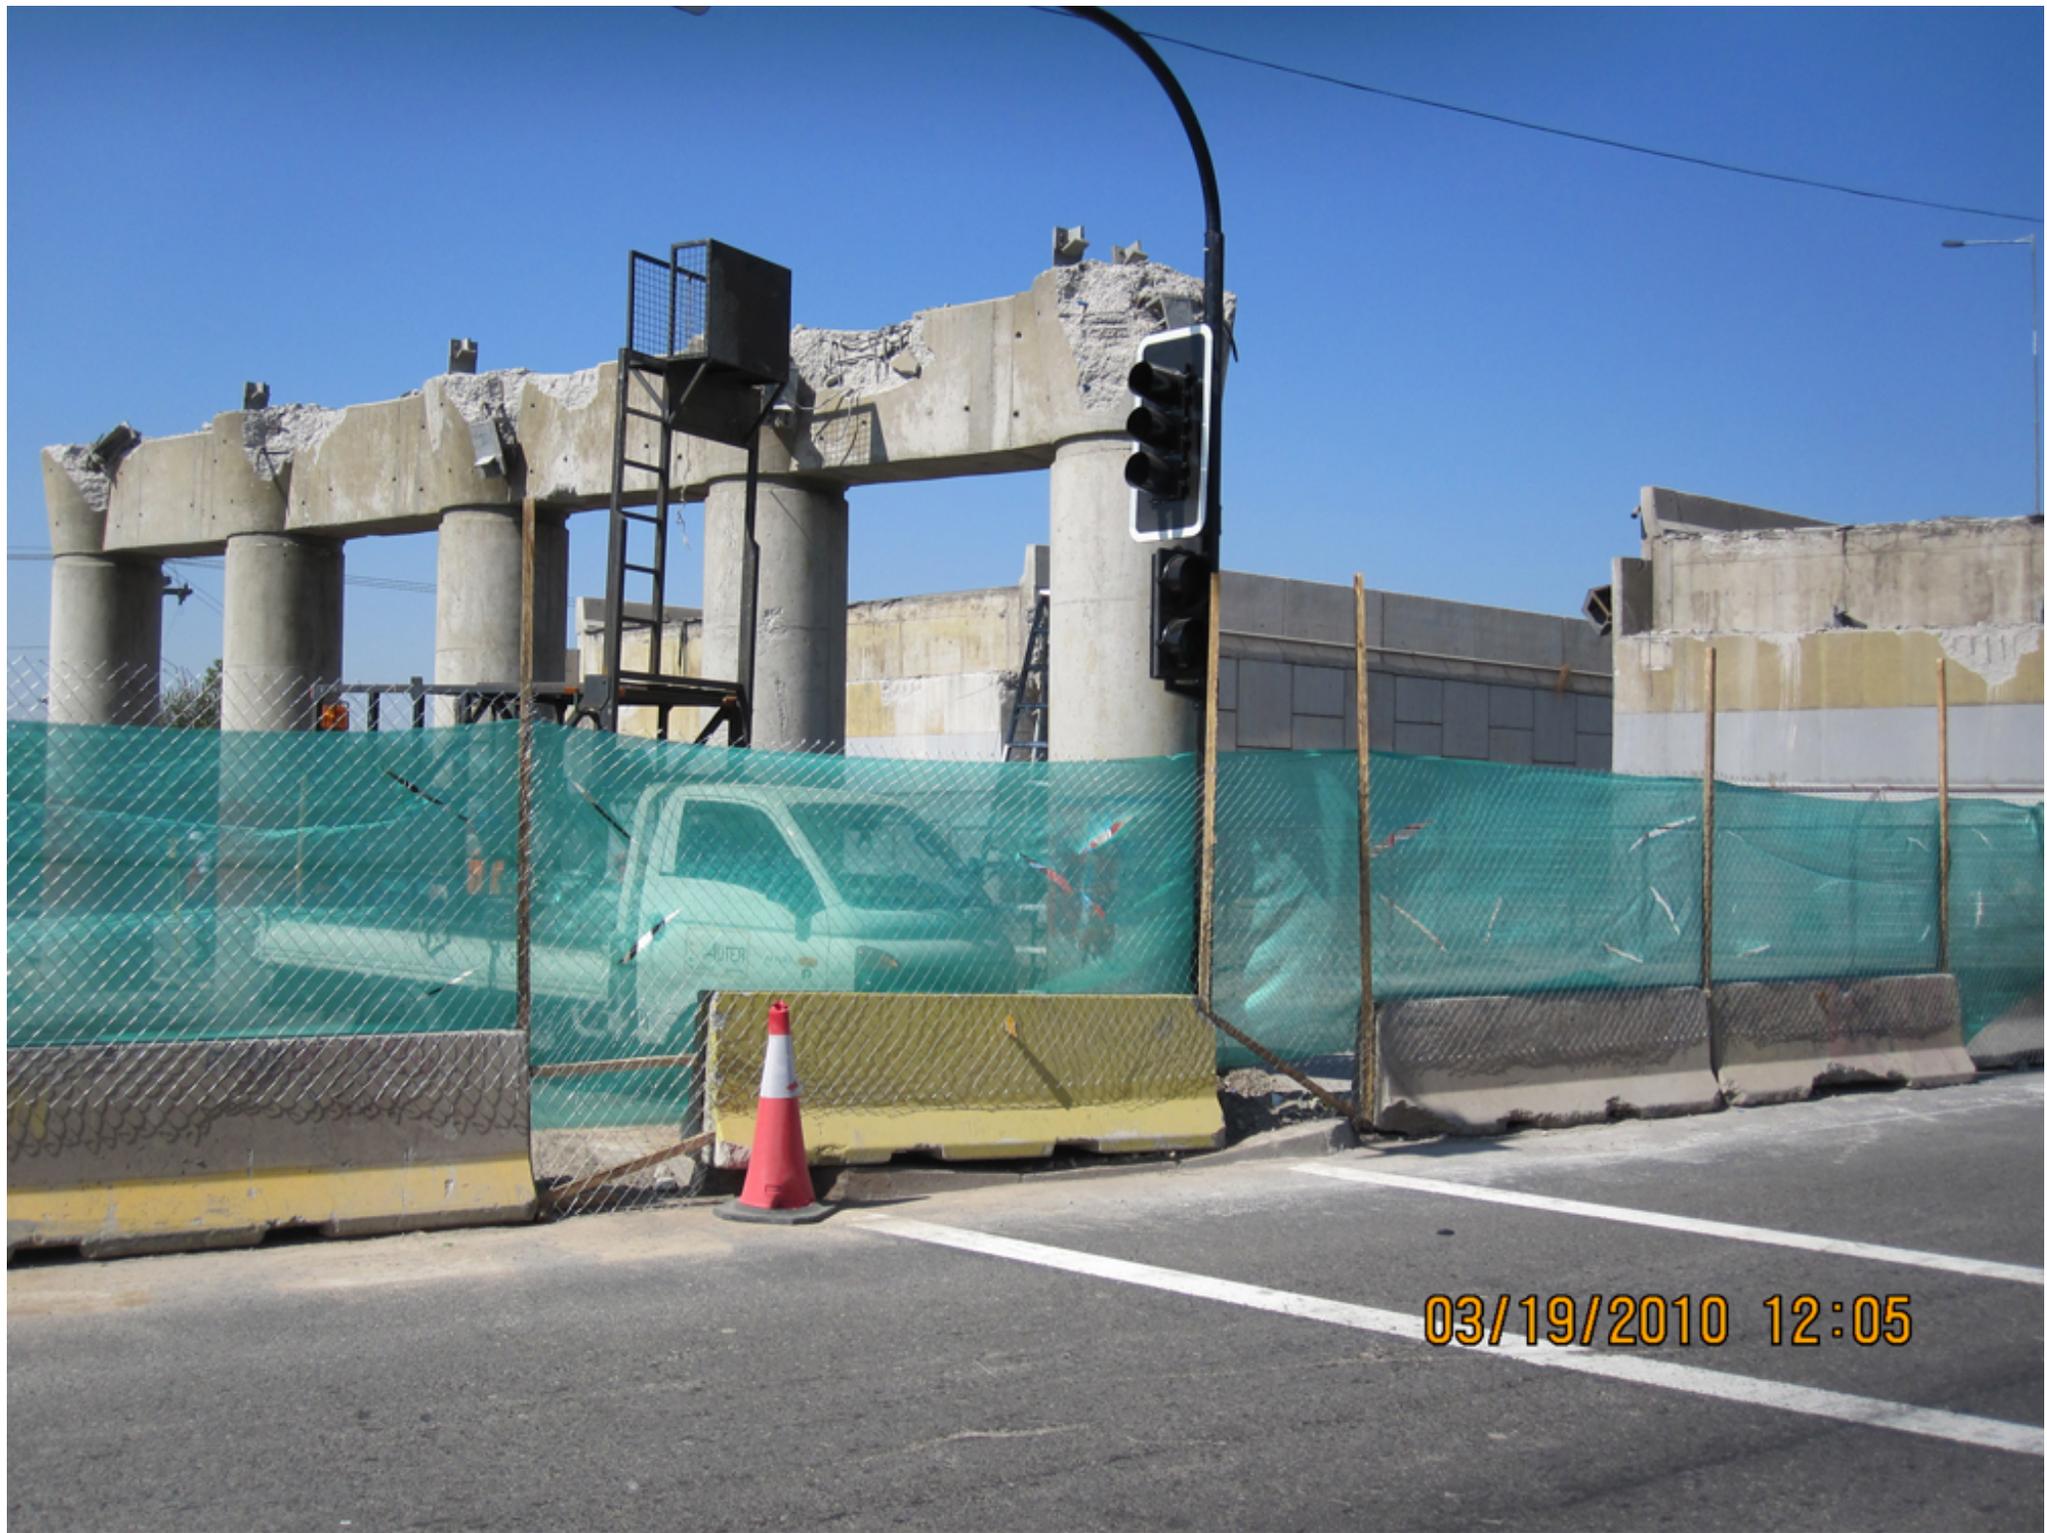
Vespucio Norte in Santiago

- Damage appears localized and suggests local site effects from soil column or topography
- Several damaged along Vespucio Norte, a tollway in NW Santiago
- Similar to other cases, traffic was often diverted to better performing older structures
- Almost no column damage was observed, but girder damage and unseating were common
