The 2011 Off the Pacific Coast of Tohoku Earthquake
- Quick Investigation Report on Earthquake Damage on Buildings -

Professor Masato Motosaka, Tohoku University
(Translation by Shunsuke Otani, University of Tokyo)

March 12, Saturday, Preliminary Investigation

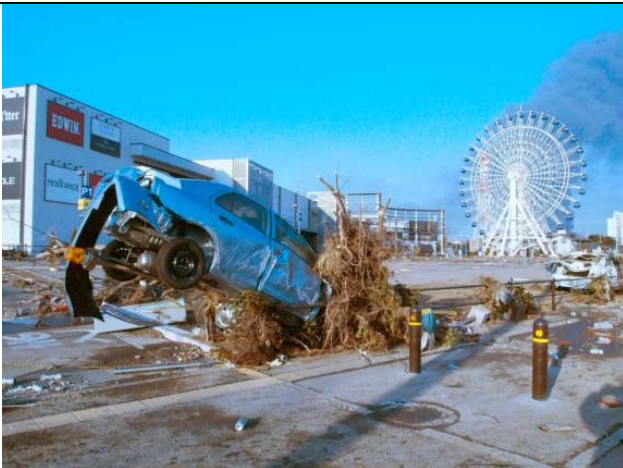
Tsunami water reached 1.0 m high in a large shopping mall, Mitsui Outlet. Some cars were floated and moved in the parking area by the tsunami wave. However, water did not go into shops. No vibration damage is observed in the buildings (Photos 20 and 21).

Photo 20: The parking area of the Mitsui Outlet shopping mall

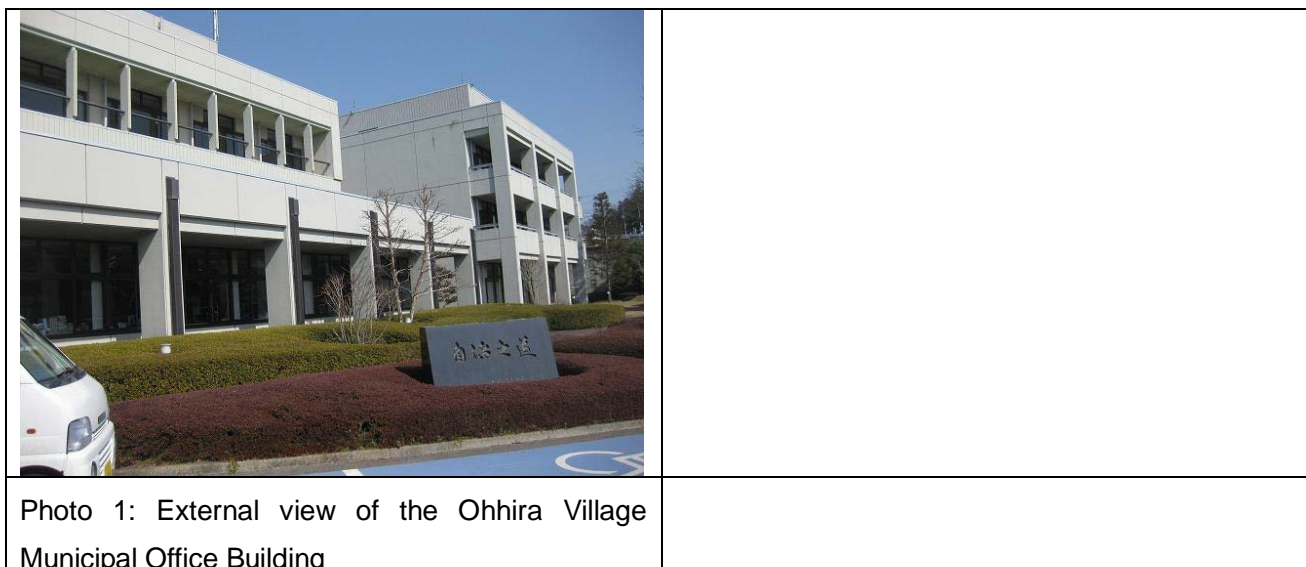
Seismic intensity (Japan Meteorological Agency Scale, JMA scale) of higher 6 was measured by the municipal intensity instrument. The municipal office is in a two-story reinforced concrete building (Photo 1); no major cracks were observed. No serious damage has been reported in the village.

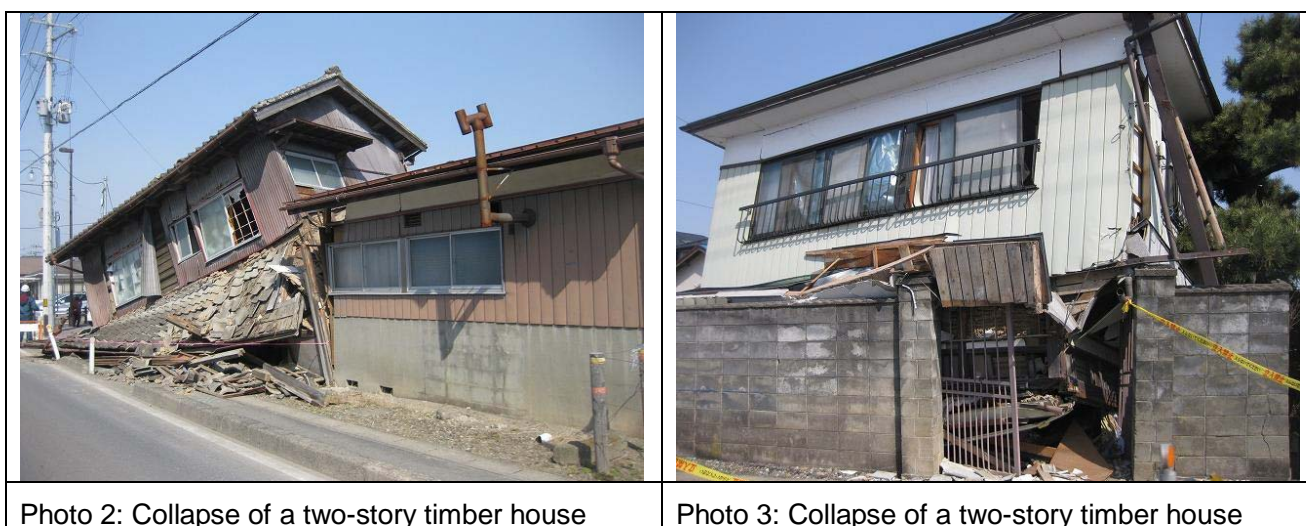
First-story collapse of residential buildings were seen here and there; the damage is serious. Even in those buildings without collapse, serious damage was observed such as fall of external walls.

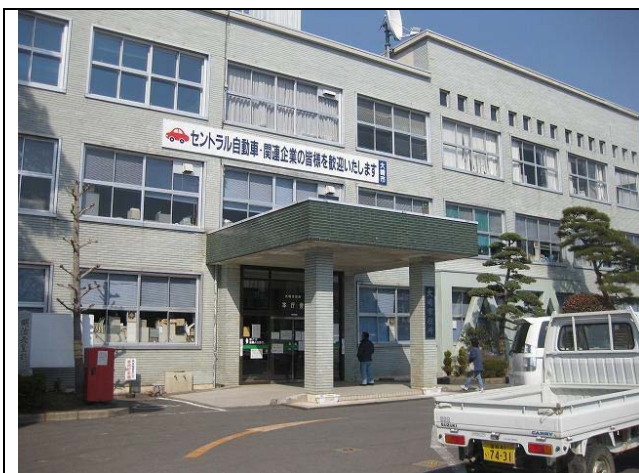
Photo 4: Ohsaki City Municipal Building

There are old houses used for combination of shop and residence, and godowns (storehouse made of mud walls) in Furukawa Mikka-machi and Nanoka-machi near the Ohsaki City Municipal Building. Many of these houses collapsed. The Furukawa No.1 Elementary School of two-story timber construction was prohibited to enter due to possible collapse during aftershocks. A seismic intensity instrument at Mikka-machi recoded the ground shaking of intensity higher 6 (JMA intensity scale).

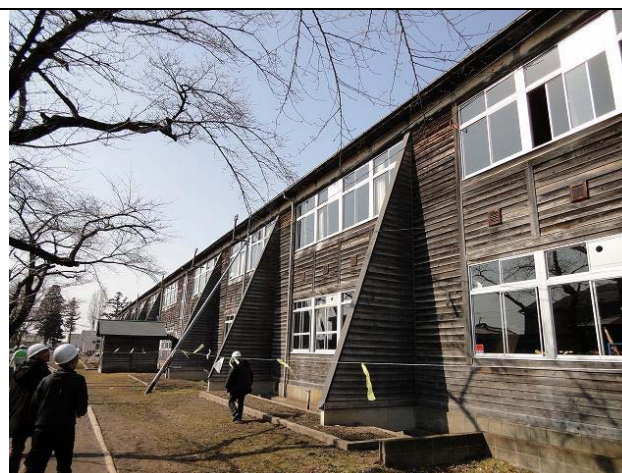
Photo 5: Ohsaki City Municipal Furukawa No.1 Elementary School (two-story timber construction)

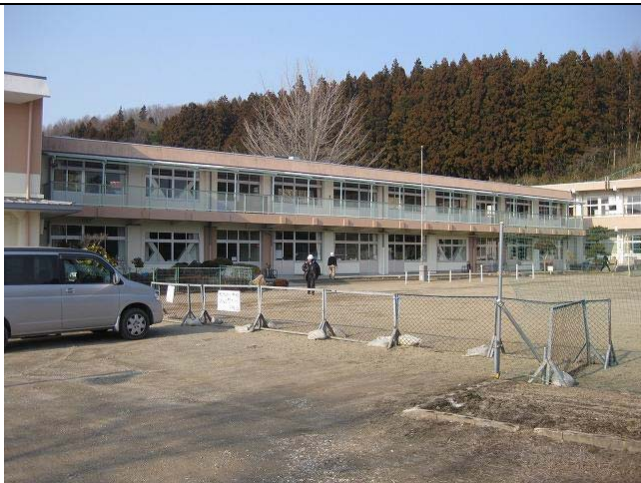
The Kaminome Elementary School building suffered serious damage in the 2008 Iwate- Miyagi Inland Earthquake. The damage was repaired and steel braces were used for retrofit. No damage was observed in this earthquake.

Photo 14: Overview of Uenome Elementary School (No damage)	
--	--
