Tohoku Chapter, Architectural Institute of Japan
Reconnaissance Report (15) on Tsunami Damage in Sendai City
The 2011 off the Pacific Coast of Tohoku Earthquake
Released on April 12, 2011

Disaster Investigation Committee

Dr. Masayuki Hando, Professor, and
Dr. Tomomi Fujita, Research Associate
Sendai National College of Technology
(Translated by Shunsuke Otani, University of Tokyo)

This report introduces the damage survey of Nagamachi, Taihaku-ku (Ward) and Oritate, Aoba-ku of Sendai City carried out by the staff of Sendai Technical college.

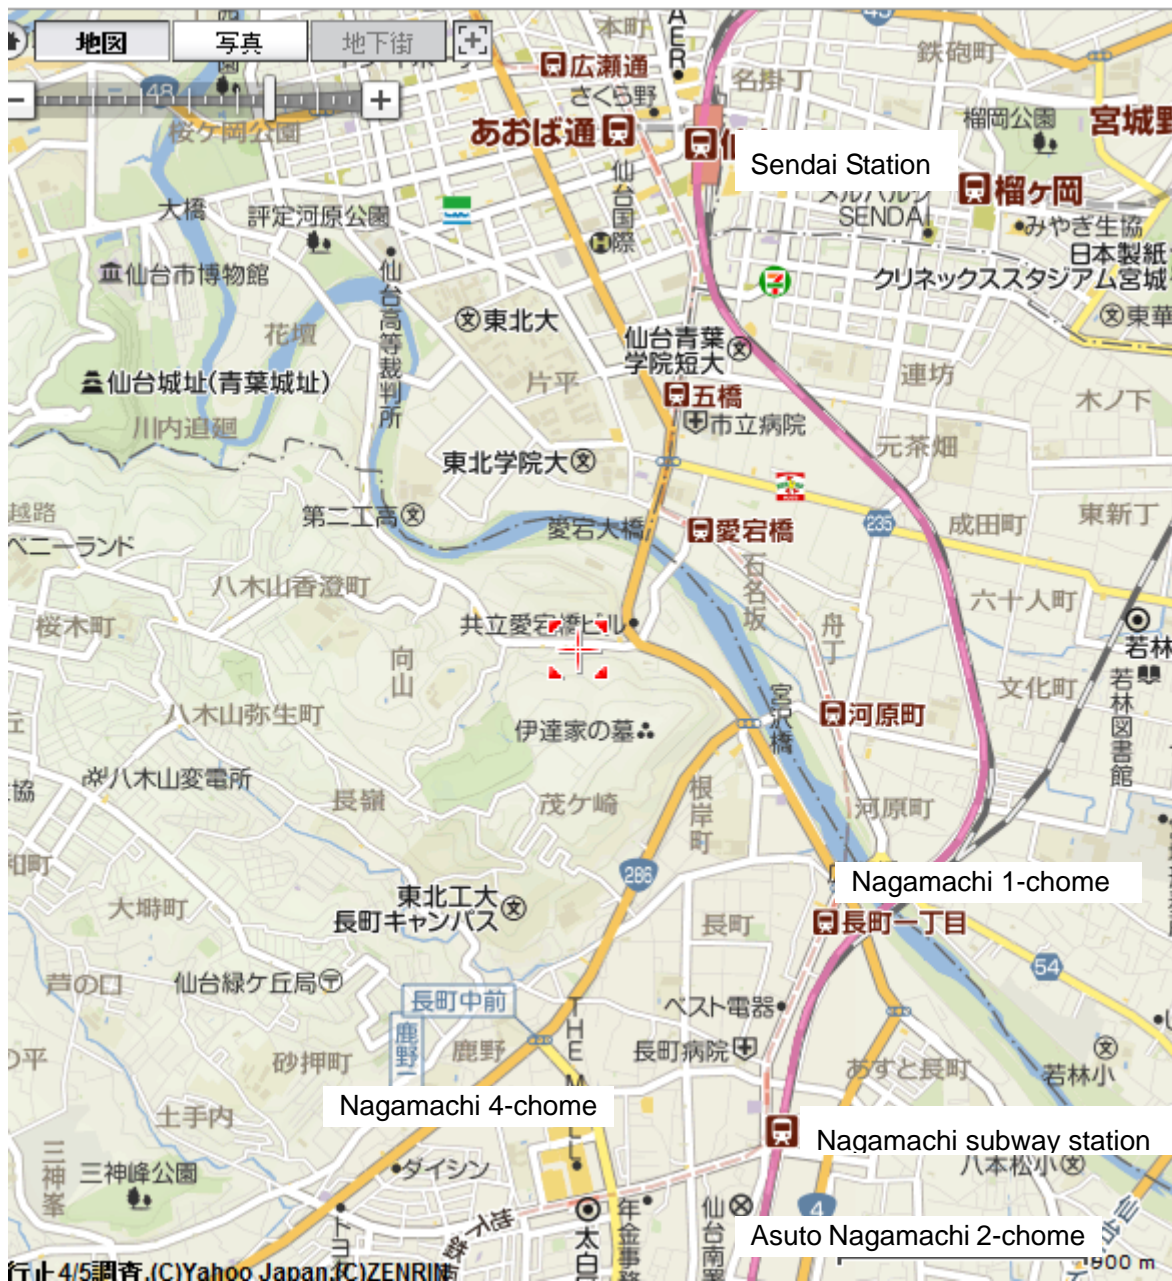
Asuto Nagamachi 2-chome, Taihaku-ku

Photo 12: Left is the Shinaknsen (1982) viaducts and right is the Tohoku Line (2006) viaducts
