## Turkish Earthquakes: Two Reports

### Lessons from the Adana-Ceyhan Quake and the Dinar Aftershock

### The Adana-Ceyhan Earthquake of June 27, 1998

### Dinar Aftershock Tests Retrofitted Buildings

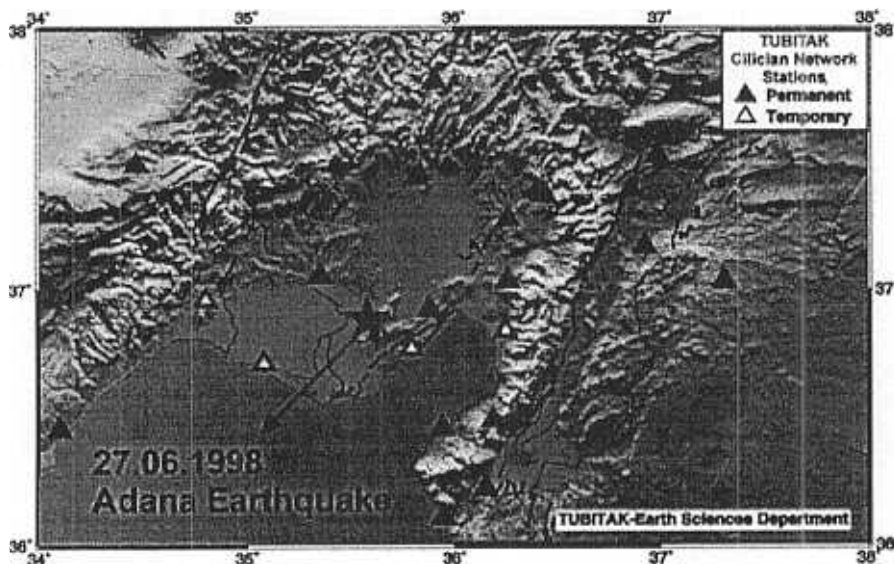
The left-lateral fault that caused the earthquake is called the Misis/Ceyhan fault (Barka, 1998). The geology of the Adana-Ceyhan (Çukurova) basin is dominated by a Quaternary alluvial valley covered by clay and surrounded in the north by the Taurus Mountains (see Figure 2). The depth of the agro-clay surface varies between one and six meters from location to location. In Adana, for example, the depth is reported to be approximately one to three meters. Below the clay sur-

**Figure 2 – Map showing the epicenter of the earthquake and the seismic network operated by Marmara Research Center ([www.nemrut.mam.gov.tr](http://www.nemrut.mam.gov.tr))**

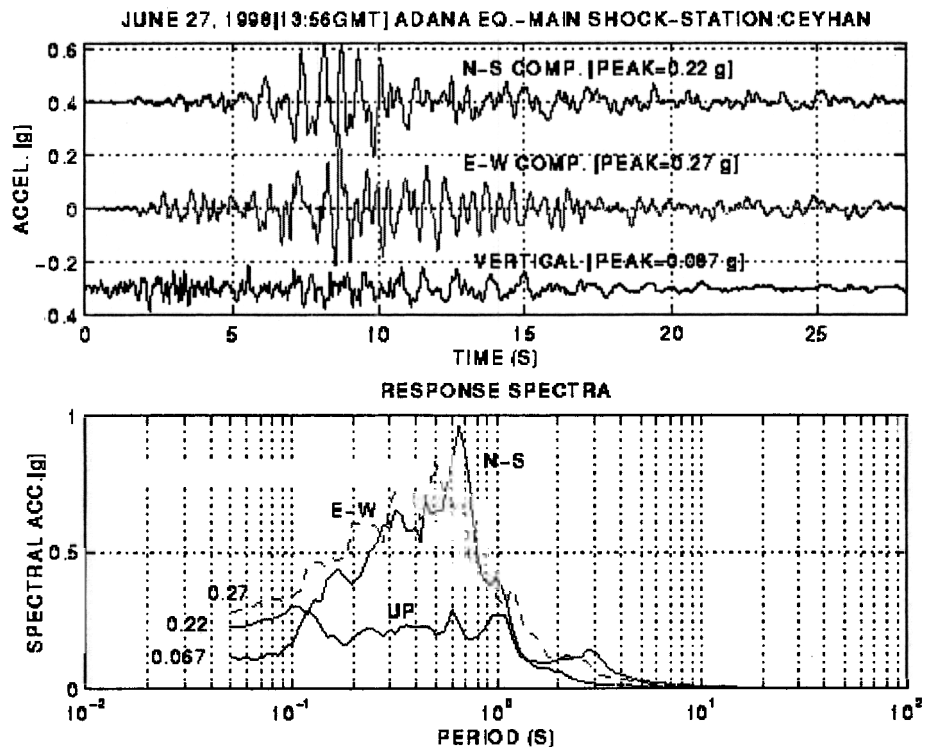
According to the Ministry of Reconstruction and Resettlement, only a single strong-motion main shock record was obtained in the area. This record from Ceyhan had peak accelerations of 0.22 g (NS), 0.28 g (EW) and 0.086 g (UP). The records show several dominant frequencies (periods) at approximately 0.7, 1 and 1.5 Hz (1.4, 1 and .67 sec). These resonating frequencies are within the site frequencies that can be expected from alluvial media with depths ranging from 25-75 m. It is possible that double resonance was one of the main causes of collapses or severe damage in the mid-rise buildings in Ceyhan. Soil-structure interaction of the rather stiff buildings (reinforced concrete frame with masonry infill walls) may have contributed to lengthening of the buildings' periods to coincide with the dominant periods of the site. The response spectra demonstrate that the horizontal components of motion had several dominant peaks within a 0.2-0.7 second band.

**Figure 4** – Strong-motion records from the Ceyhan Station (on ground floor of three-story building) and corresponding response spectra.

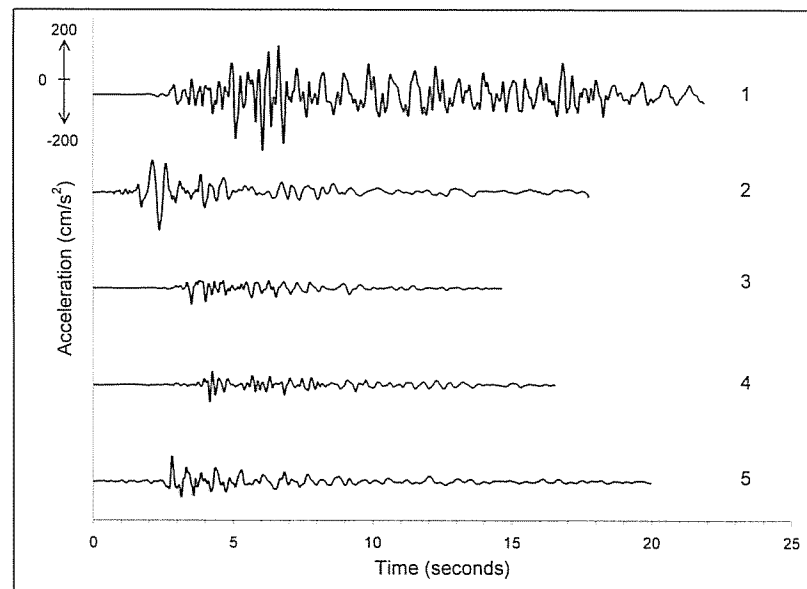
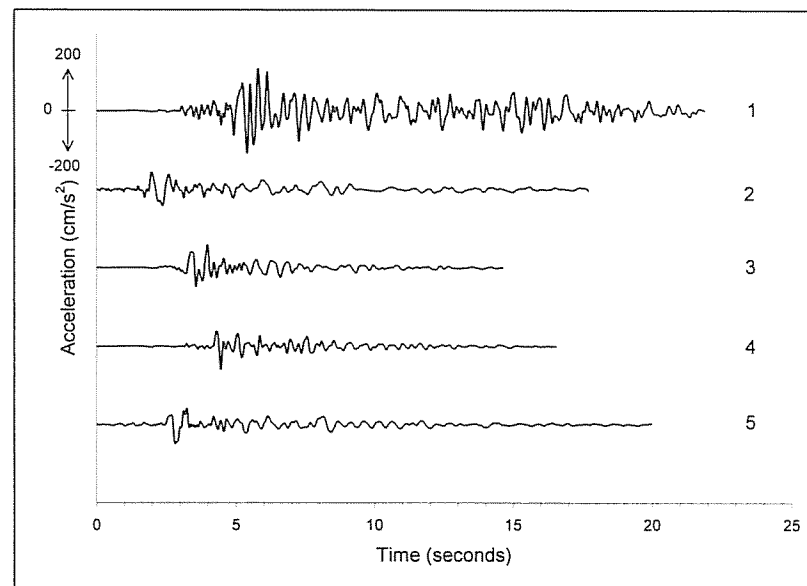
A comparative evaluation of the 1995 mainshock and aftershocks with the 1998 aftershock reveals interesting features of the strong ground motion recorded at the Dinar Meteorological Station (see Table 1). Events 1-4 date from 1995, and event 5 is the 1998 earthquake. The NS and EW components of the five sets of ground accelerations are shown in Figure 11 in the same order as in Table 1. Basic features of the five events and their associated ground motion parameters are presented in the same table.

Figure 11 - The NS and EW components of ground accelerograms.
