# The Reconstruction of Erzincan, Turkey

*This report was contributed by Mehmet Celebi (EERI 1980).*

### Introduction

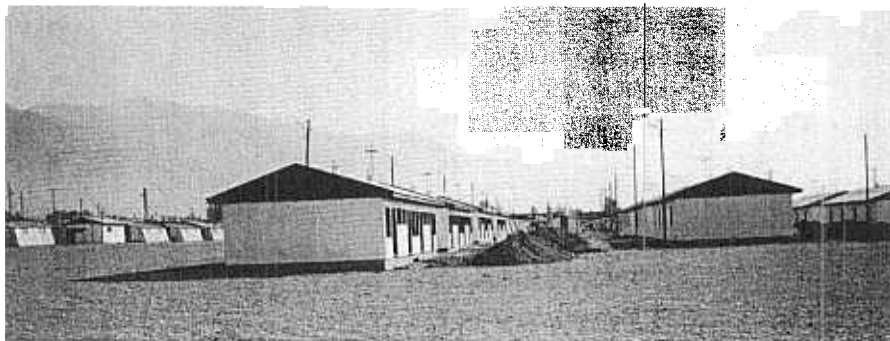
Figure 1 - Two types of prefabricated temporary housing

earthquake are still being used by displaced people (Figure 1). The temporary units erected in Erzincan are publicly financed and owned. They were erected within two weeks of the earthquake to provide temporary housing and to replace tents. These units are normally stored in Ankara and are trucked quickly to natural disaster areas. In areas with favorable weather conditions, they are used

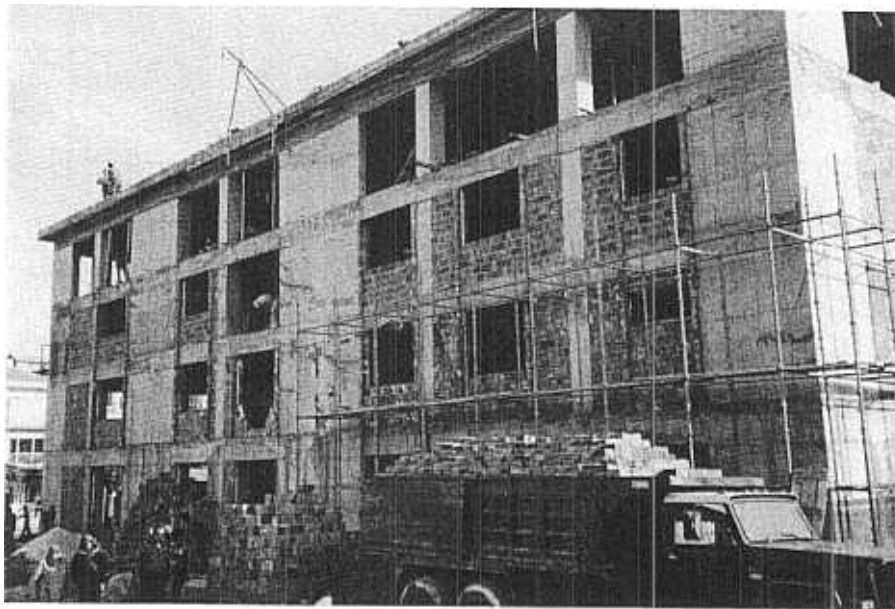
There was clear evidence of improved design and construction of new, privately owned buildings. A new private building under construction is shown in Figure 2. The design exhibits better proportioned lateral force resisting elements and construction quality superior to that of typical pre-earthquake buildings.

Figure 2 - A privately owned four-story new building (note corner and central shear walls)
