Learning from Earthquakes

Preliminary Observations on the Sultandagi, Turkey, Earthquake of February 3, 2002

This report was contributed by the reconnaissance team from the Department of Earthquake Engineering at the Kandilli Observatory and Earthquake Research Institute of Bogazici University, Istanbul, Turkey. The team was in the field the morning of the day after the earthquake, and the field survey continued for two days. The team was comprised of Professor Mustafa Erdik; Research Assistants K. Sesetyan, M. B. Demircioglu, U. Celep, and Y. Biro; and Assistant Professor E. Uckan. The publication and distribution of this report are funded by the National Science Foundation as part of EERI's LFE Program, under Grant #CMS 0131895.

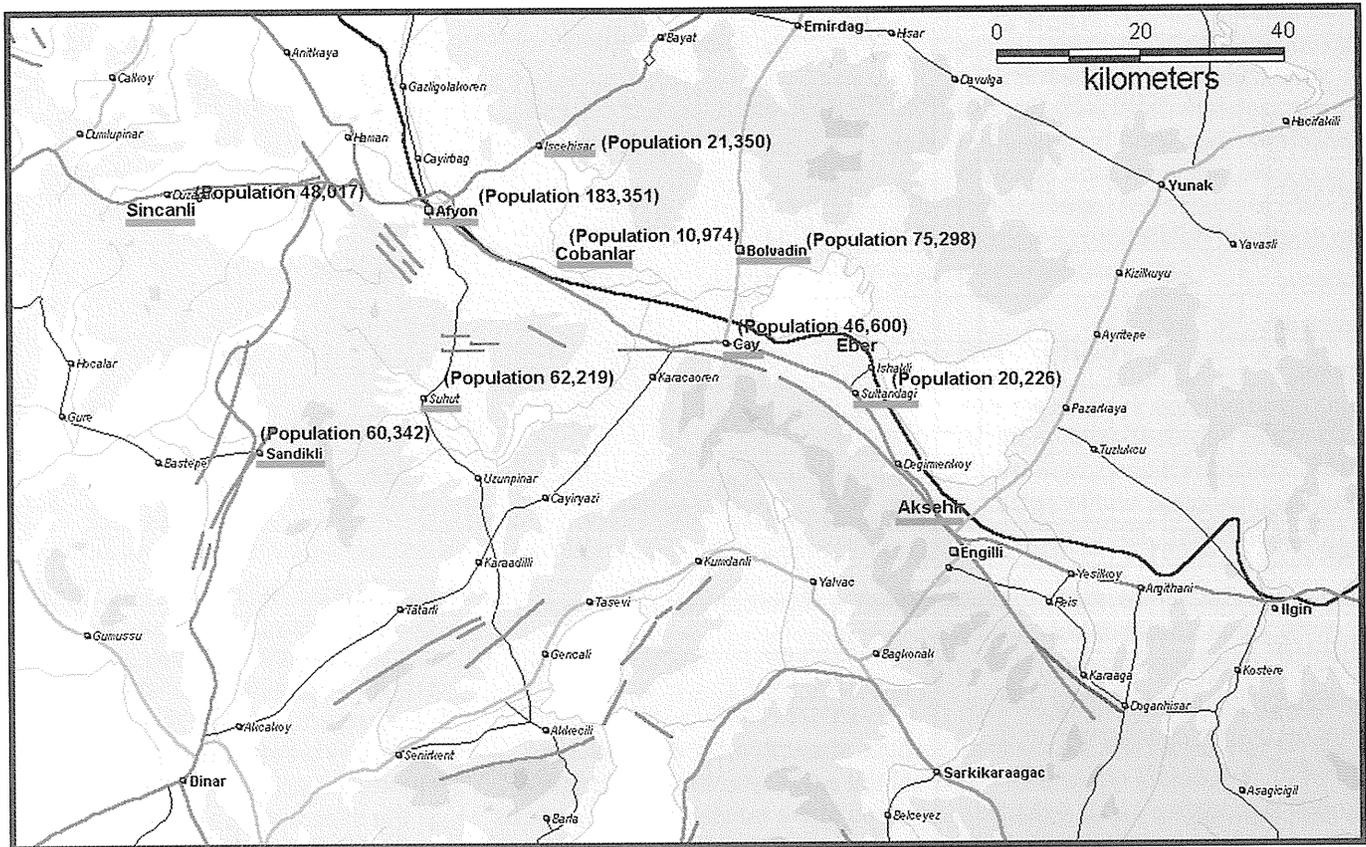
The distribution of casualties and damaged buildings are given in Tables 2 and 3.

The damaged towns are illustrated in Figure 4.

Intensities were estimated with the help of the tabulated damage and field observations as follows: VII in Cay and 20 km to its southeast, and VI in an 80-km oblong area centered on Cay.

Heavy damage and total collapse were particularly concentrated in a narrow region in Cay. Older single-story buildings in the region are commonly himis structures (buildings composed of timber frames and braces with adobe infills), whereas newer ones are unreinforced masonry and reinforced concrete structures with two or three stories.

Figure 4 - Damage distribution.
