TECHNICAL COMMUNICATION:
THE LICE, TURKEY, EARTHQUAKE OF SEPTEMBER 6, 1975
(RECONNAISSANCE REPORT)

by
Peter I. Yanev

November 1975

URS/John A. Blum & Associates, Engineers

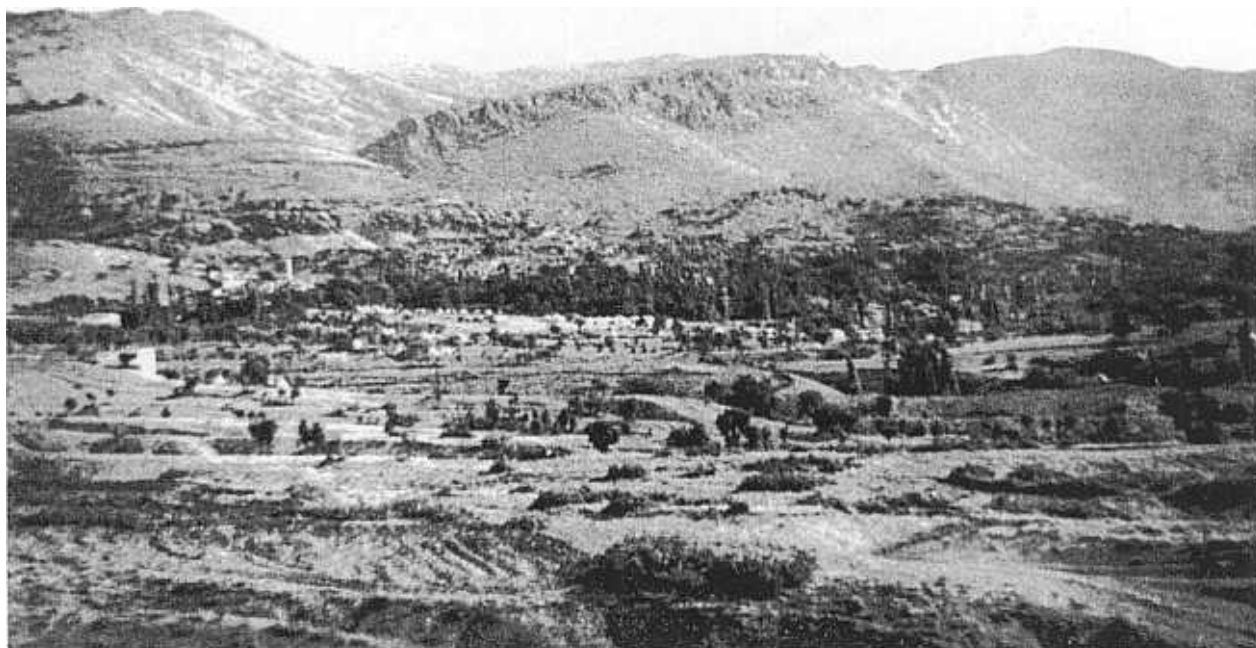
FIGURE 2 VIEW OF LICE LOOKING NORTH TOWARD THE THRUST FAULT SYSTEM
AND THE TAURUS MOUNTAINS.

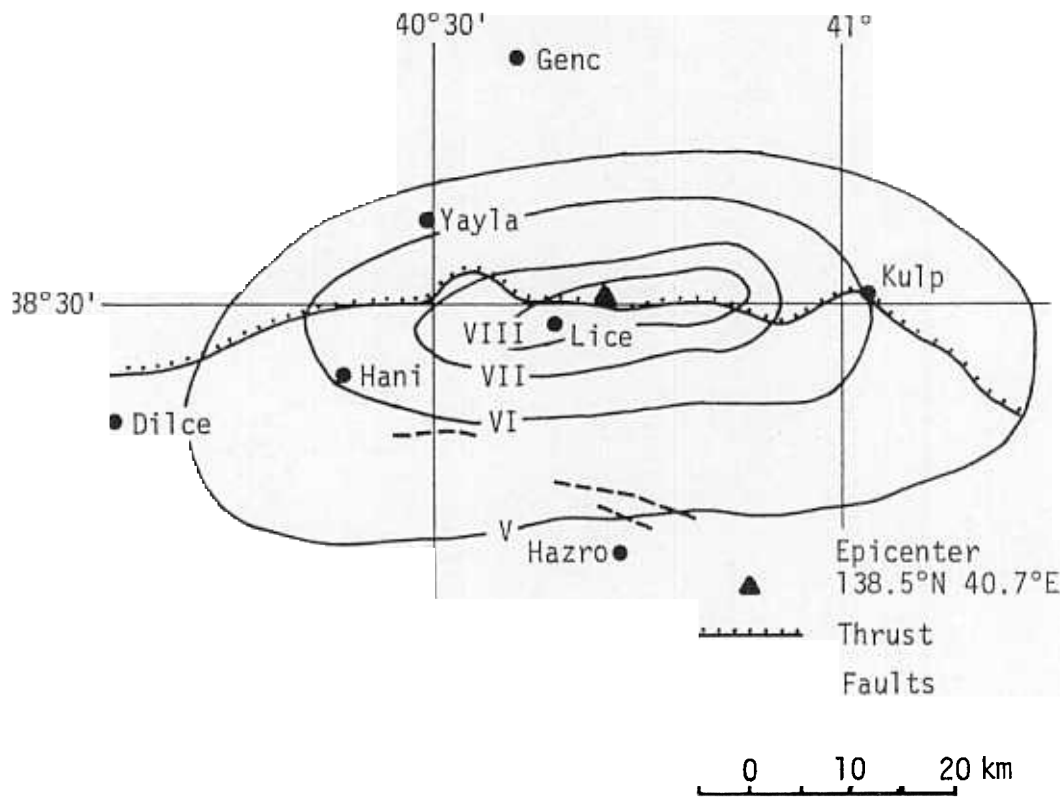
Figure 4 shows the isoseismal map of the September 6, 1975, earthquake, as presented at the 5ECEE in Istanbul. The highest Modified Mercalli intensities noted by the author in the vicinity of Lice were IX, as evidenced by the almost total destruction of masonry D, heavy destruction of masonry C, many rockfalls, and massive destruction of the rock formations along the ridge overlooking Lice. The following information was also presented at the 5ECEE:

FIGURE 4 ISOSEISMAL MAP OF THE SEPTEMBER 6, 1975, EARTHQUAKE

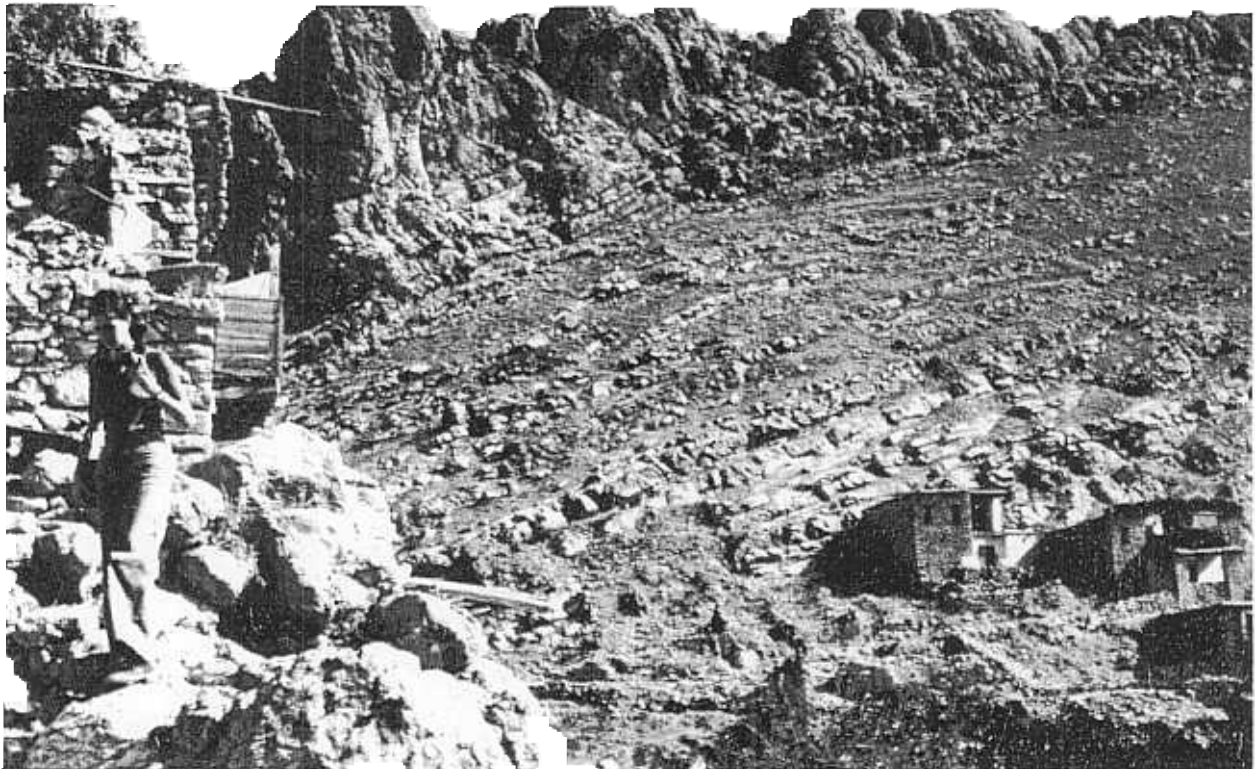
The author was unable to visit the areas of possible faulting; the preceding statement is presented as very preliminary information. Rockfalls were, however, abundant along the slopes of the mountains paralleling the roads between Lice and Hani. Very large rockfalls and landslides were observed just to the east and west of Lice. Large areas of whiter, less weathered limestone were abundant along the rocky ridge tops. In Lice, broken rocks had showered the older section of the town, causing many fatalities and spectacular damage. Figures 5 through 11 illustrate these ground effects.

FIGURE 11 GENERAL VIEW OF THE RIDGETOPS SHOWN IN FIGURE 10

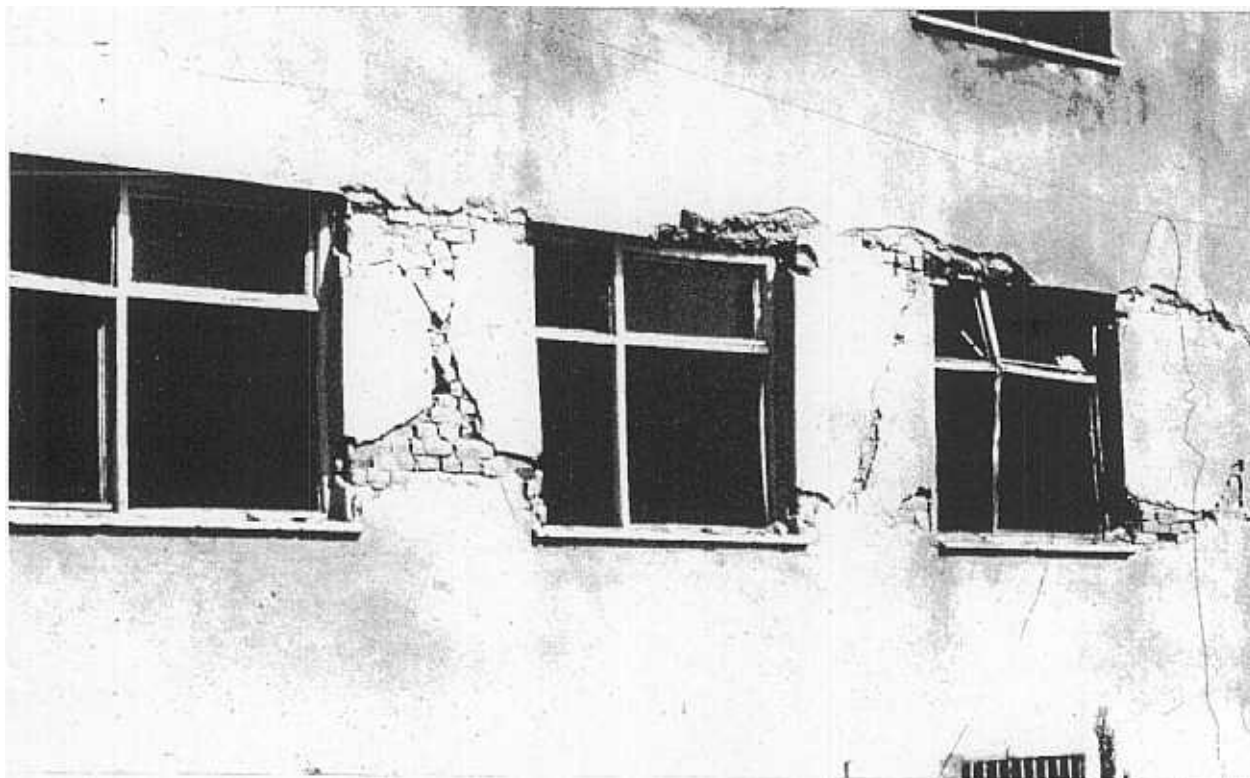
FIGURE 20 DETAIL OF THE POLICE BUILDING.
