# Damage Assessment and Seismic Retrofit of Buildings Following the 2015 Nepal and 2016 Ecuador Earthquakes

*H. Kit Miyamoto, PhD SE and Amir SJ Gilani, PhD SE  
Miyamoto International  
Los Angeles, CA*

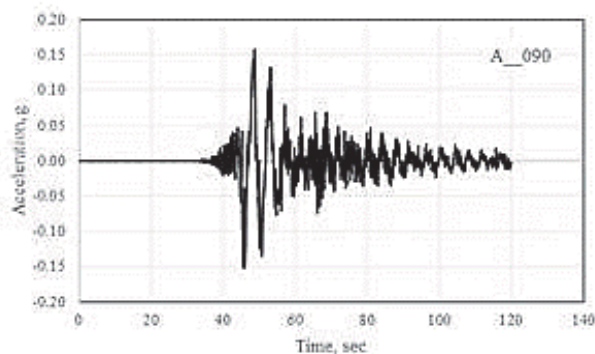
**Figure 1. Acceleration record**

Earthquake; see Figure 1, was available and the peak ground acceleration was approximately 0.10-0.15 g. However, site amplification resulted in large spectral acceleration at periods of 2 to 4 sec; see Figure 2 These peaks at larger periods, in-turn excited the tall buildings with fundamental periods in this period range, resulting in significant damage to these modern concrete buildings. As seen in the figure, the spectral acceleration demand on buildings, in particular, for structures with periods of larger than 1 sec, is significantly larger than the spectrum used to design these structures (NBC 1994 and IS 2002). Accordingly, buildings, in particular mid- and hi-rise, designed per code would experience larger forces and displacements than were anticipated. As a result: i) for buildings with ductile detailing, the larger demand would result in plastic hinging and damage and ii) for buildings without ductility, severe damage and collapse could occur.

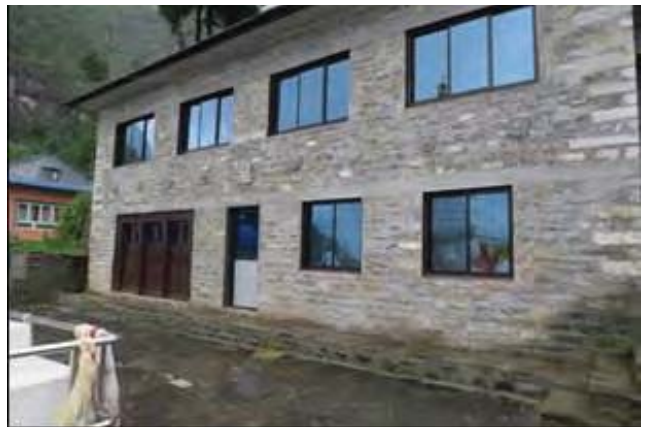
The level of damage in traditional construction was depended on the construction practice. The buildings with stone and mortar generally performed well. By contrast, in older buildings where either no mortar was used or when mud was used as mortar, there was significant damage. For these buildings, see Figure 5, the out-of-plane failure of walls was the most common mode of failure, where stonewalls fell over or stones fell out, generally at the top of the walls. Since these bearing walls carry both seismic and gravity loading, their out-of-plane failure can compromise the gravity load path and can result in collapse of roofs and floors. For the surveyed buildings, a secondary wood beam supporting the roof was observed in many of the buildings. This member supported the roof after the failure of walls and prevented collapse of the roof. Accommodation structure built with cut rock, cement and ring beams that performed well; see Figure 6. Wood structures were mostly undamaged. The structural assessment of the buildings was conducted in accordance with the internationally recognized ATC-20 (ATC 2005) and the national guidelines for post-earthquake damage assessment specified by the Department of Urban Development and Building Construction (DUDBC) of the Government of Nepal. Out of approximately 710 surveyed buildings, earthquake damage of structural concern was observed in 120 buildings (17%); 83 percent of buildings were given a green tag per ATC-20 and DUDBC guidelines. It was found that most of the damaged buildings were repairable

**Figure 6. Undamaged accommodation building**

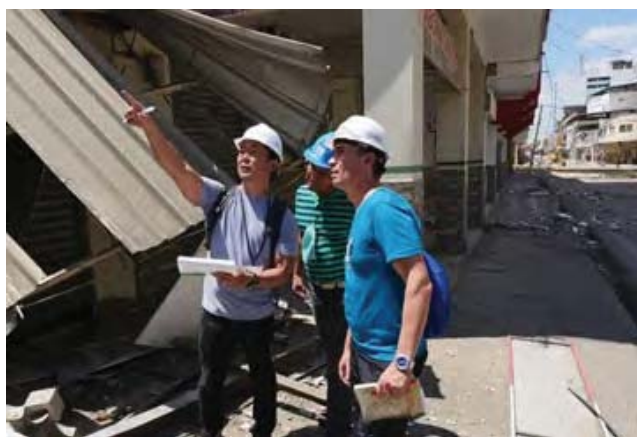
Portoviejo's previously vibrant downtown of 223,000 citizens was fenced-off, 40-block Red Zone; see Figure 11. Over 200 people died in this city. In the red zone, heavy machinery was used to tear down damaged structures. A command center was setup on a campus. The recovery organization team and the prepared map of damage zone was quite adequate. The local officials have a plan to identify and demolish the dangerous buildings and then reduce the size of the corded off zones to allow normality to return to the city. It was also envisaged to setup public-private partnership to assist in recovery and seismic retrofit efforts. A drone was used to conduct aerial reconnaissance and prepare a detailed damage assessment map. The buildings were marked in green (inspected), yellow (damaged, limited entry), red (dangerously damaged, do not enter) and black (collapsed).

**Figure 11. Downtown Portoviejo**

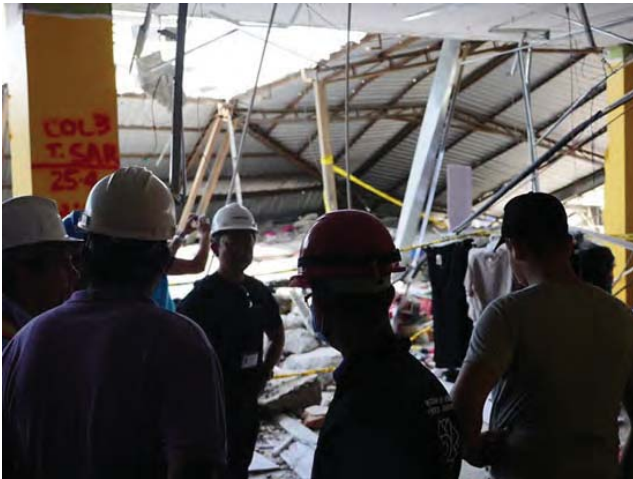
To provide training, local assessors are incorporated into assessment teams. The group then conducts damage assessment surveys of some buildings as a mean of providing first-hand training so local engineers and volunteers can then continue the work for the rest of buildings; see Figure 14.

**Figure 14. Damage assessment training**
