## Reconnaissance of the effects of the M7.8 Gorkha (Nepal) earthquake of April 25, 2015

# Reconnaissance of the effects of the M7.8 Gorkha (Nepal) earthquake of April 25, 2015

Department of Civil Engineering, Indian Institute of Technology Kanpur, Kanpur, India

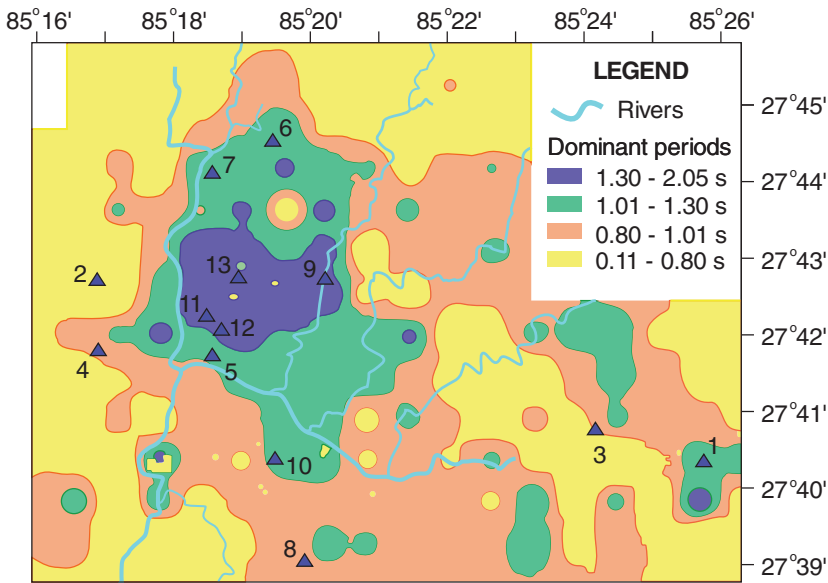
The contour map of dominant period of ground of the Kathmandu region is shown in [Figure 3](#) (redrawn after Paudyal et al. 2012). Various places where major damage was observed are also indicated in [Figure 3](#). These dominant period contours provide some valuable information which can be correlated with the observed damage. The old unreinforced masonry buildings in Nikosera (marked as 3 in [Figure 3](#)) generally fall under the acceleration-sensitive region of the spectra with a period range of 0.1–0.6 s which closely matches with the dominant period of ground of the affected region (0.11–0.80 s). Similarly, the failure of the Dharahara tower (12), a 203-feet tall unreinforced masonry tower, could also be related to the long-period dominance in the central region (1.30–2.05 s). The USGS station KATNP (13) also lies in the central area of the valley with long-period dominance, hence the record from this station cannot be used as a representative data for the entire Kathmandu valley. Thus, for better understanding of the seismicity of the region, strong motion stations should be set up at numerous locations.

The fundamental time period of multi-storey RC buildings can be approximated as  $0.1N$ , where  $N$  is the number of storeys (Kramer 1996). Hence, buildings of 10–20-storey height possess fundamental time period in the range of 1–2 s, which is the predominant frequency in the central region of the valley. The time period of 14-storey Parkview Horizon building (6), which suffered major damage to the masonry infills,

Figure 3. Variation of dominant period of ground of the Kathmandu valley (Paudyal et al. 2012). Various places where major damage was observed are also indicated in the map (1: Bhaktapur Durbar square, 2: Sitapaila, 3: Nikosera, 4: Kalanki bus stop, 5: Teku road, 6: Parkview Horizon apartments, 7: Gongbu new bus stand, 8: Cityscape apartments, 9: Kalopul, 10: Patan Durbar square, 11: Kathmandu Durbar square, 12: Dharahara tower, 13: USGS KATNP station). Reproduced with permission from J. Earthquake Engineering, 16, 8 (2012). Copyright 2012 Taylor and Francis. To view this figure in colour, please see the online version of the journal.

falls dangerously close to the dominant period range of 1.01–1.30 s. Thus, the development of new high-rise buildings should be regulated based on the study of soil profile and its properties. The construction of buildings along the banks of river such as in Kalopul (9) and along banks of river Bishnumati near Gongabu Bus stand (7), Machha Pokhari also led to severe damage.
