# **Preliminary update - Mw7.8 Kaikoura Earthquake (15 November 2015)**

## **Upper Part of South Island**

**By Dmytro Dizhur and Marta Giaretton**

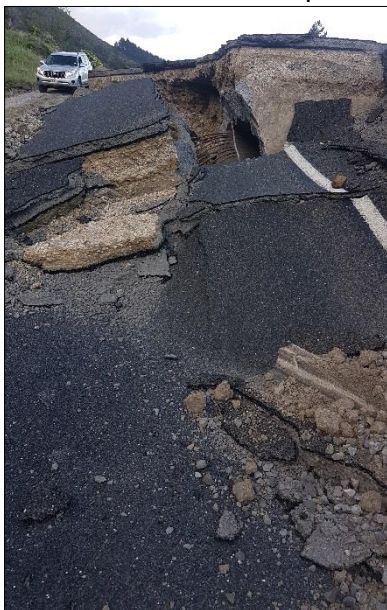
Upto 3 meters of vertical drop in road level (looking north)

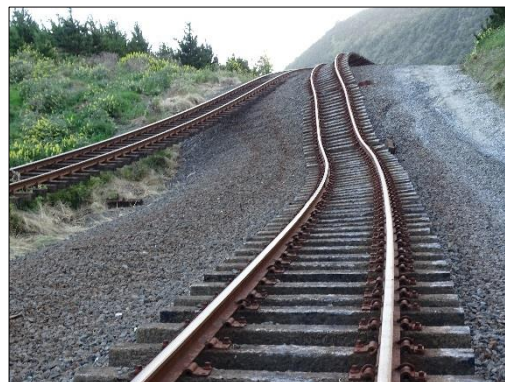
Major lateral displacement of railway lines

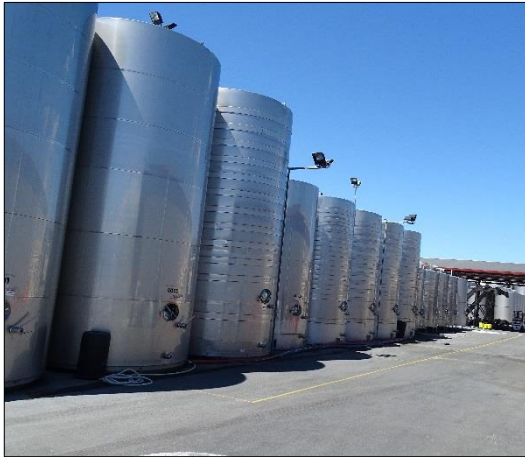
Typical tanks inspected

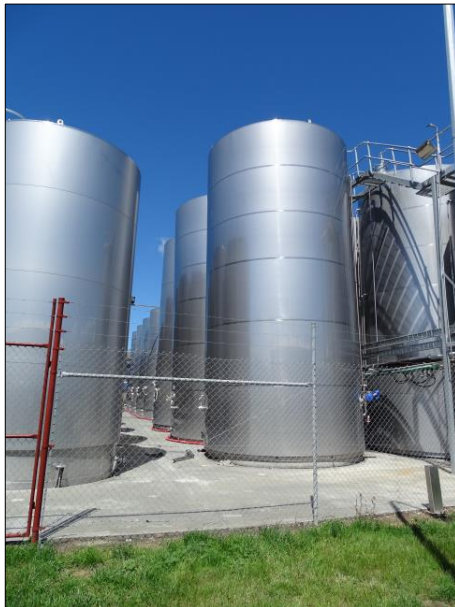
Typical tanks inspected

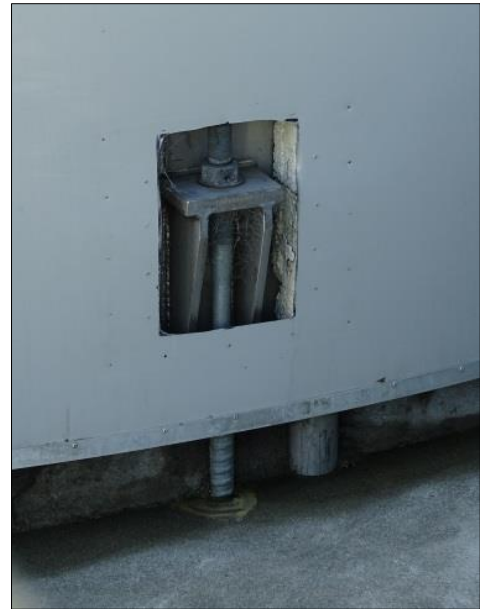
No damage observed for large connections

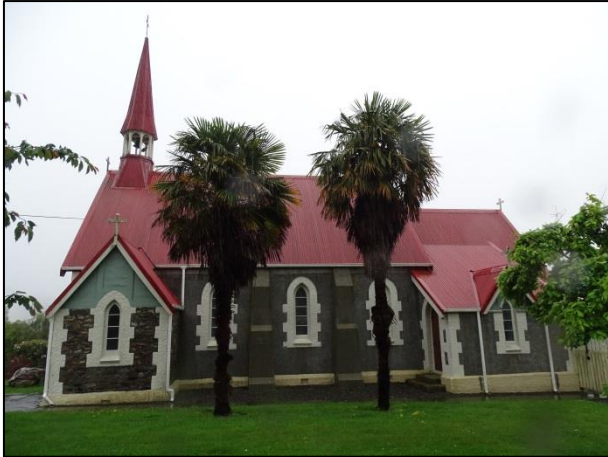
St Peter's Church, stone masonry probably retrofitted

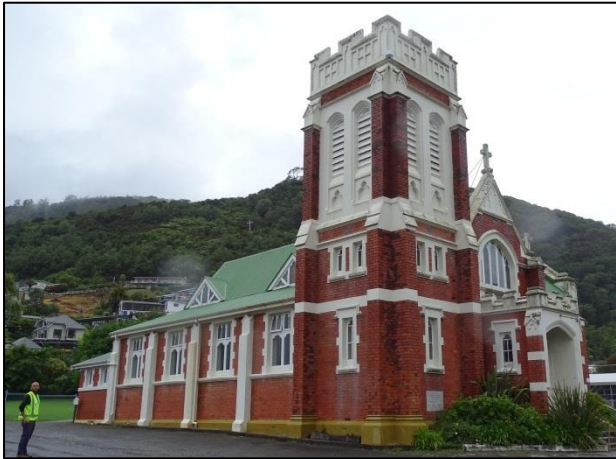
St Joseph's Church, clay brick masonry cavity-wall building (probably retrofitted)

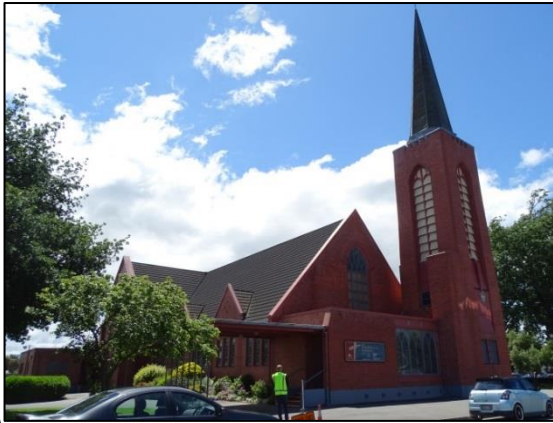
The Church of Nativity, retrofitted clay brick masonry building

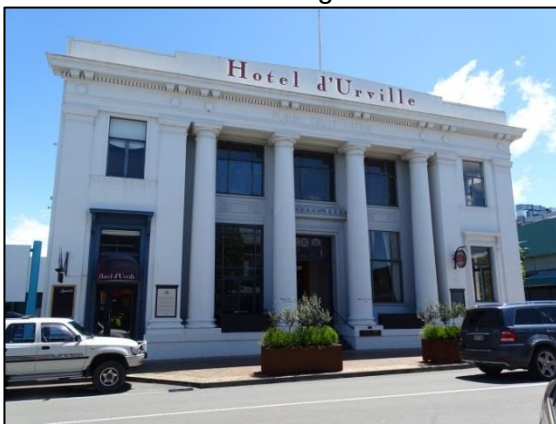
Hotel d'Urville, retrofitted concrete building

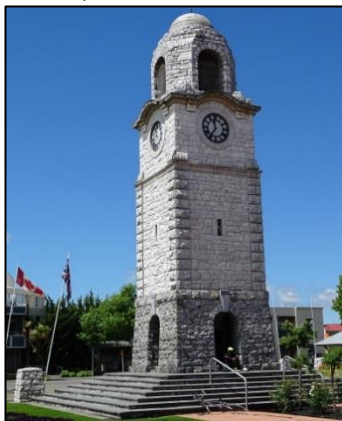
War Memorial and Clock Tower, stone and concrete

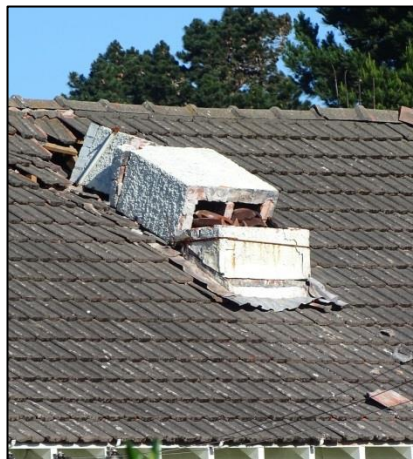
Inward collapse, Clarence

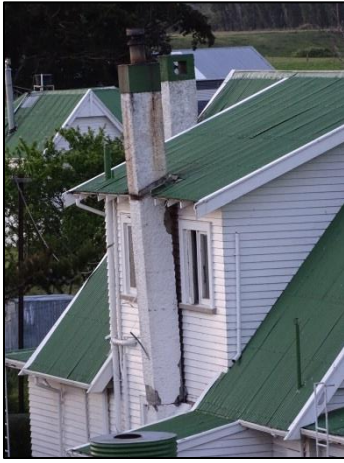
Out-of-plane detachment of the chimney stack, Clarence

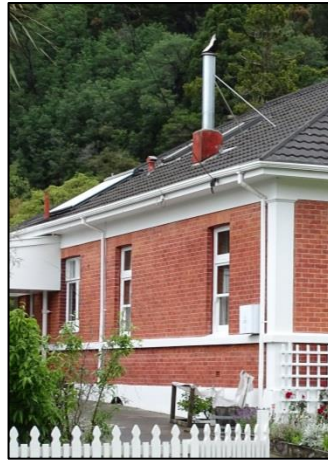
Example of removed chimney, Picton

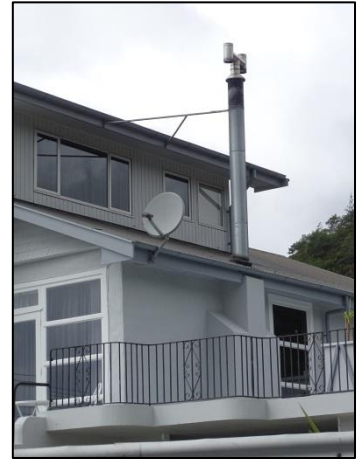
Example of removed chimney, Picton
