# **Preliminary update - Mw7.8 Kaikoura Earthquake (15 November 2015)**

## **Upper Part of South Island**

**By Dmytro Dizhur and Marta Giaretton**

This is a preliminary set of notes from observations made on 15 November 2016, route taken is shown below.

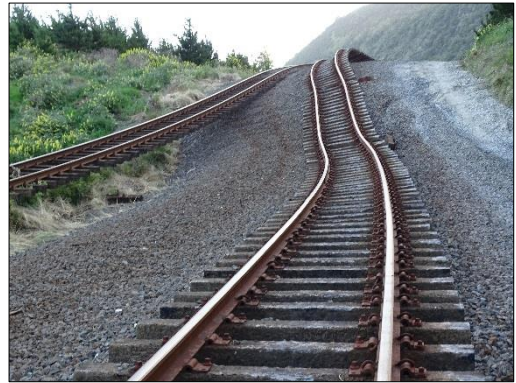
Major lateral displacement of railway lines

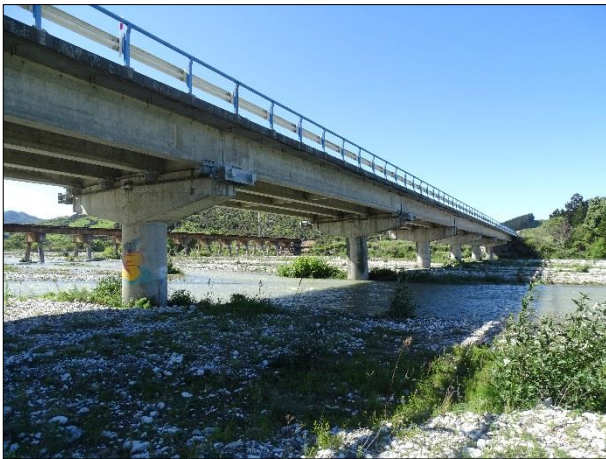
Overall bridge view – accessible to trucks

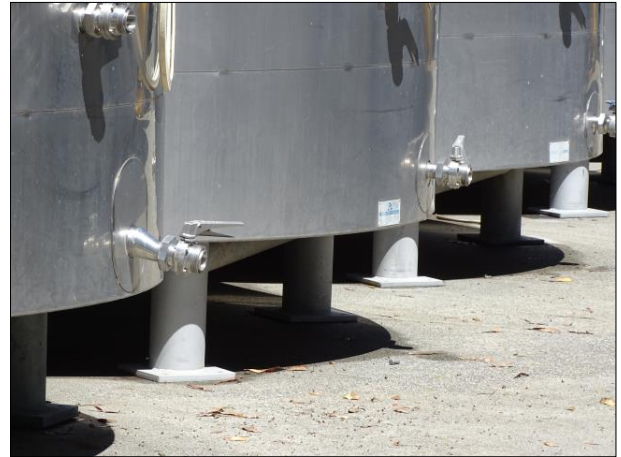
Free standing tanks – no evidence of significant movement

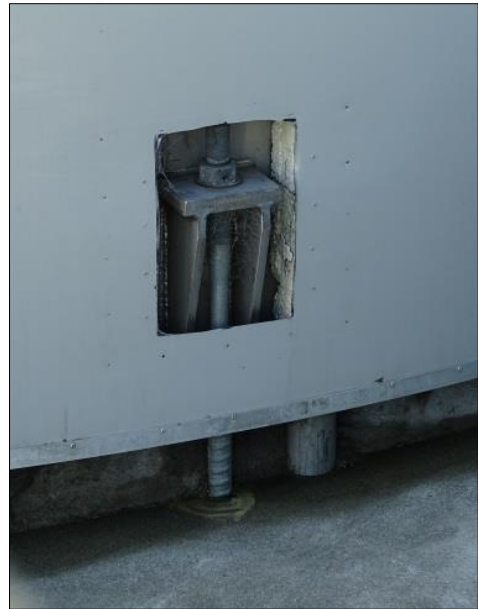
No damage observed for large connections

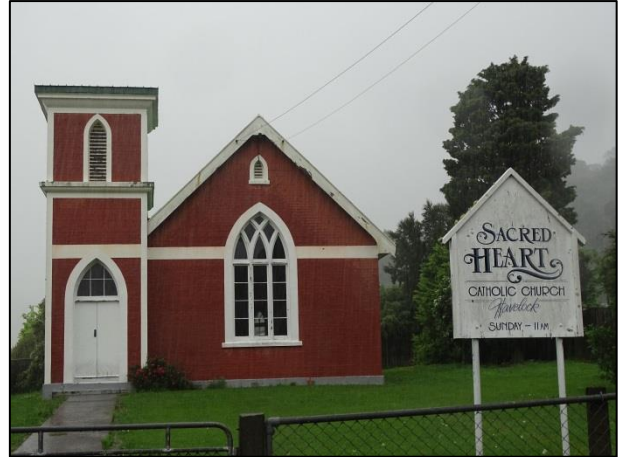
The Sacred Heart Church, clay brick masonry

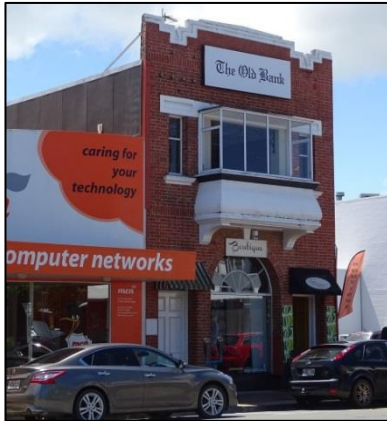
Bank of Australasia, retrofitted clay brick masonry building

Bank of Australasia, internal view

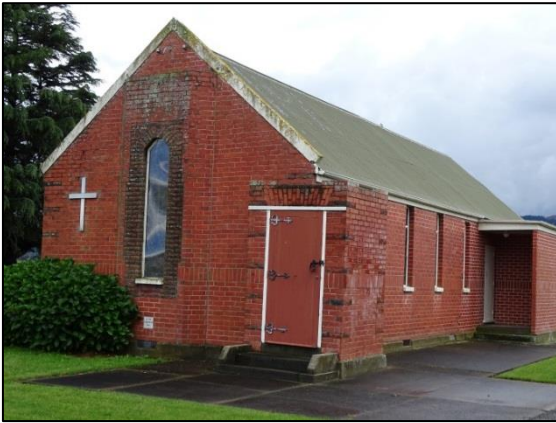
Rapaura Community Church – no visible damage

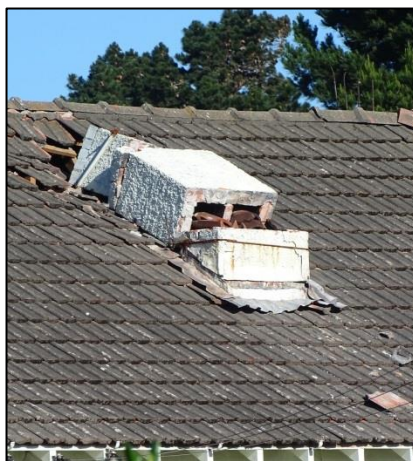
Inward collapse, Clarence

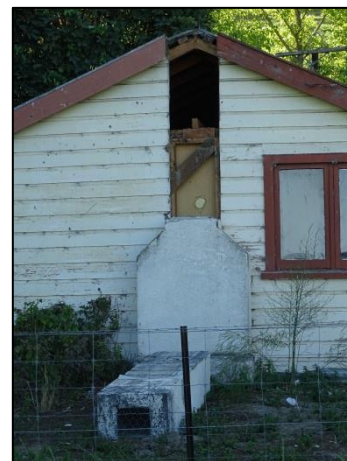
Outward collapse of the chimney stack, Clarence

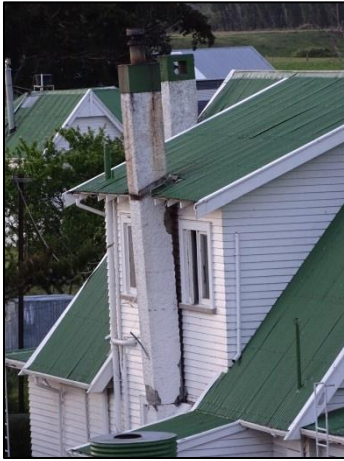
Out-of-plane detachment of the chimney stack, Clarence
