## Preliminary update - Mw7.8 Kaikoura Earthquake

**(16-17 November 2015, supplement to 15 November update)**

### Upper Part of South Island

# Preliminary update - Mw7.8 Kaikoura Earthquake (16-17 November 2015)

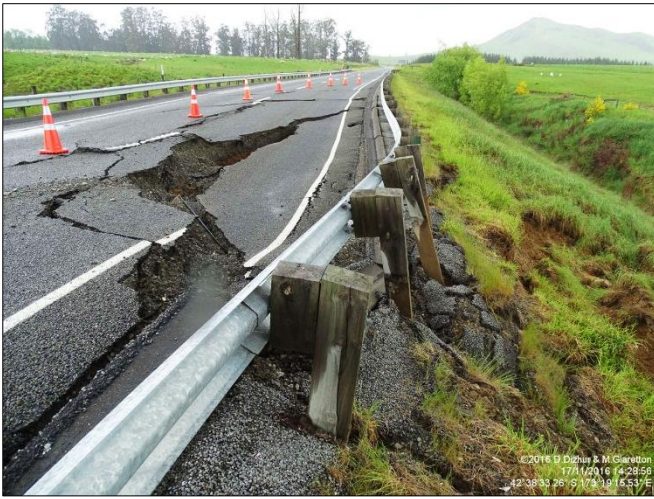
Landslide into a creek below. State Highway 1, north of Leads Road

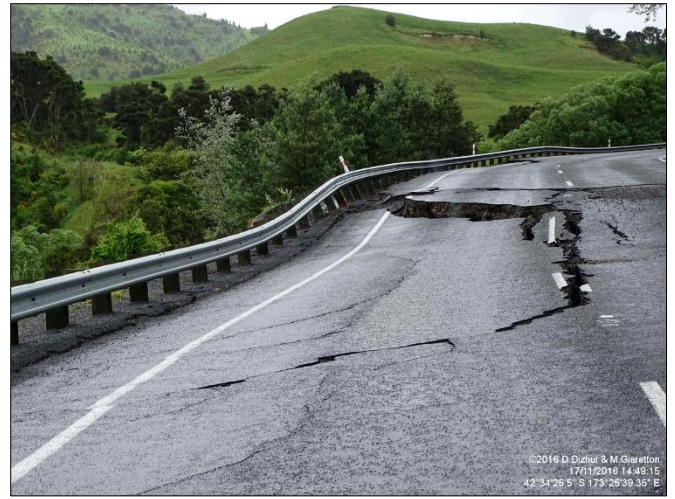
Movement of pavement due to land sliding below

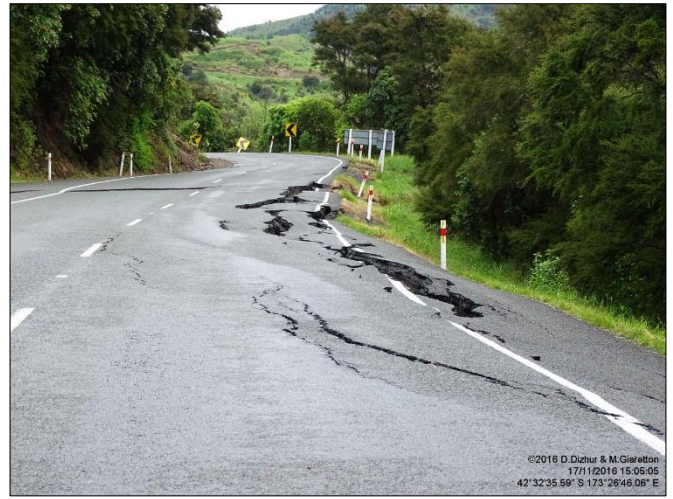
Significant road pavement deformation near SH1

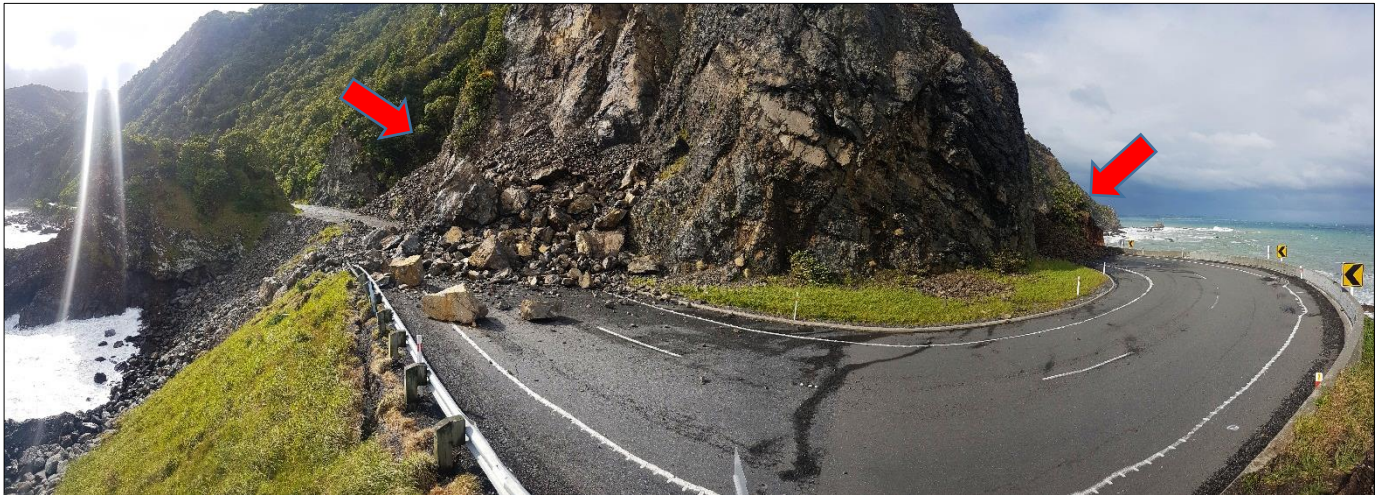
End of the road – Attempts are being made to start removing the rock fall  
(-42.449696, 173.575200)

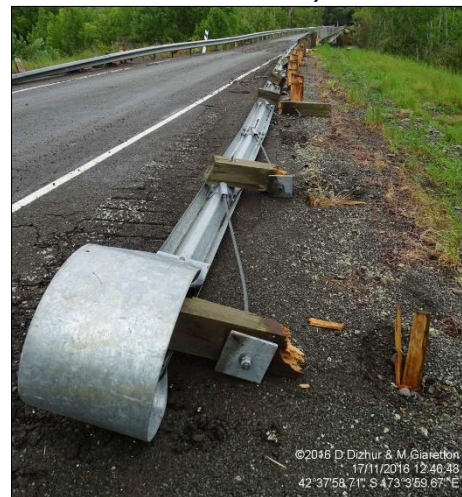
Breaking of the railing supports due to significant displacements of the deck structure

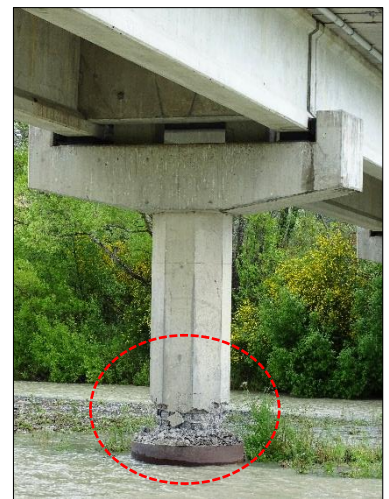
Hinging of bridge columns (see close-up)

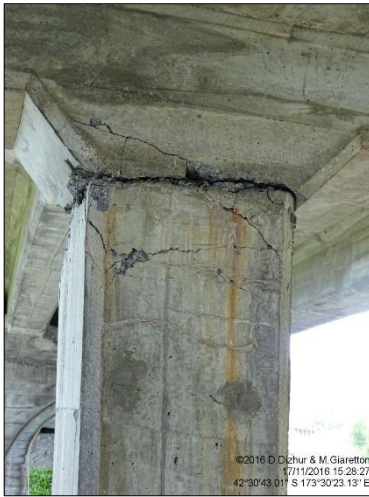
Plastic hinging at the top of column

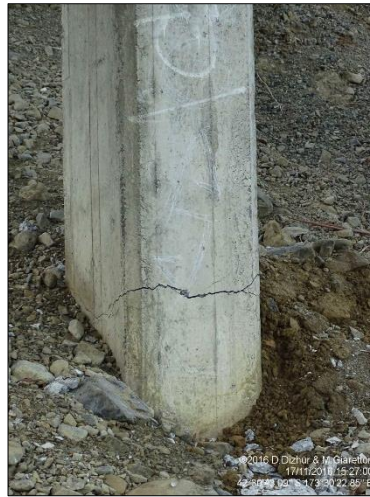
Signs of hinging at the column base

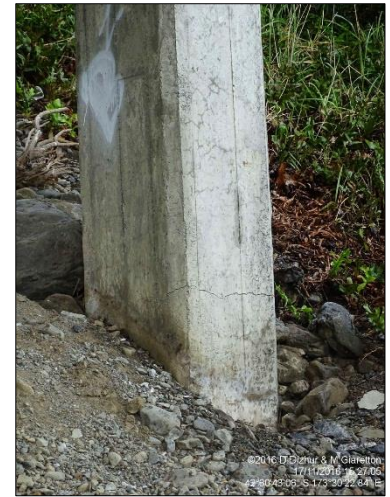
Signs of hinging at the column base

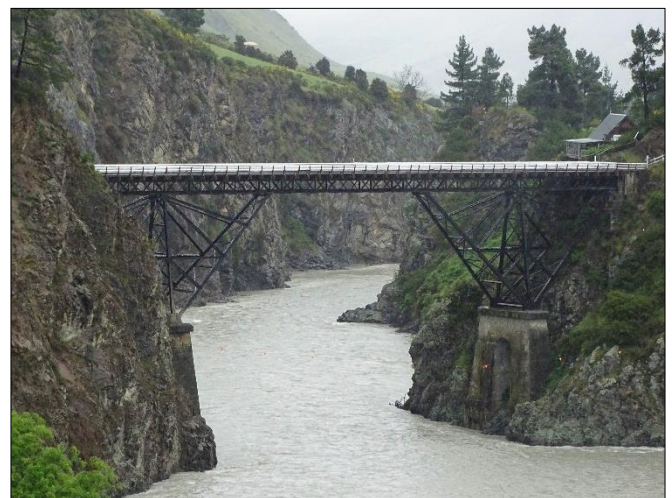
Historic steel bridge originally constructed in 1887. No observed damage, open to all traffic (SH7A leading to Hanmer Springs)  
(-42.584195, 172.782635)

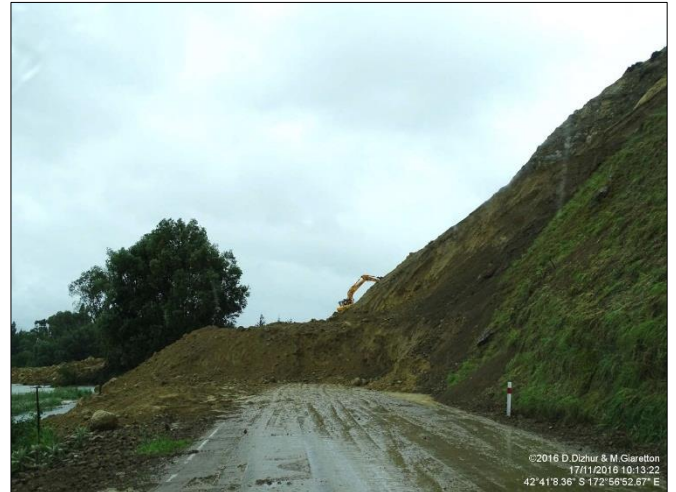
Land slide being cleared SH70 towards Waiau (by pass available)

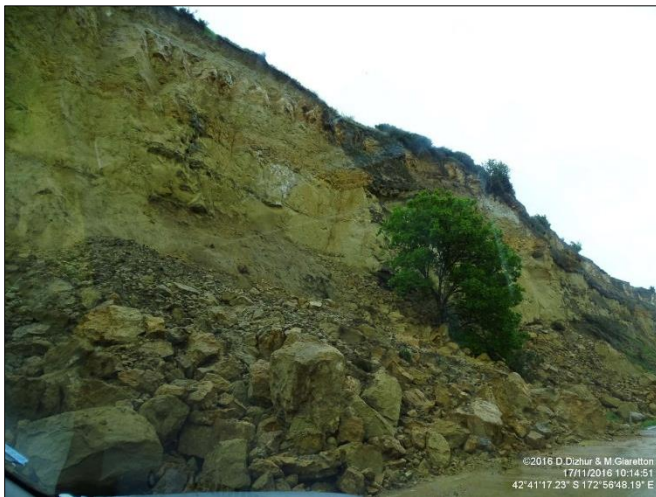
Major rock fall on SH70

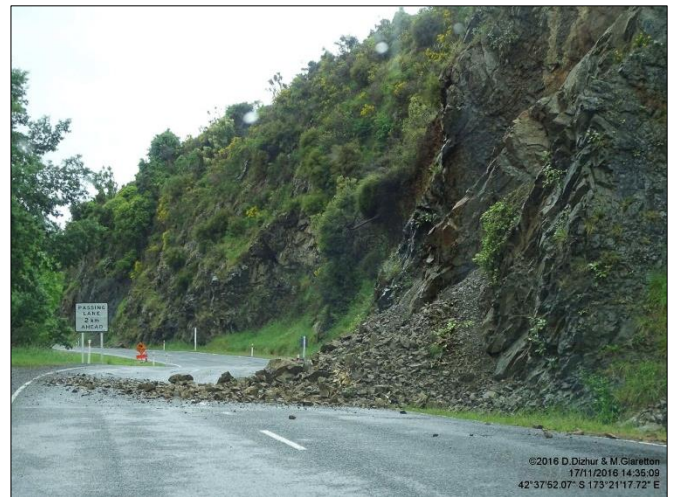
Example of typical rock fall on SH1, numerous cases along the stretch of road from Chevron to Kaikoura

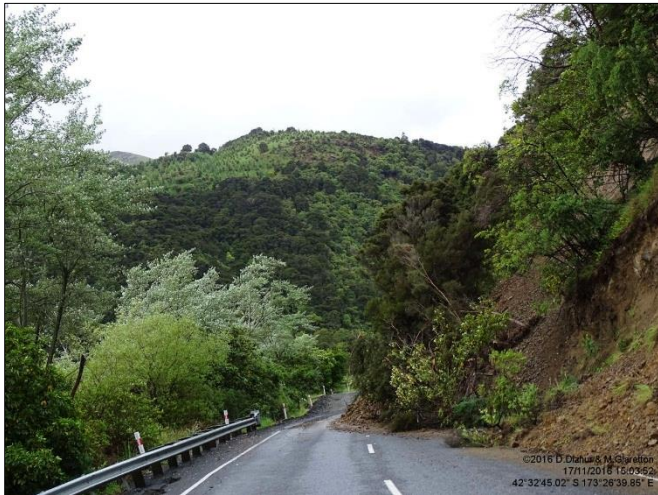
Major slide along SH1

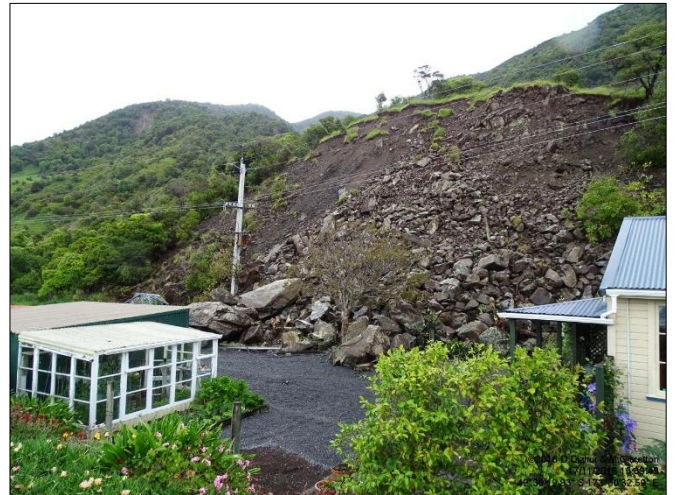
Major rockfall near coast along SH1, near miss of residential dwelling

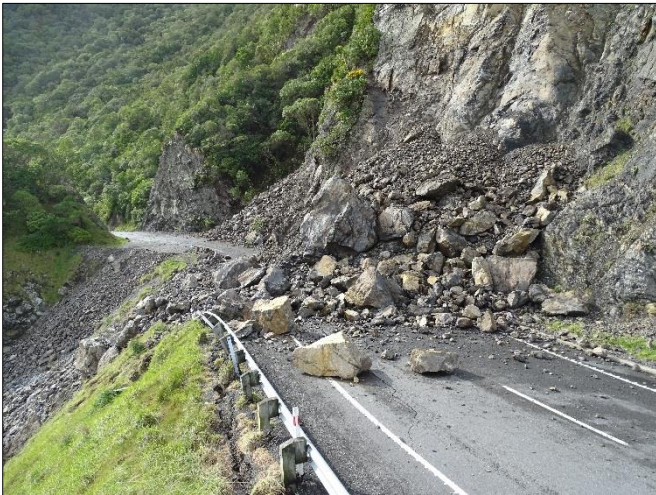
(b) Major rock fall over SH1 – attempts were been made to partially cleared

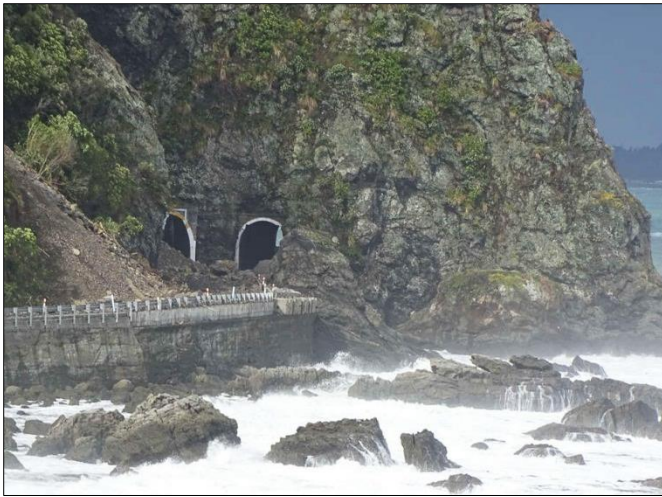
(d) Blockage of tunnel entry due to rock fall, looking south

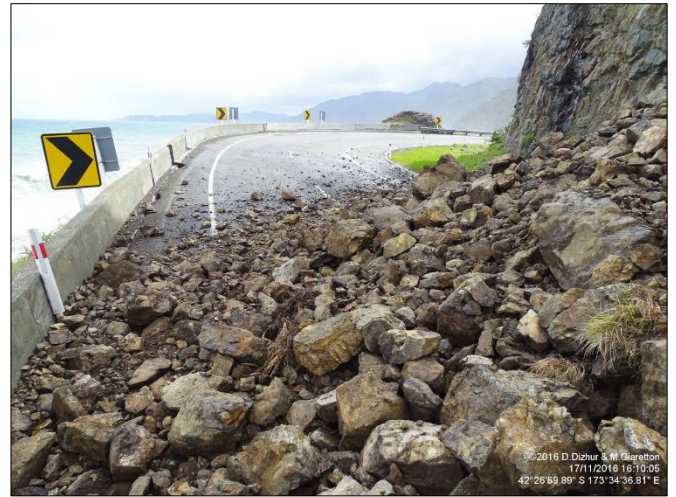
Rockfall over SH1, looking north

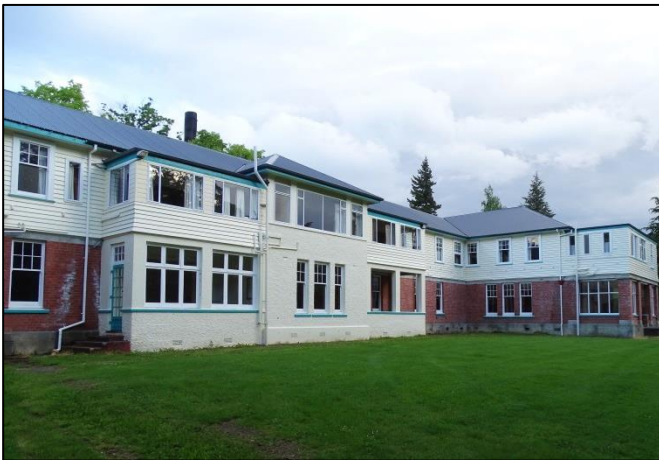
Queen Mary Hospital (1916) – Nurses' Hostel (no damage to loadbearing masonry)

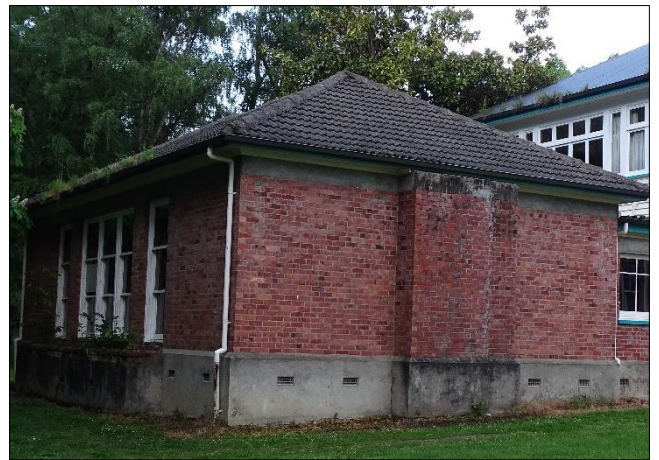
Clay brick cavity masonry building - Queen Mary Hospital (1916) – Chisholm Ward (no damage)

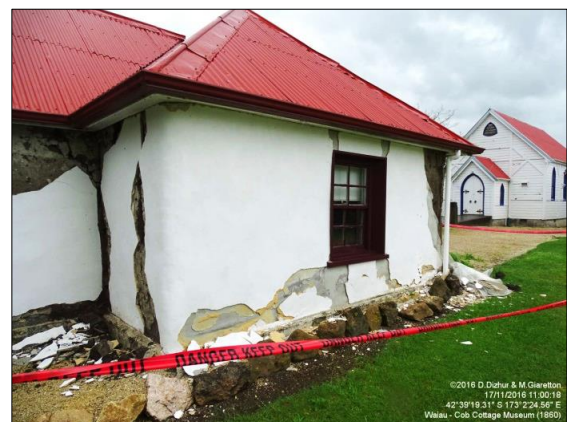
Cob Cottage museum – evidence of textile reinforced mortars used as retrofit

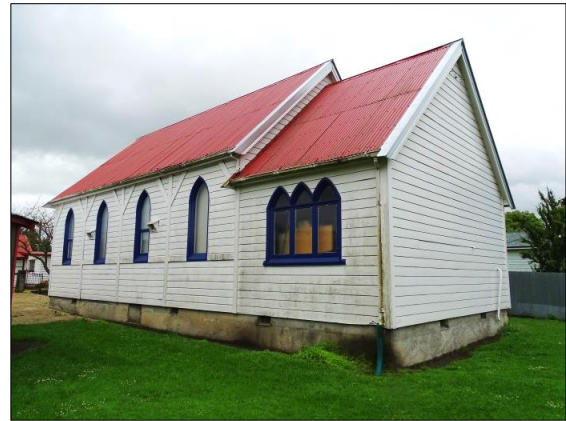
Presbyterian Church – timber framed building with no damage

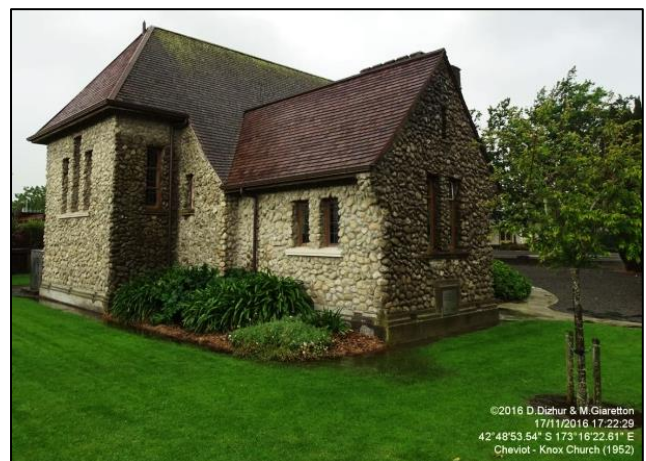
Knox Presbyterian Church – rear view with no observed damage

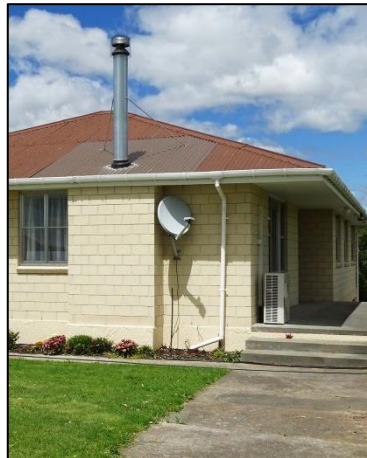
Example of removed chimney, Seddon

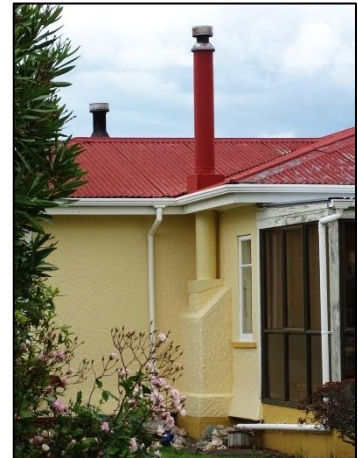
Example of removed chimney, Seddon

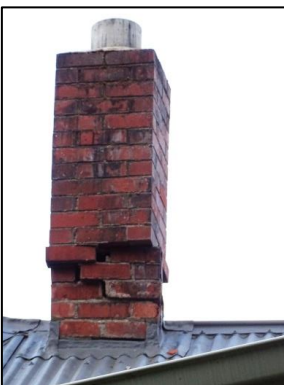
Horizontal crack at the chimney base and torsion, Hanmer Springs

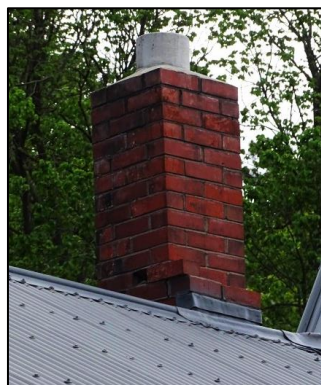
Horizontal crack at the chimney base and sliding, Hanmer Springs

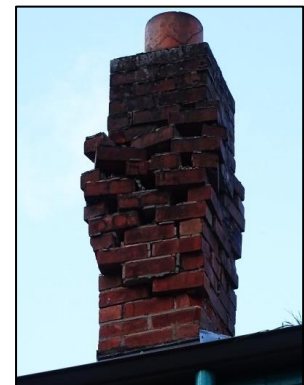
Extensive dislodgment of the bricks, Hanmer Springs

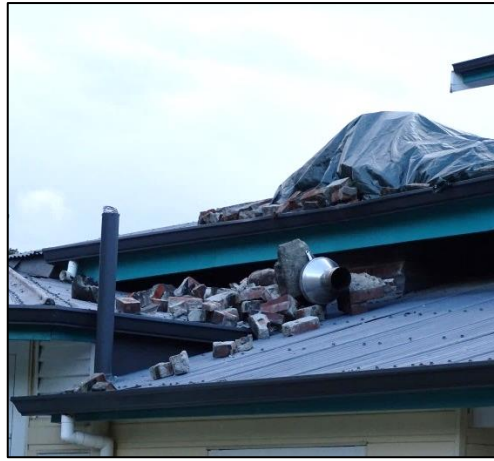
Collapse, Hanmer Springs

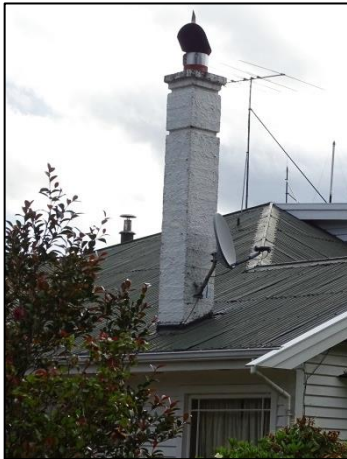
Non-damaged tall chimney,  
Hanmer Springs

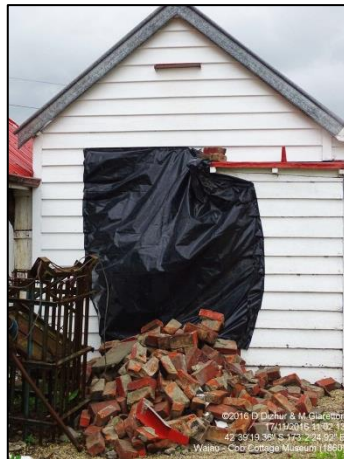
Full collapse, Waiau

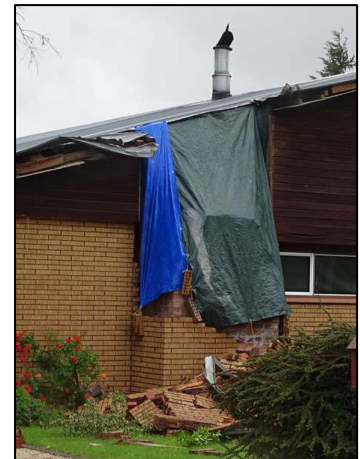
Collapse of the chimney stack,  
Waiau

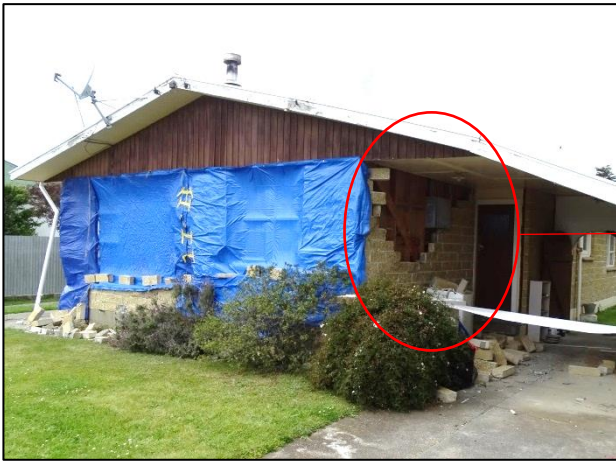
Out-of-plane collapse, Seddon

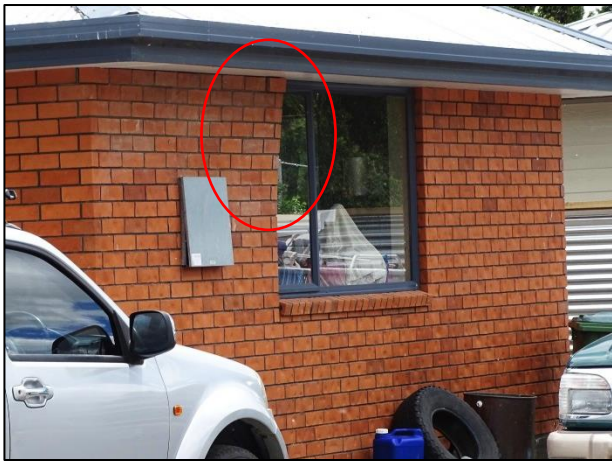
Detachment at the top of the veneer wall and initiation of out-of-plane collapse, Seddon

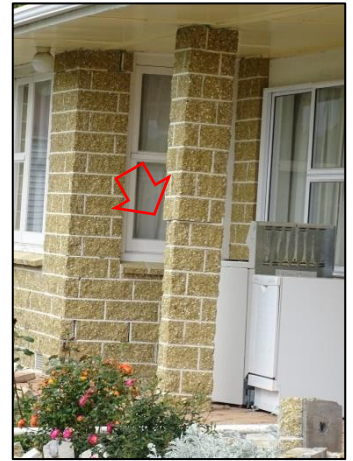
Torsion of the top part of the column, Seddon
