EARTHQUAKE IN SOUTHERN ITALY NOVEMBER 23, 1980

Reconnaissance Tour December 2-5, 1980

Dr. A. Smolka, Geologist* and J. Eber, Civil Engineer

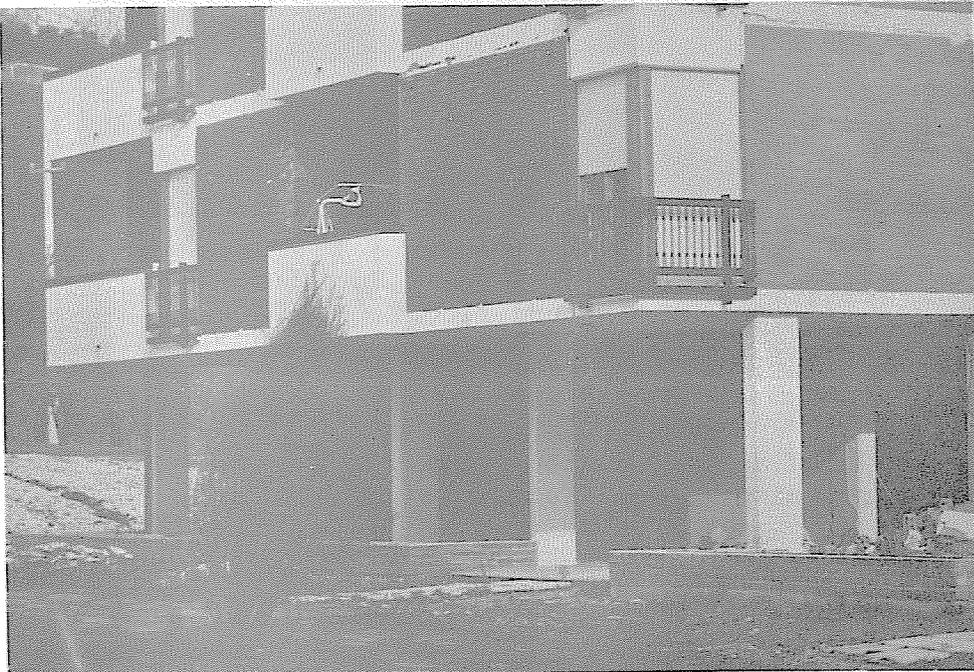
Nonstructural damage to ground and first floors of apartment house at Monteforte Irpino (near Avellino). Construction was just finished.
