Fast Report on The Nagano-ken Seibu Earthquake of September 14, 1984 in Central Japan

- Prepared for the EERI Newsletter Earthquake Insert by Yasushi Sasaki, Head, Ground Vibration Division, Earthquake Disaster Prevention Dept. PWRI, MOC.

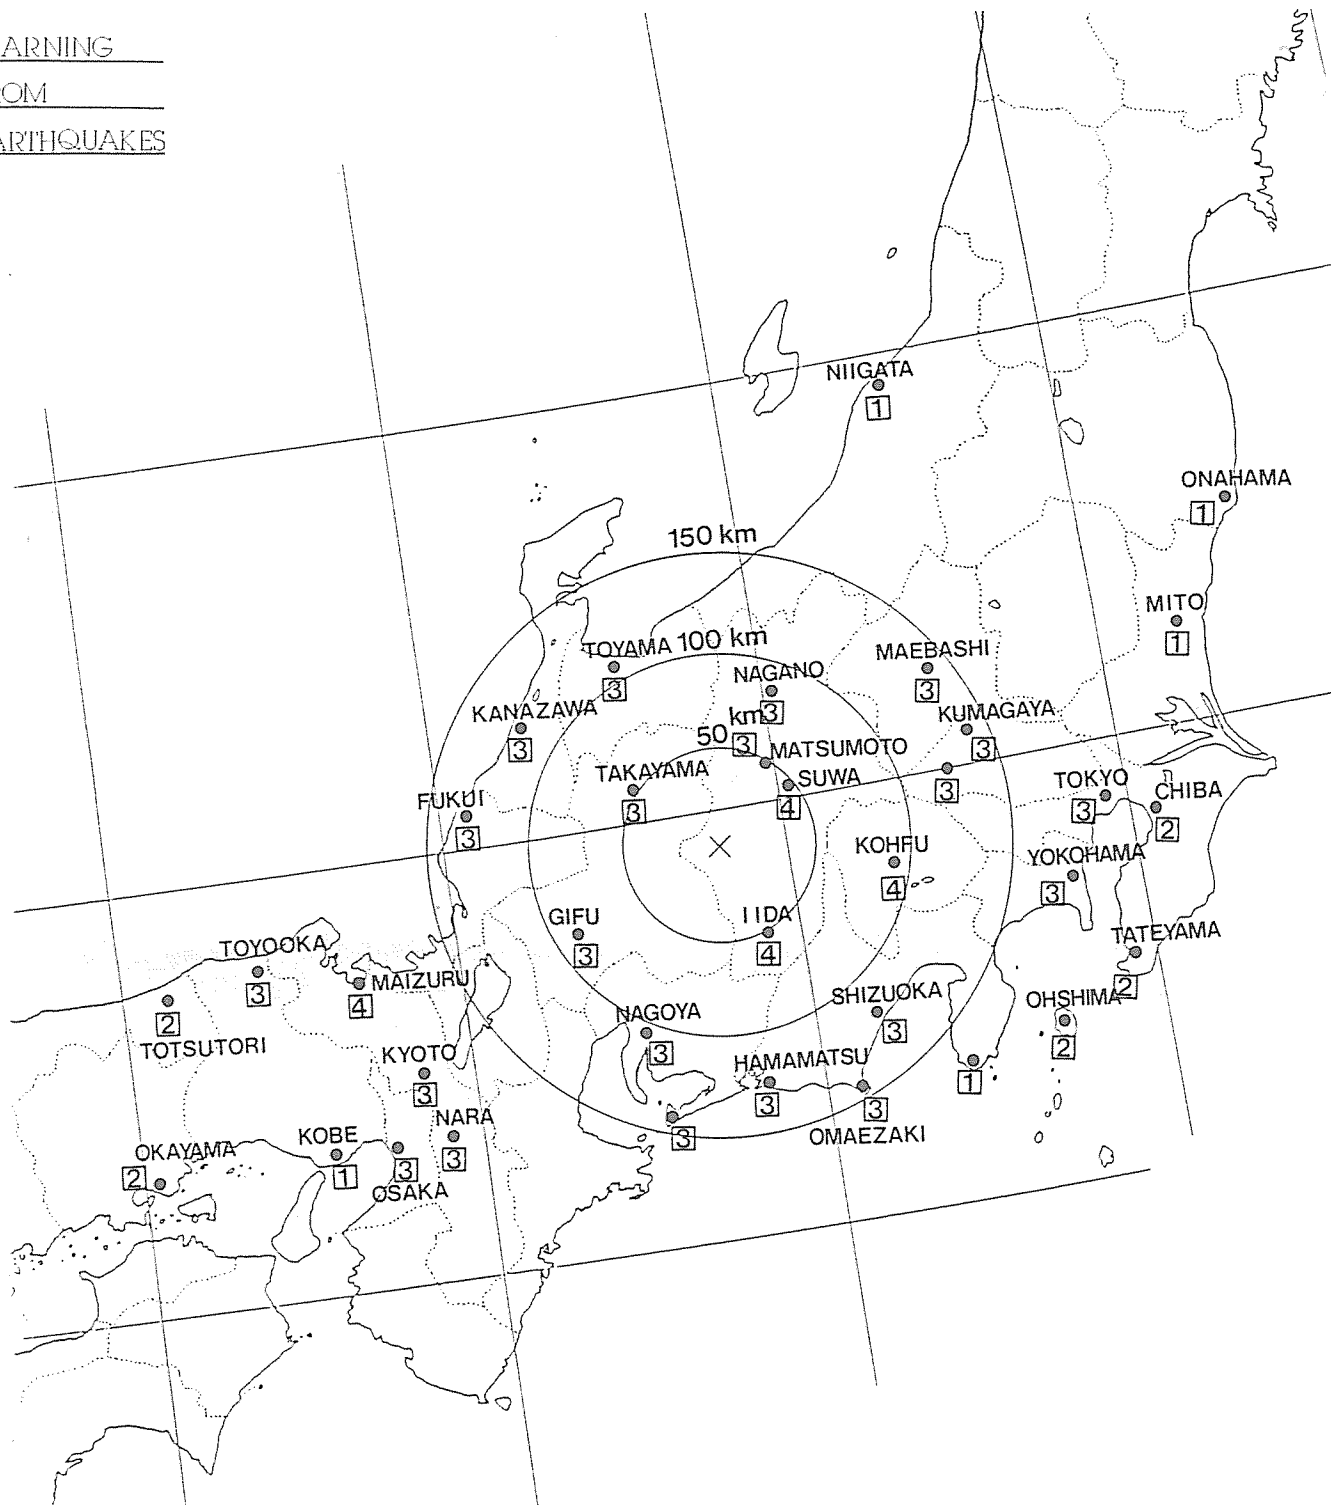
Fig. 1 Distribution of Seismic Intensity in JMA Scale (After JMA)

On Sept. 14, 1984, a severe earthquake of magnitude 6.9 on the Richter scale occurred at a central part of Japan. Since the epicenter was at the middle of Honsyu Island, the shaking was felt in wide area from Tokyo to Okayama as shown in Fig. 1, although this felt area

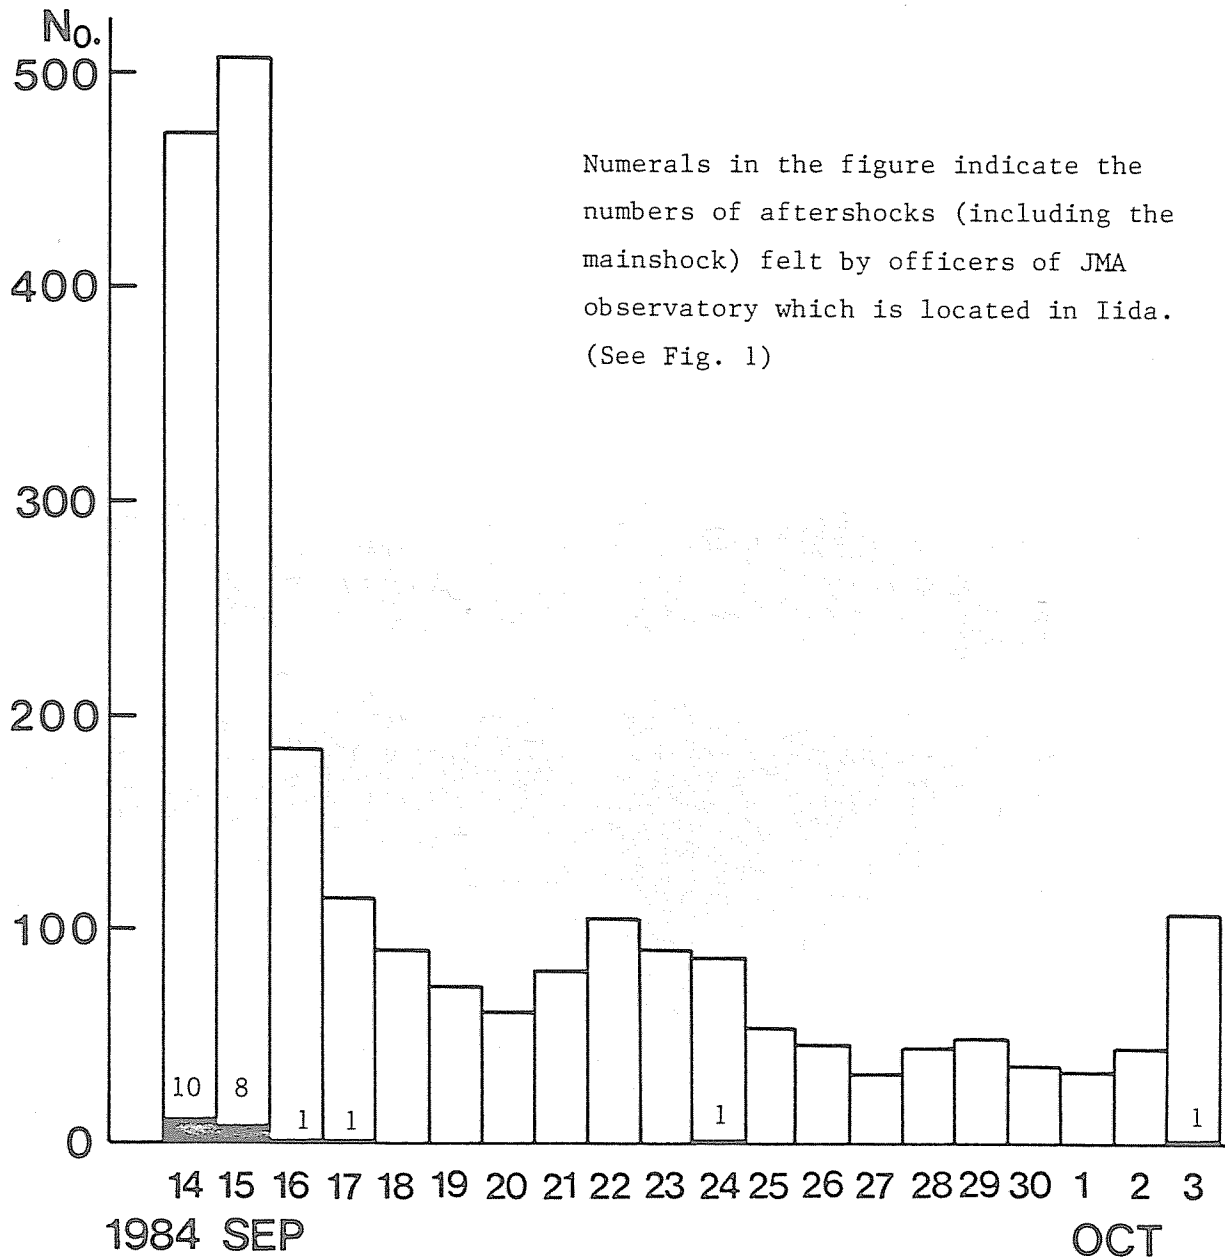
Fig. 2 Number of Aftershocks (After JMA)

The origin-time of the main shock was 8:48 am and the epicenter is temporarily reported to be 35° 47' N and 137° 31' E with focal depth 0 to 10 km by the Japan Meteorological Agency. Observed aftershocks are shown in Fig. 2. Among the aftershocks shown in Fig. 2, the one with magnitude of M = 6.4 which occurred on 7:14 am of Sept. 15 was the largest aftershock.

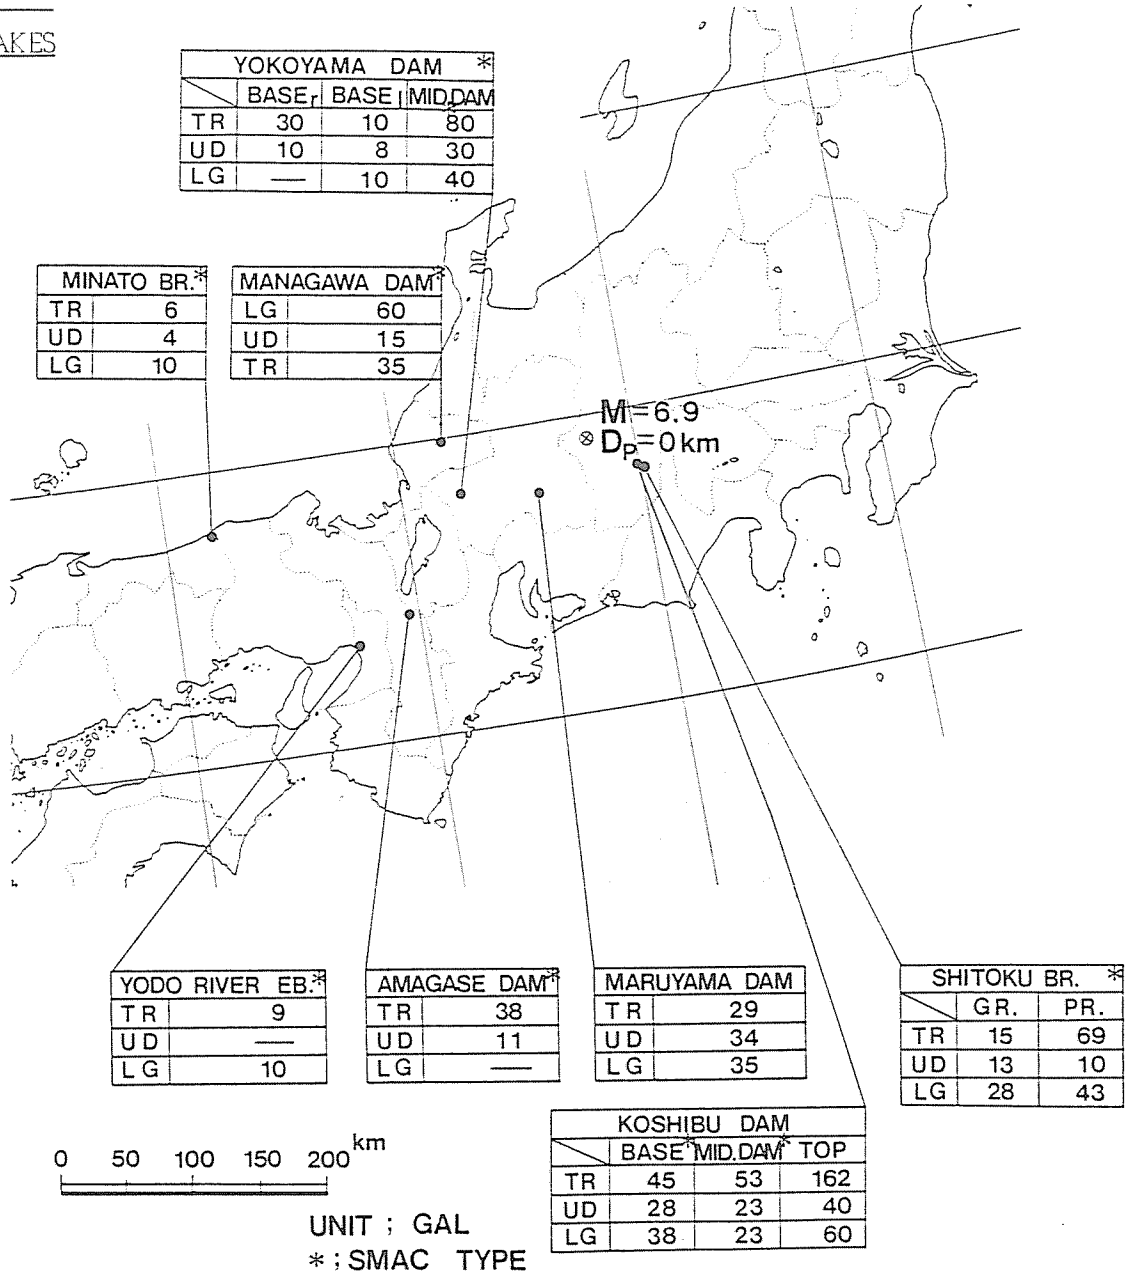
Fig. 3 Records of Strong Motion Accelerometer (Tentative)

Strong motion acceleration records are not precisely analyzed yet, however, maximum ground accelerations are tentatively compiled as shown in Fig. 3. The maximum ground acceleration recorded by SMAC-type accelerometer was at Shitoku Bridge site, 47 km apart from the epicenter, which was 28 gals in longitudinal direction to the bridge axis.
