ENGINEERING ASPECTS OF THE LIMA, PERU EARTHQUAKE OF OCTOBER 3, 1974

THE EERI RECONNAISSANCE TEAM

PRELIMINARY RECONNAISSANCE REPORT
JANUARY, 1975

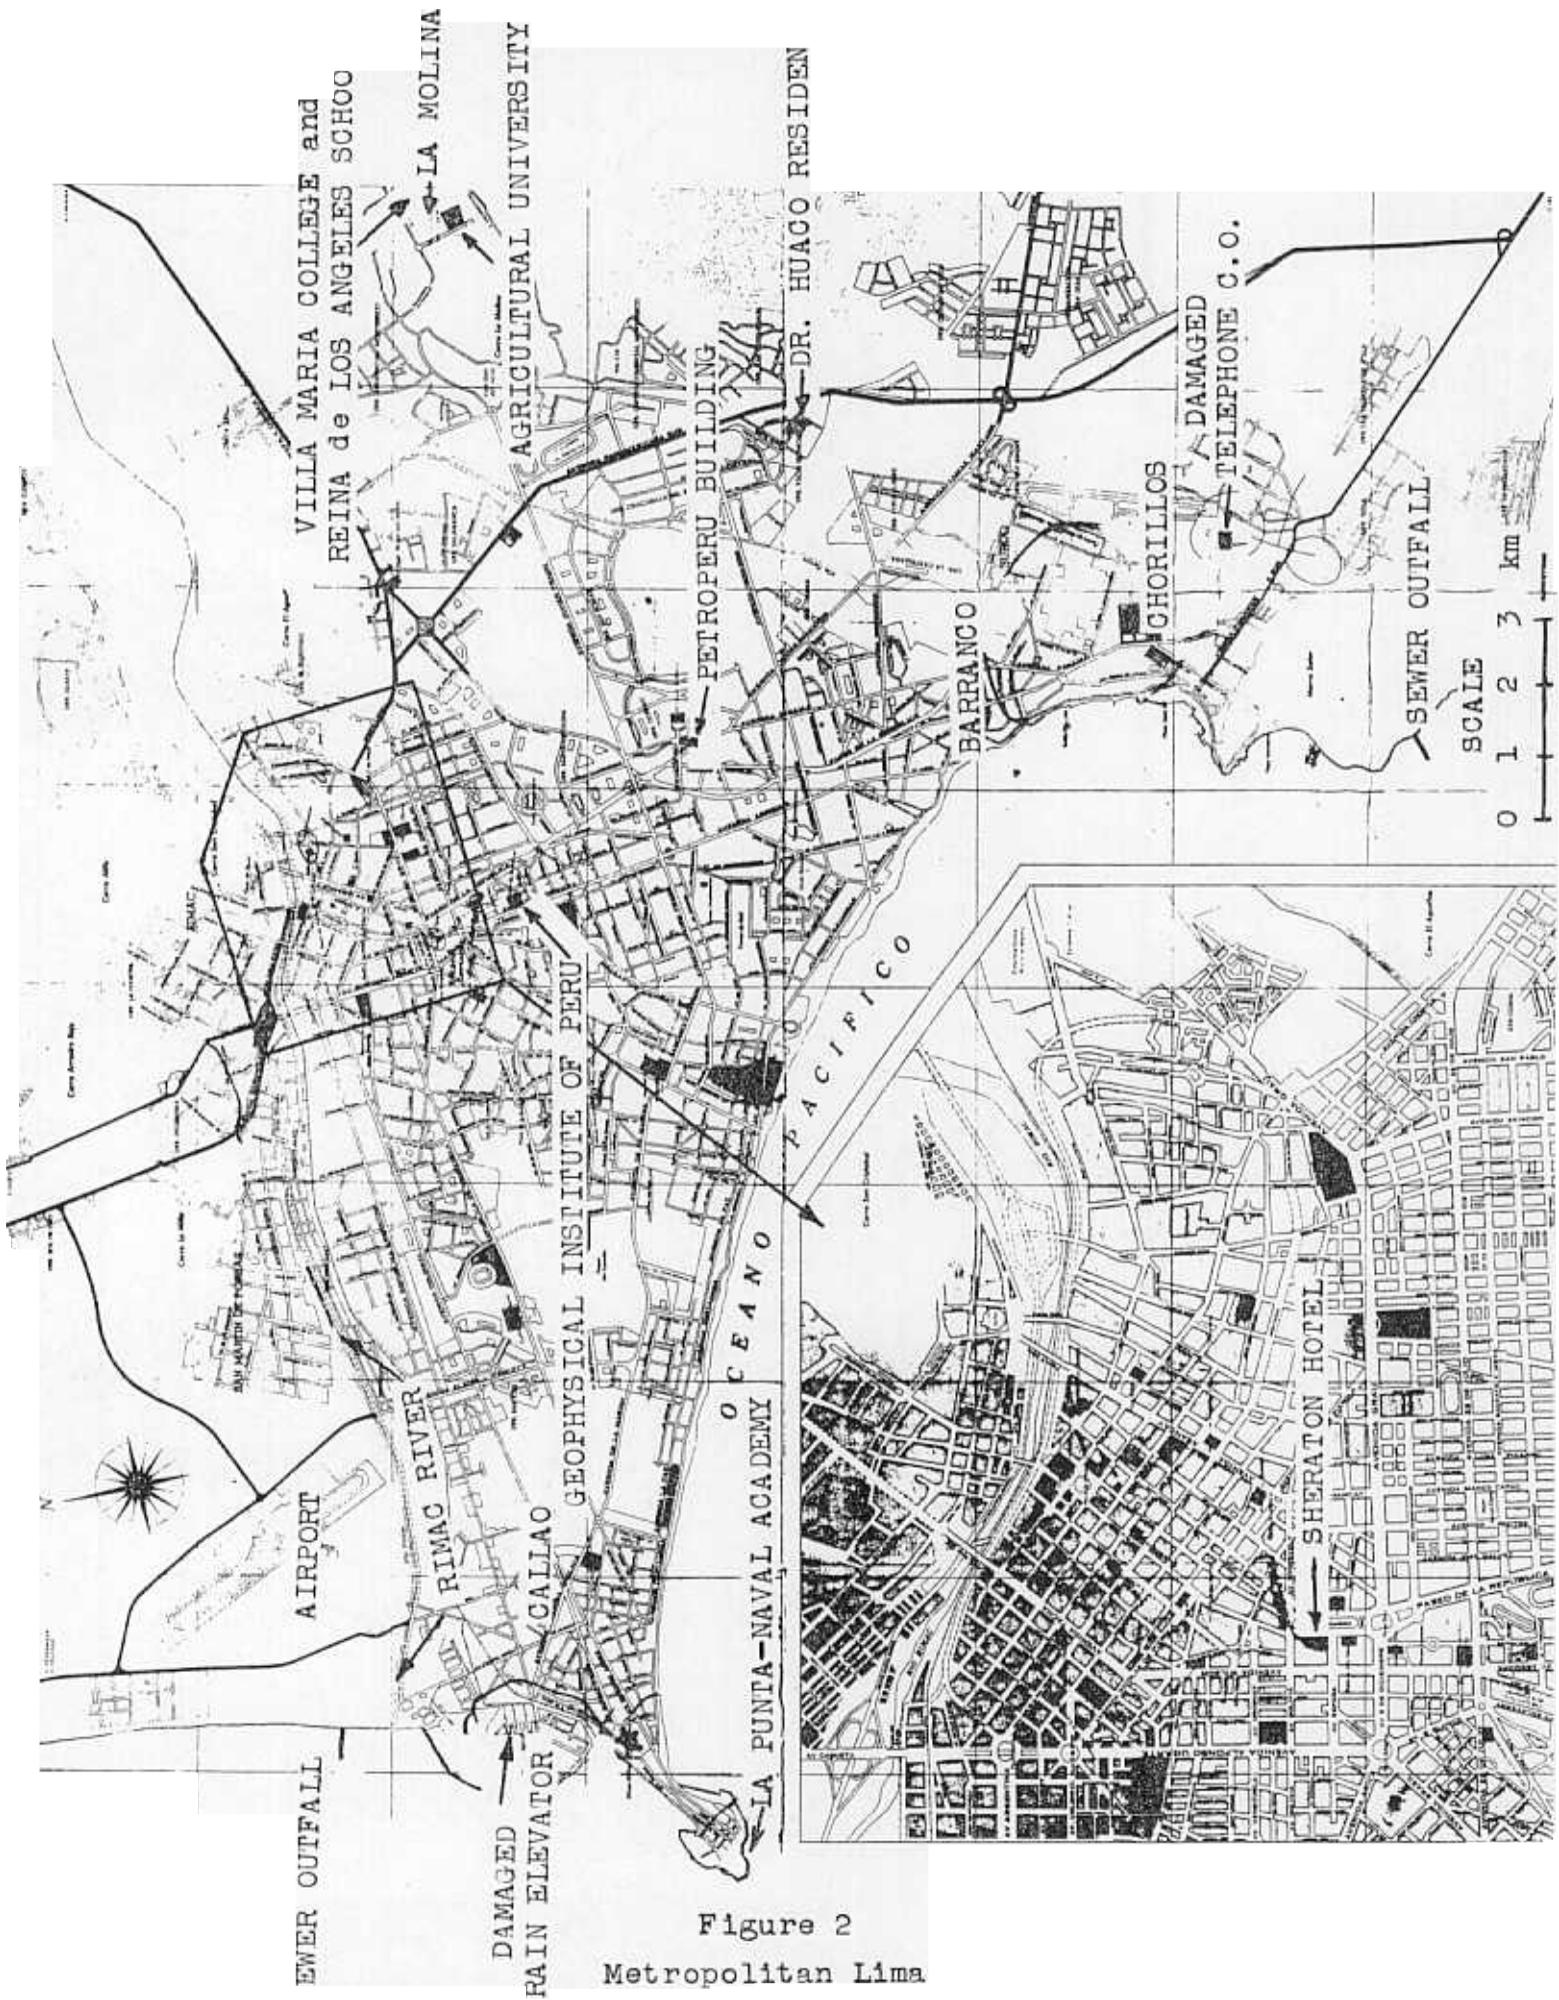
Figure 2
Metropolitan Lima

Metropolitan Lima has a population of about 3 million, many modern high-rise buildings, a few freeways, and sophisticated community lifeline systems (Fig. 2).

central Lima and the other (a SMA-1) at the Dr. Huaco residence in Lima's eastern suburbs (Fig. 2). The Geophysical Institute of Peru sent these records to the Seismic Engineering Branch of the USGS for processing and analyses. A reproduction of the major portion of both of these records is shown in Figure 4. Preliminary scalings of these records give the values shown in Table 3.

The La Molina area, located in the eastern suburbs of Lima (Fig. 2), is a relatively new residential area with several modern educational institutions.

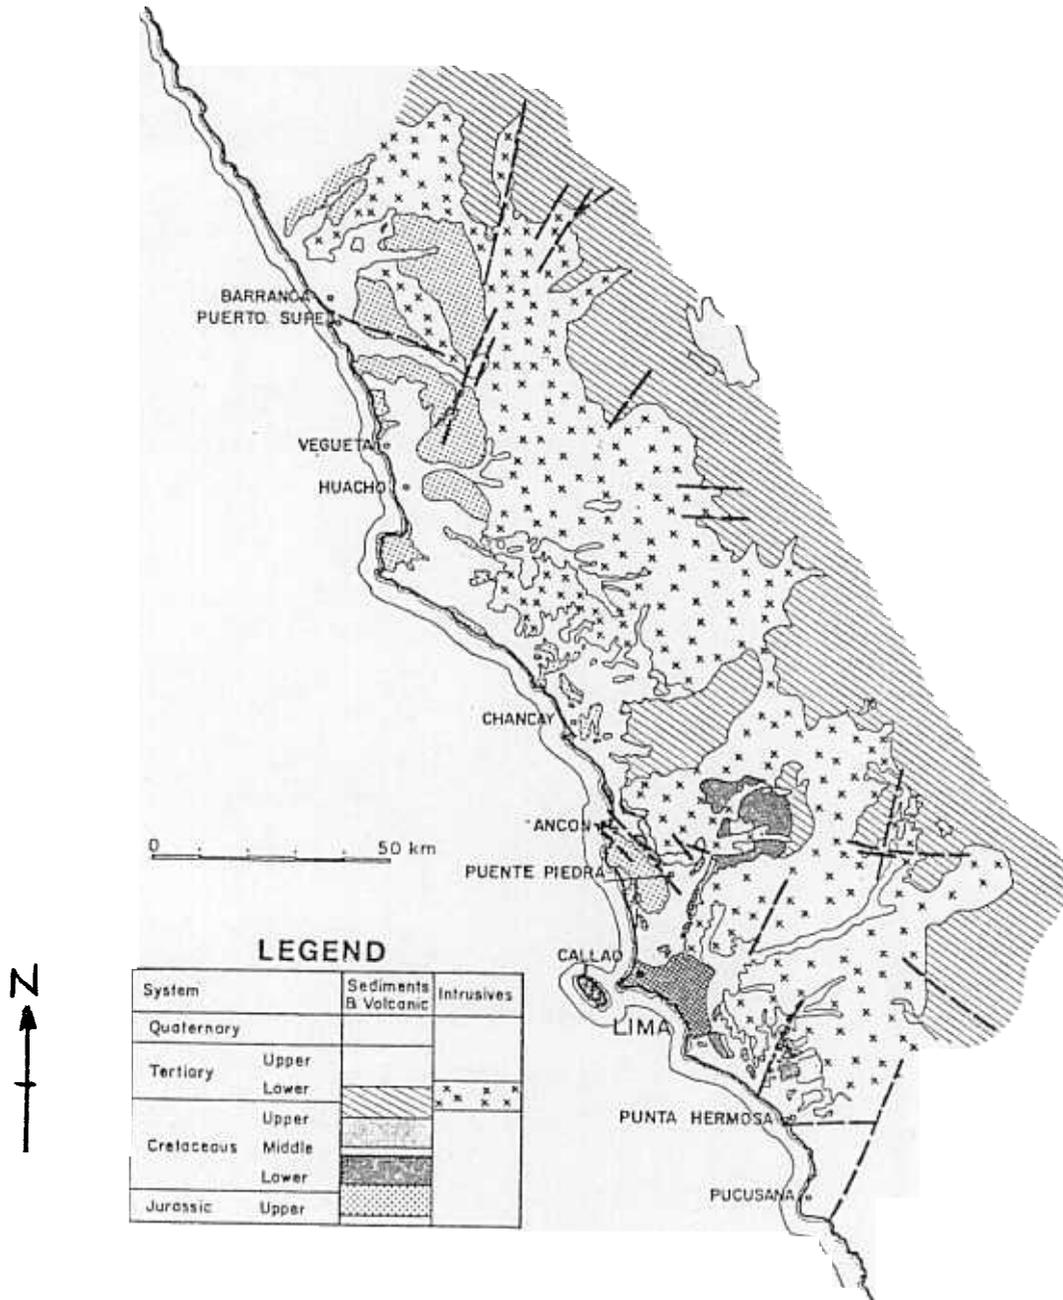
Figure 3
 Geology of the Department of Lima - Coastal Sector

Figure 3 presents a geologic sketch of the coastal sector near Lima (from Reference 1).

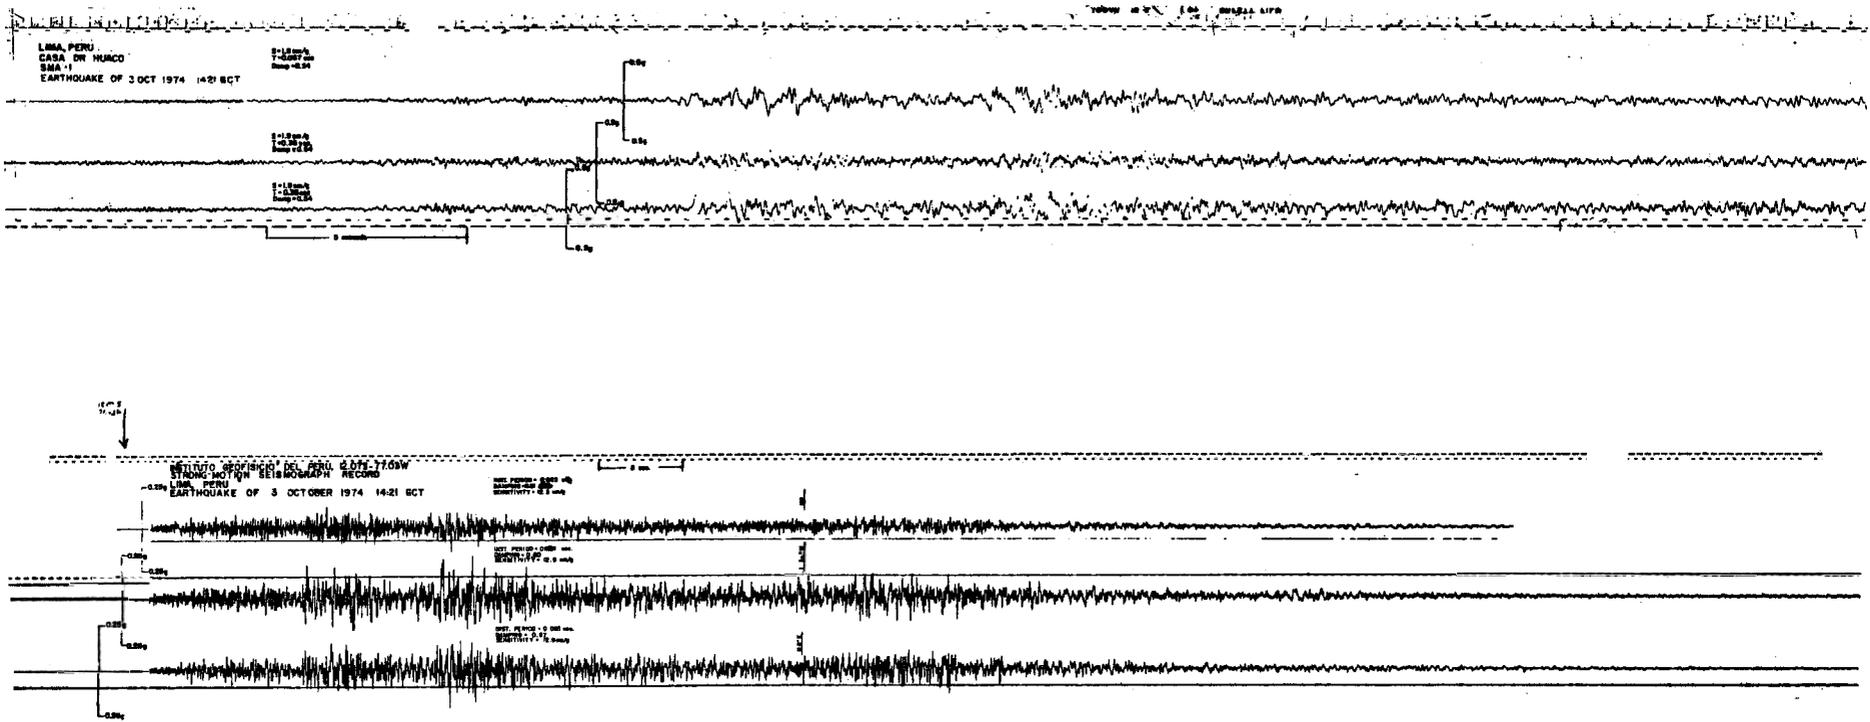
Figure 4

Strong Motion Accelerograph Records-Oct. 3, 1974
