# Geotechnical Aspects of the M = 8.8 February 27, 2010 Chile Earthquake

*Jonathan Bray, UC Berkeley; David Frost, Georgia Tech;  
Ramon Verdugo, Universidad de Chile; Christian Ledezma, Pontificia  
Universidad Catolica de Chile; & Terry Eldridge, Golder Assoc.*

# M = 8.8 Chile Earthquake

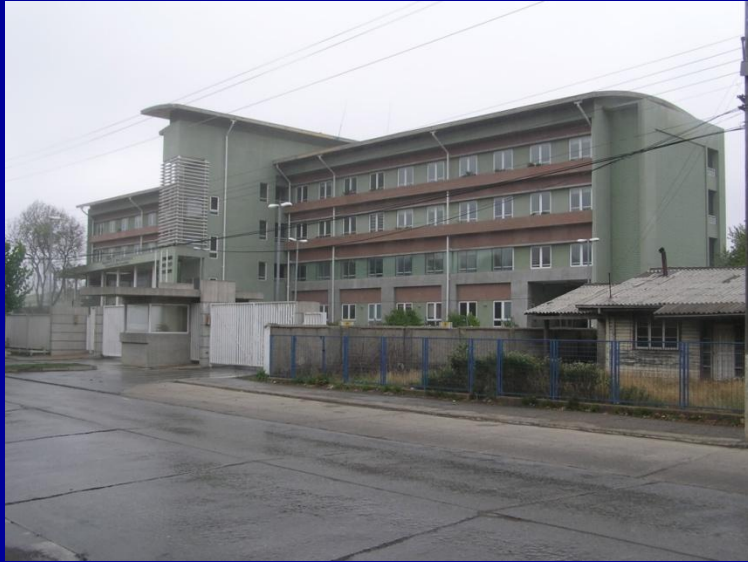
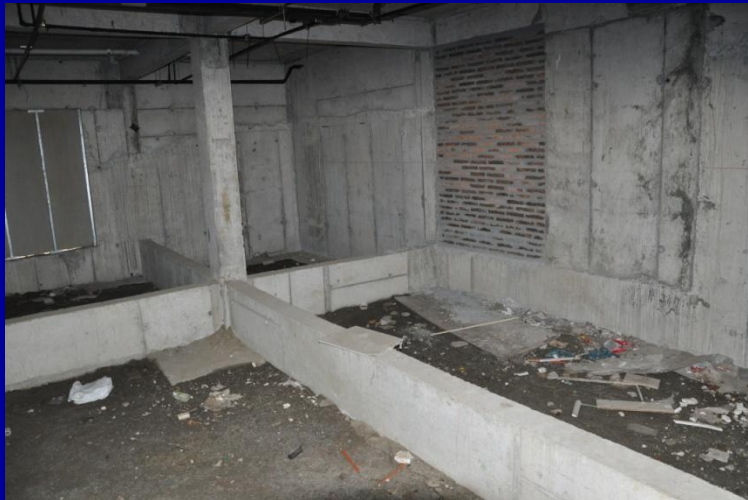
## Hospital in Curanilahue

# Effects of Ground Failure on Buildings

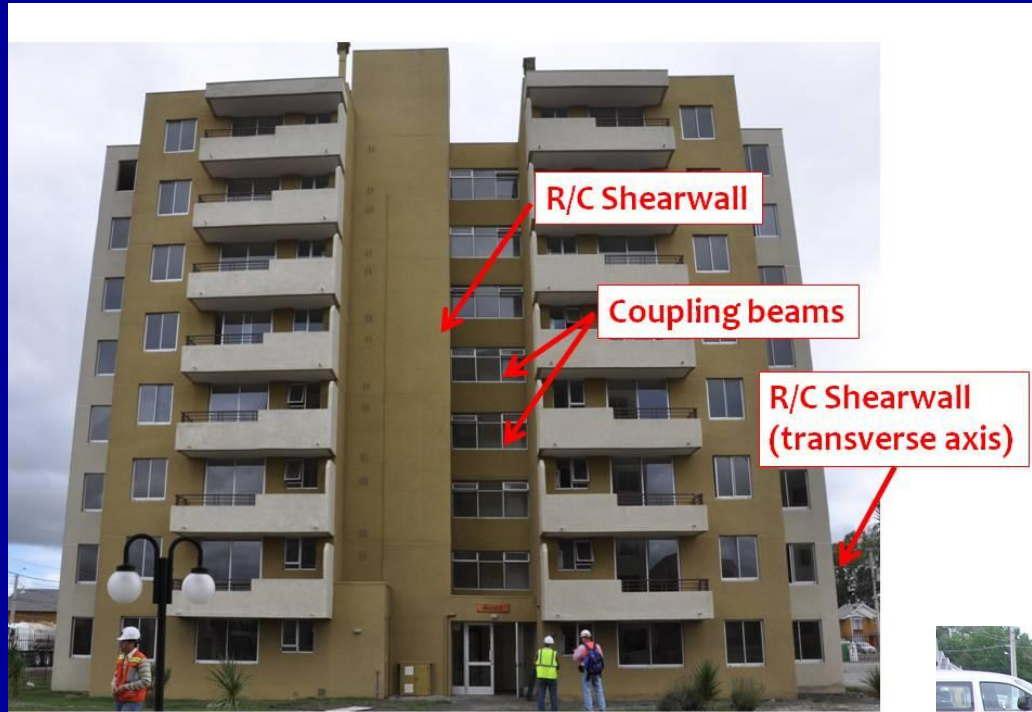
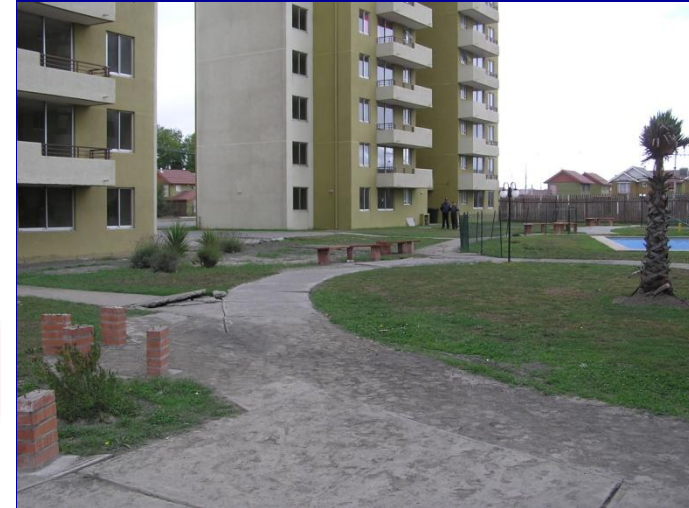
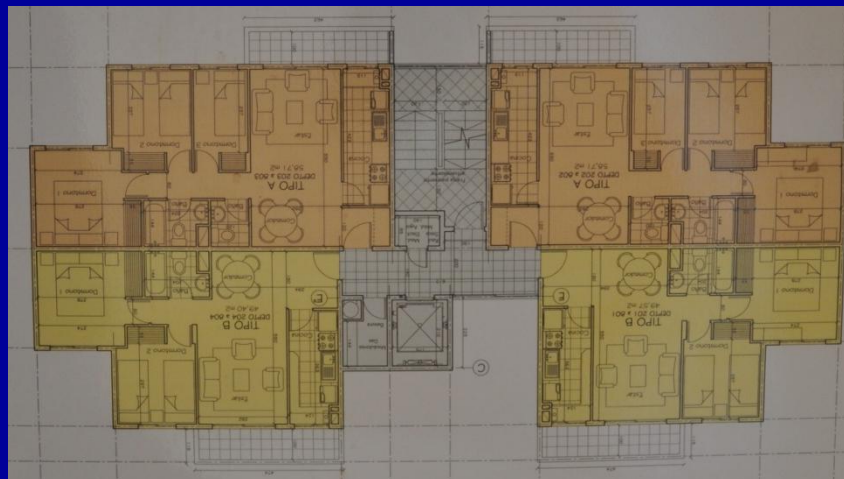
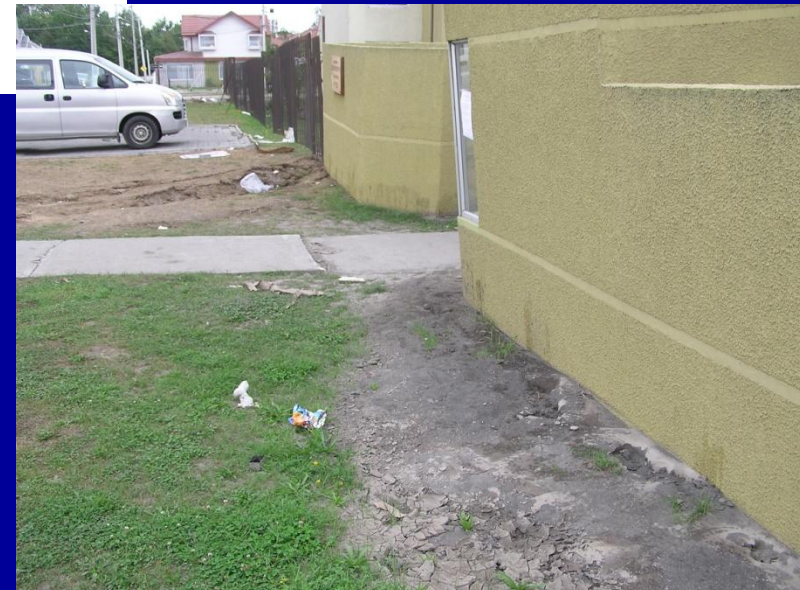
## Four 8-Story Condominiums, Concepción

# Effects of Ground Failure on Buildings

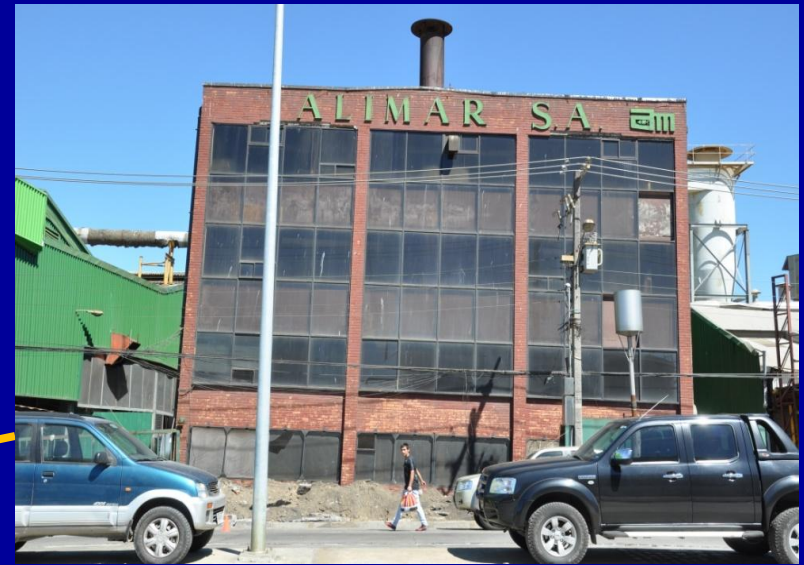
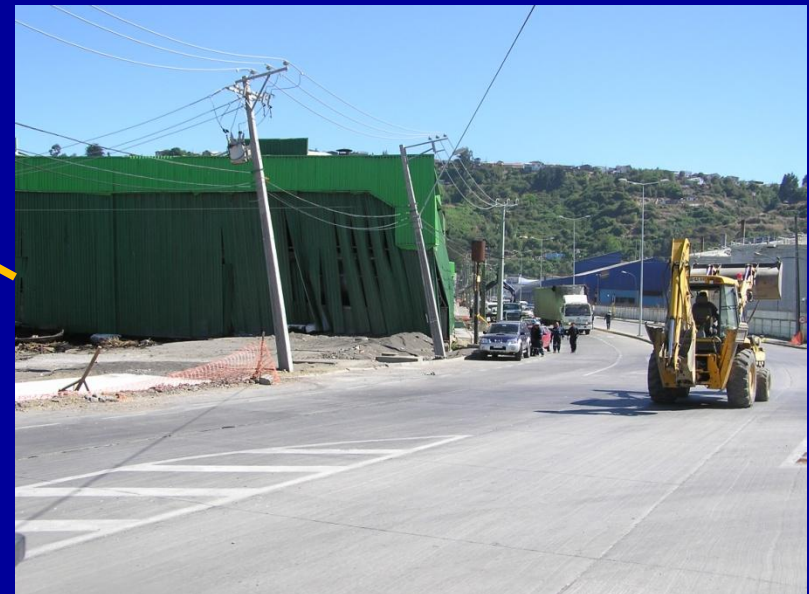
## Fish Packing Facility, San Vicente

# Lateral Spreading Effects on Industrial Facilities
