27 February 2010 M_w 8.8 Maule Earthquake

Discussion on Pre 1985 and Post 1996 Reinforced Concrete Buildings in Viña del Mar

Alvaro Celestino
EERI Recon Team Member (Concrete Buildings sub-team)
Degenkolb Engineers

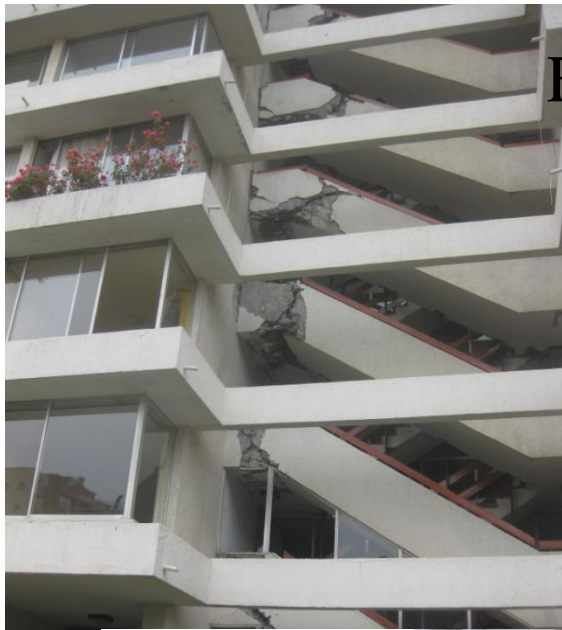
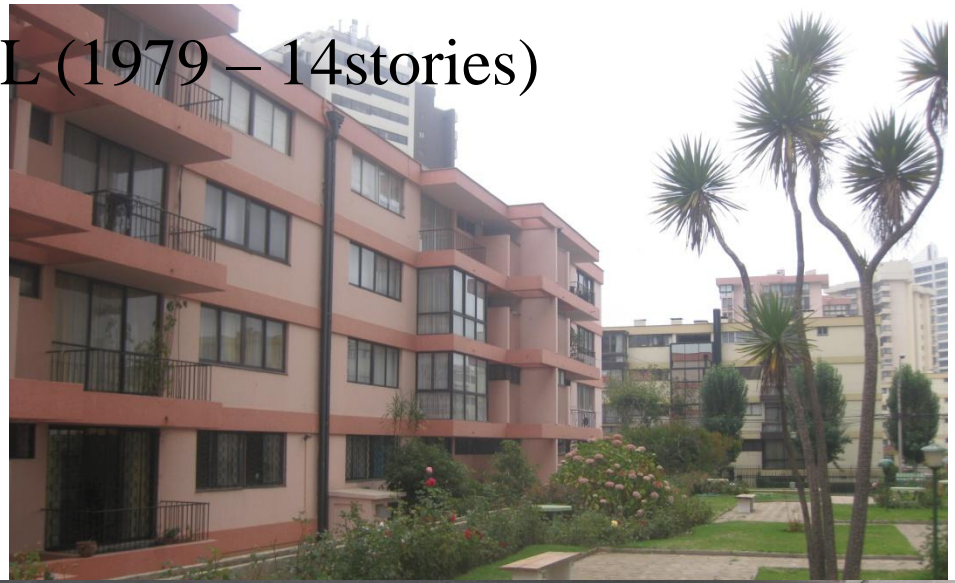
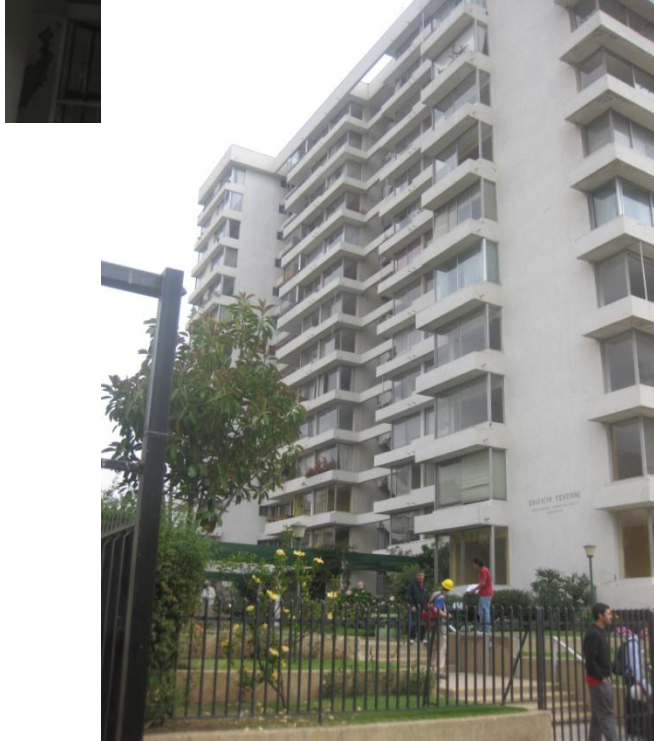
FESTIVAL (1979 – 14stories)

Damage 2010: Severe crushing, rebar buckling, rebar fracture on N-S and E-W walls
