# THE OCTOBER 23, 2011 VAN, TURKEY EARTHQUAKE (MW=7.2)

## EARTHQUAKE DAMAGE

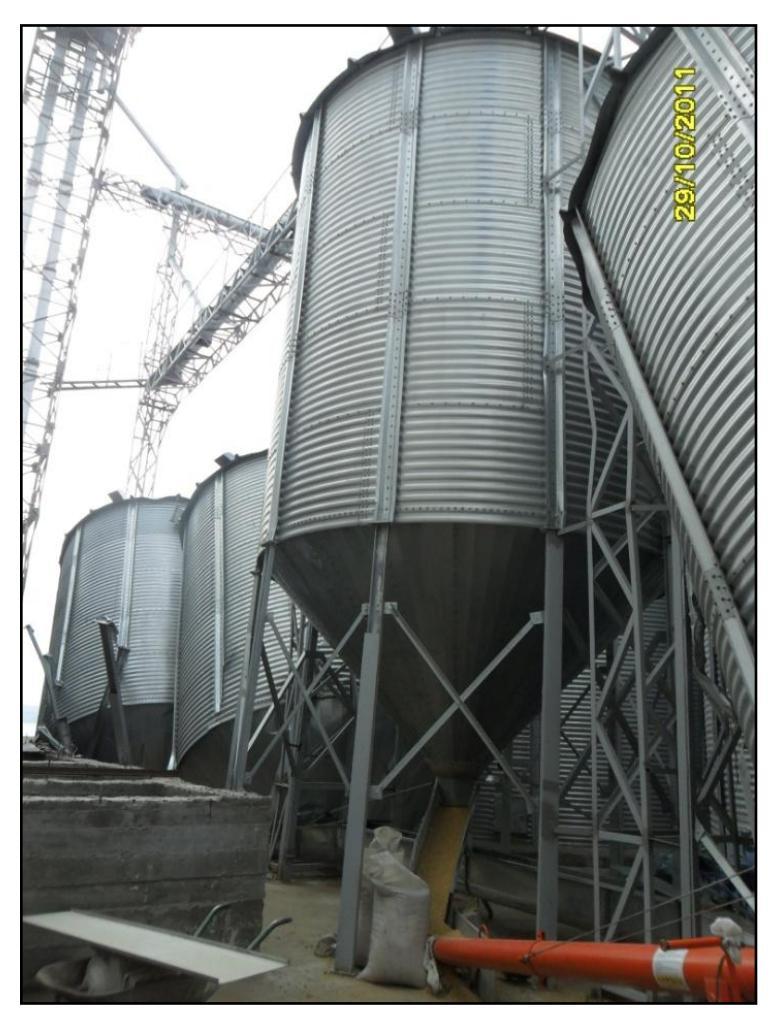
A number of wheat silos in Van Industrail Zone, collapsed due to inadequate dimensioning (Figures 10 and 11).

Figure 11. Collapse of the elevated wheat silos (Facility 2), Van

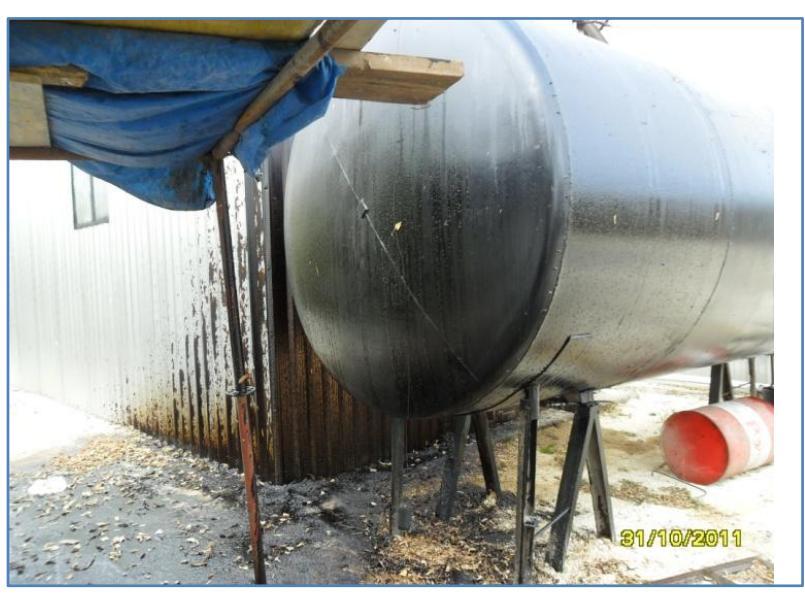
Tank damage was minimal. Some amount of deformation was observed at the weak supports of a small elevated fuel oil tanks in Ercis. Small amount of liquid overflow due to insufficient free board was observed. Similar problems occured in some larger size other tanks in the surroundings of Ercis (Figure 12 and 13).

Figure 12. Overflow of liquid at elevated fuel oil tank (Ercis)

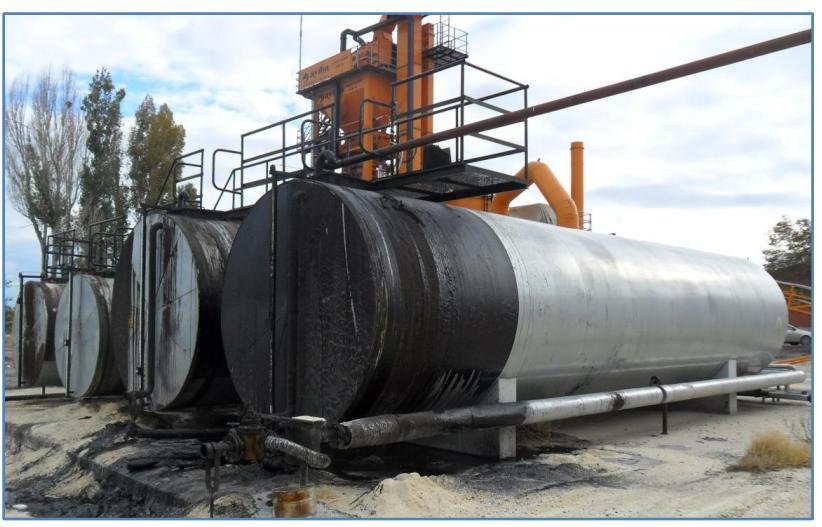
Figure 13. Overflow of asphalt in storage tanks (Ercis-Adil Cevaz highway)

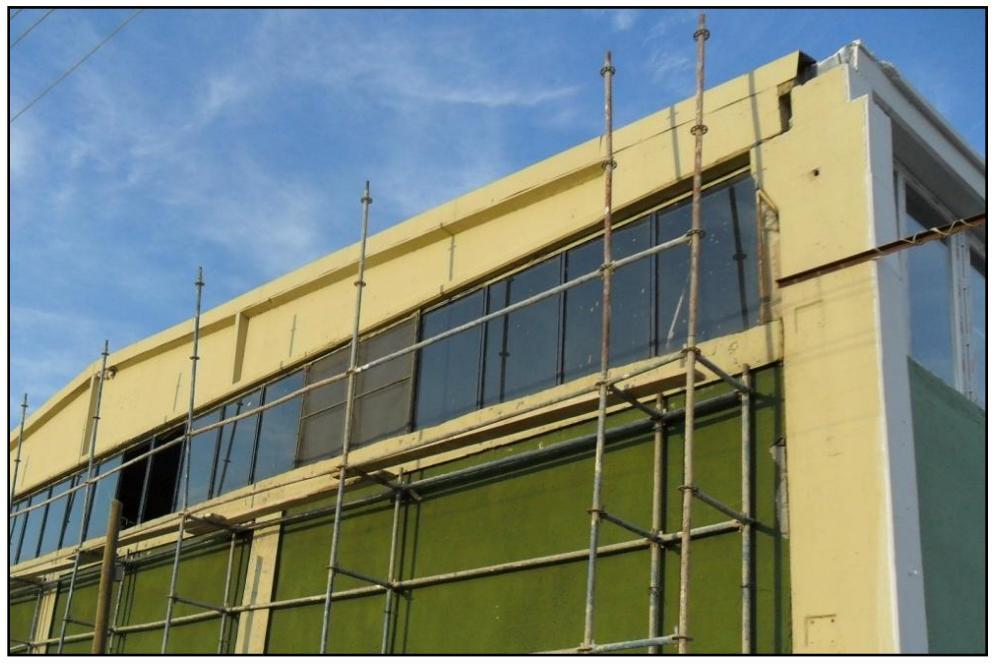
The heavy precast-concrete frames with precast roof beams suffered from connection problems. Noticable movements were observed at the beam- column connections (Figure 14) of the structures located around the Van-Ercis highway. More severe cases were observed at the Industrial zone of Van. The beams slipped-off from their seats because of inadequate steel-concrete bondage (Figures 15-17). Precast-concrete beams collapsed because of inadequate anchorage at the column –beam connections (Figure 17), at the top. Also column bending cracks occured at the bottom of columns (Figure 18).

Figure 14. Joint seperation in prefabricated stuctures

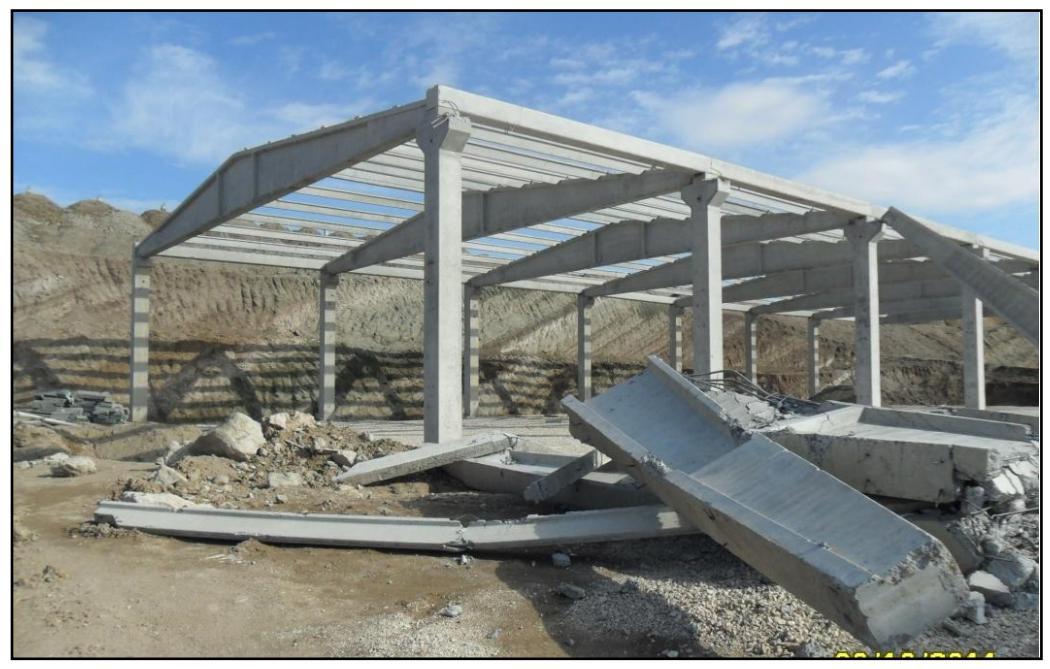
Figure 15. Collapsed prefabricated structure in Van Industrial zone (Facility 1)

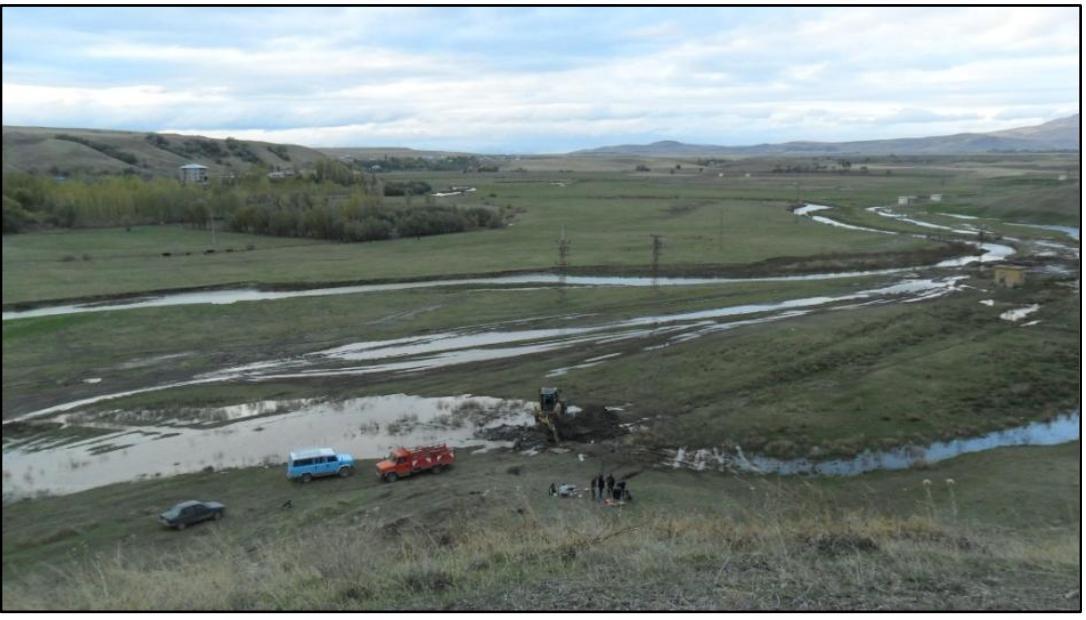
In Van, extensive liquefaction induced lateral spreading, settlement and rock falls took place near the village Topakca, next to the river in Northern Van, 6 km's to the nortwest of the 100. Yıl University (Figures 24- 28).

Figure 24. Liquefaction and settlement zone near Topakca village, Northern Van

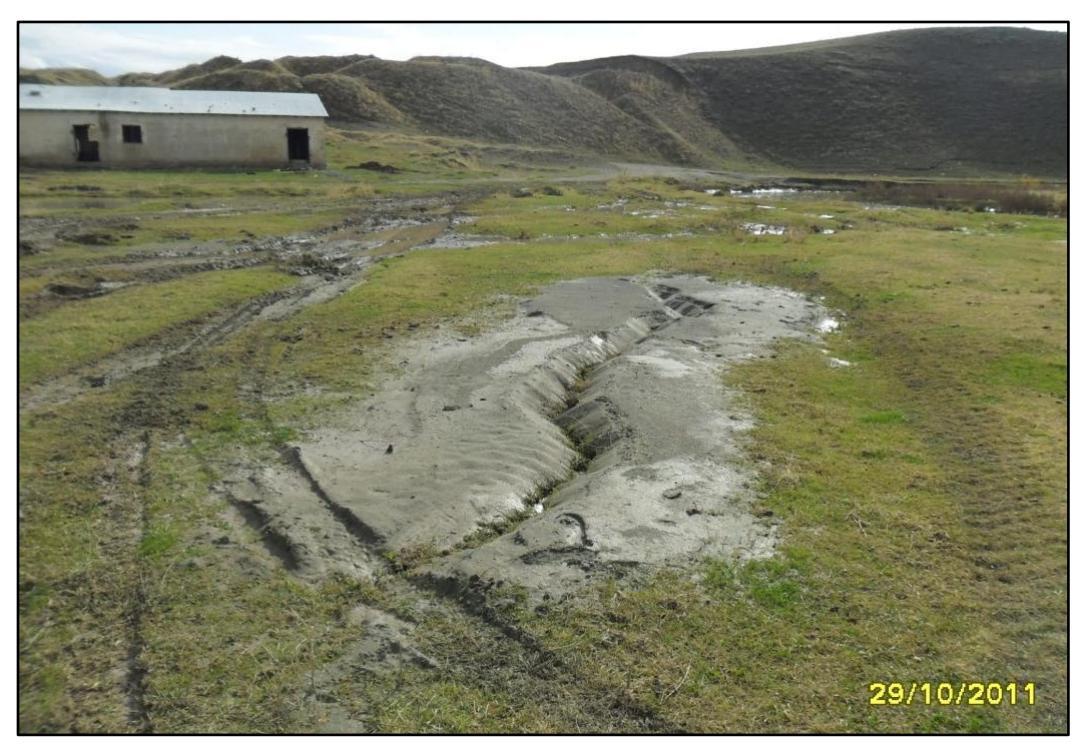
Figure 25. Sand boils due to liquefaction in Topakca (Mermit) village, Van

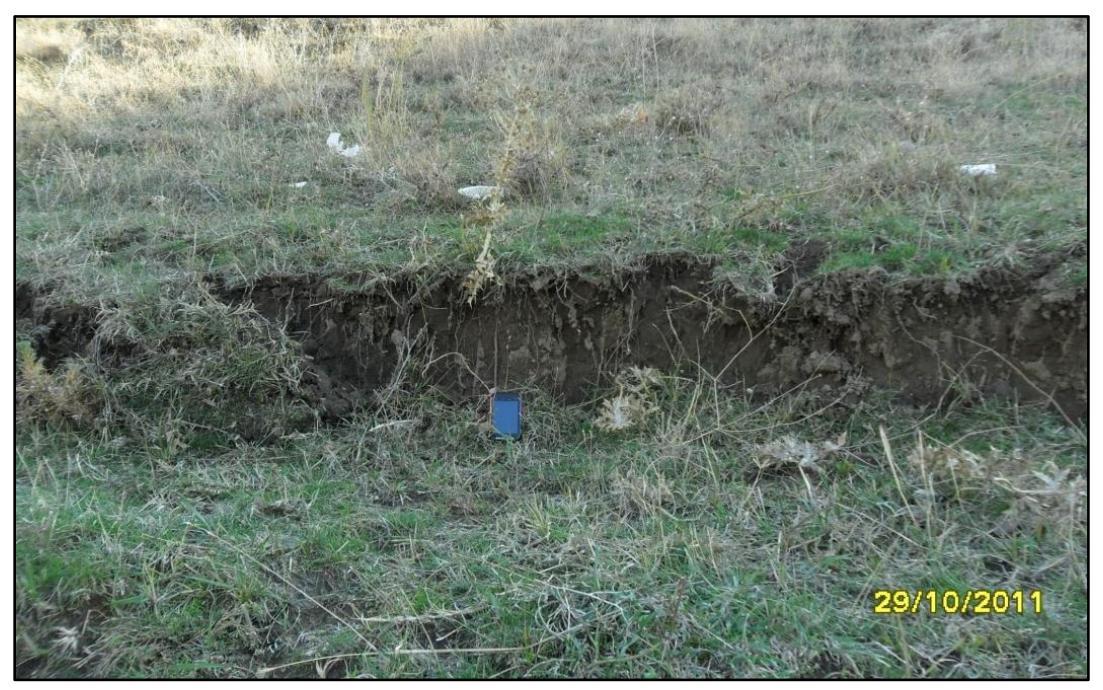
Figure 26. Overall basin settlement (upto 50cm) in the village Topakca

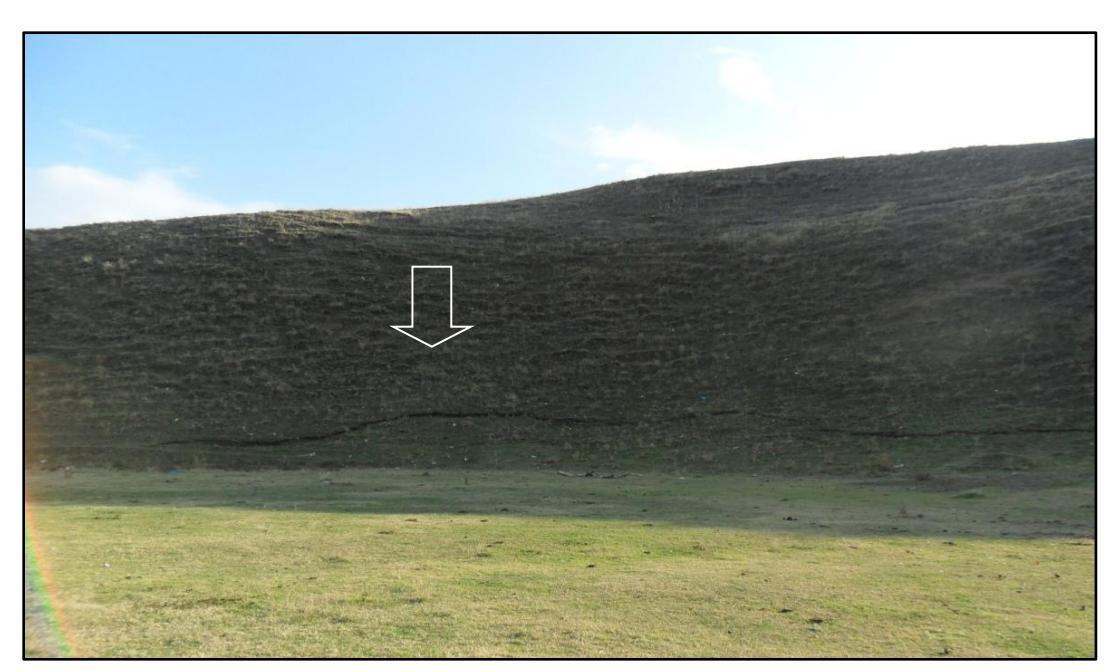
Figure 27. Overall basin settlement nearby the Topaktas village
