April 24, 2016

Preliminary Reconnaissance Report on Building Damage  
(2016 Kumamoto Earthquake)

Objective: Preliminary reconnaissance of reinforced concrete (RC) buildings damaged by the 2016 Kumamoto Earthquake

Site: Kumamoto city, Mashiki town, and Uto city in Kumamoto prefecture

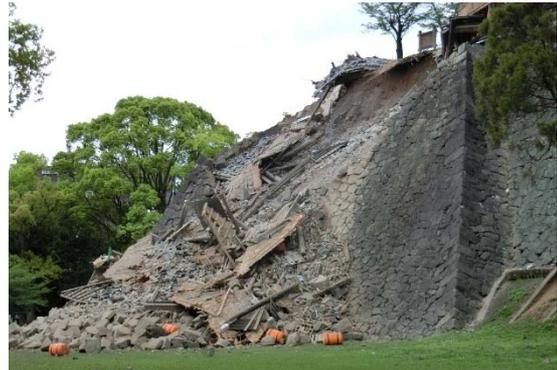
- Stone retaining wall and two of the turrets of the Castle suffered damage
- The turrets are located on the east boundary of the castle
- Wooden structure of the castle turret came down as the stone wall underneath collapsed
- Partial collapse of the stone retaining wall also observed at other turret-less locations

Collapsed Higasi-Jyuhakken turret and the  
surrounding stone retaining wall

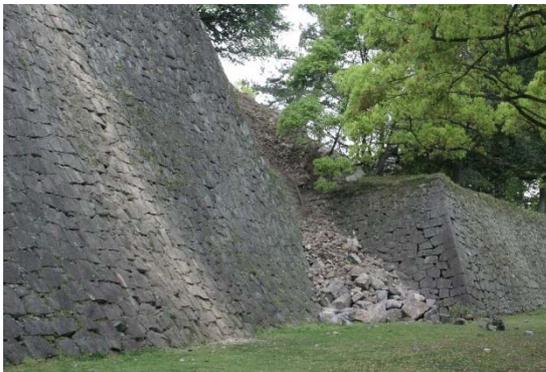
Collapsed Kita-Jyuhakken turret and the  
surrounding stone retaining wall

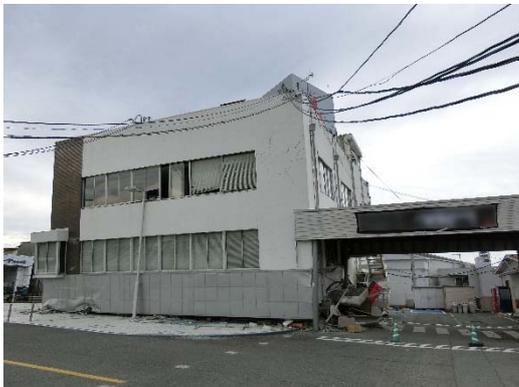
- 4 bay by 2 bay building structure
- West and south facade at the first floor had no walls due to shop windows.
- Longitudinal and transverse reinforcements of column found to be round bars.
- First story collapsed with the south side of the second floor touching the ground.

South view

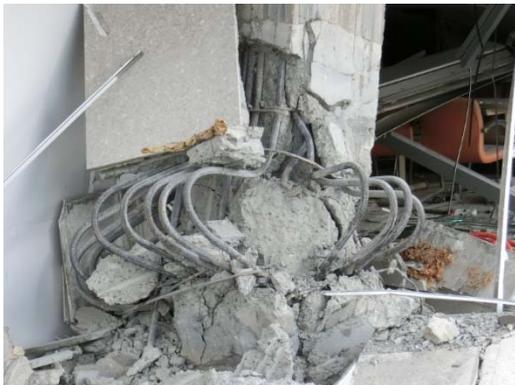
Axially crushed column

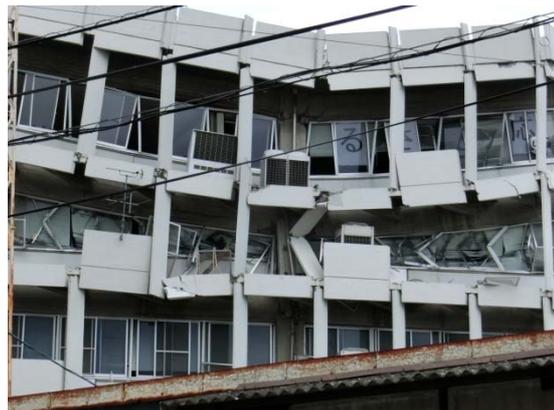
- The structural system above the second floor consists of three frames with two bays in both directions.
- Local collapse at fourth story was observed in exterior frame.
- Failure of beam-column joints was observed at the top of columns in the third and fourth stories.
- Columns in second floor were damaged at the column base.
- Columns in the top story (fifth story) failed in flexure at the top end.
- Ornamental column strips at the tip of cantilever beams were fell-off or broke down at many places.

Collapsed fourth story

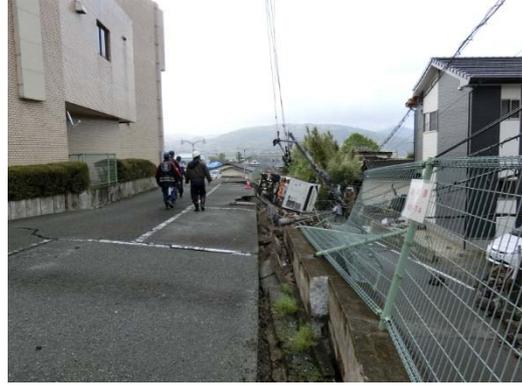
- Building appears to be built on a banking.
- Surrounding ground deformed extensively at many places.
- Building was retrofitted with an outer frame on the south side.
- Shear cracks were observed on the connecting beams of the outer frame.
- Flexural cracks were observed on the third floor which was not retrofitted with any outer frame.
- Damage was observed at the top and bottom of columns supporting the connecting corridor.

Surrounding ground deformation

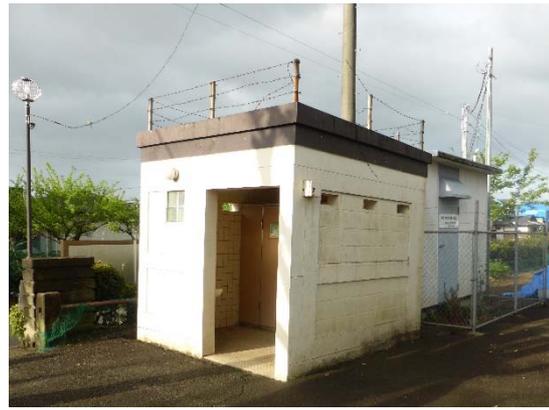
- Surrounding ground surface is very soft. Adjacent public lavatory subsided and inclined as result of the ground deformation.
- Installation is located at the edge of a small embankment next to the peripheral road.
- A number of wooden houses collapsed in this area.

Inclined public lavatory

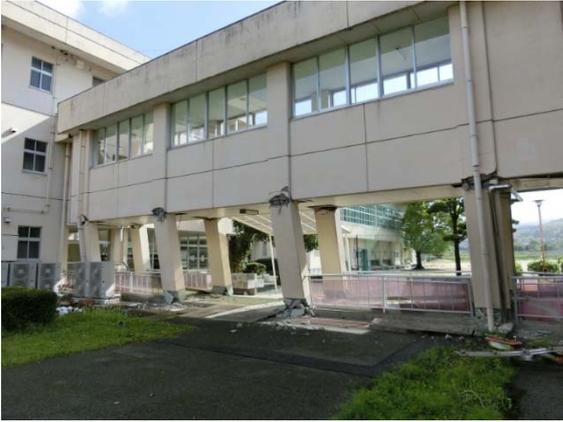
- Two parallel school building are joined by two connecting corridors. This connecting structure exhibits flexural failure at the top and bottom of columns, and is inclined largely in transverse direction. Residual drift ratio is 6 % in the west corridor, and 20% in the east corridor.
- South building consists of 8 bays in longitudinal direction and 2 bays in transverse direction. No obvious damage was observed.
- North building consists of 9 bays in longitudinal direction and 2 bays in transverse direction. Two central spans are braced on the first and second story. Cracks observed in the concrete mortar connecting the brace to the RC frame.
- Shear cracks in a mullion wall (residual crack width 2.5 mm) and flexural cracks in columns and spandrels also observed in the south part of the north building.
- All the steel braces in the second story of the gymnasium show buckling.

Elevation of the east corridor

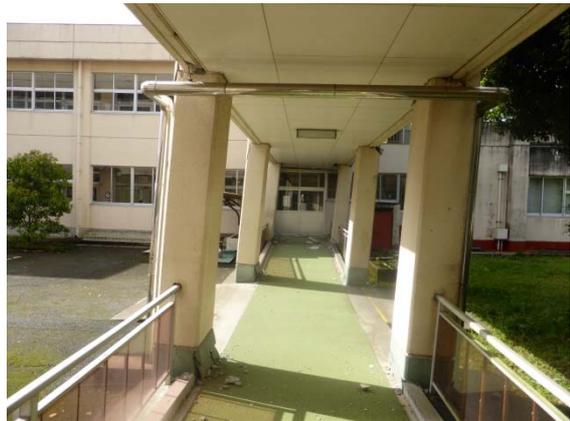
Story drift of the west corridor

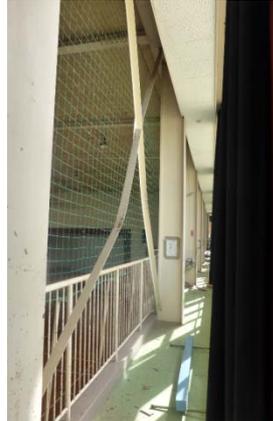
Buckled brace

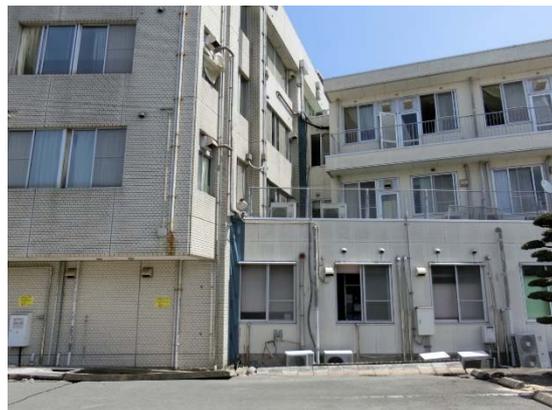
- Considerably displaced soil and asphalt observed around the periphery of the building
- Adjacent parking space also found to have deep ground openings
- Movement appears to have happened at the expansion-joint connecting the front and back portions of the building. Latter portion found to have tilted 1.9% to the south as the retaining wall at the back of the building failed.
- Diagonal cracks observed in the wall panels at the first floor. However, no significant damage observed in the building frame.

Displacement across the expansion joint

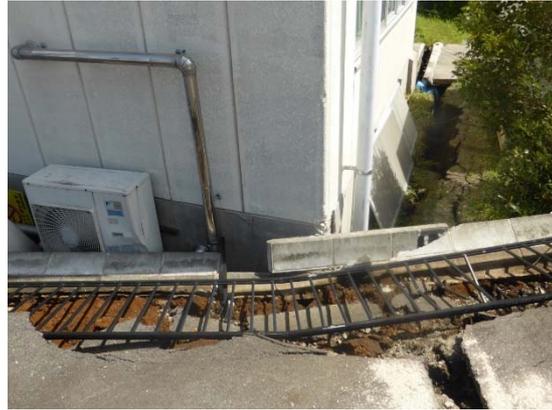
Ground displacement at the back of the building

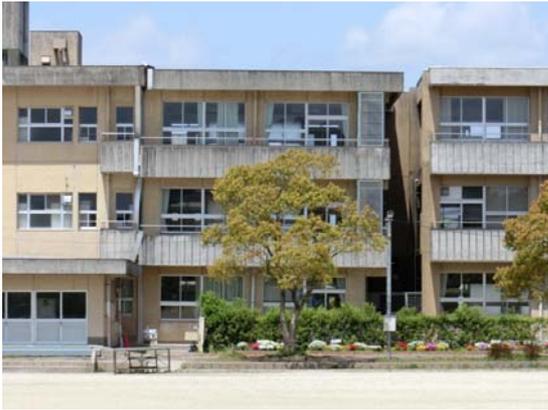
- South part of the building is divided by an expansion joint. Furthermore, an extension has been built on the east side
- Both the north and south school buildings were retrofitted seismically by steel-braced frames in the longitudinal direction.
- Middle part of the south school building inclined 1.9% to the east. Ground displacement was also observed around the buildings
- Movement appears to have happened at the expansion-joints connecting the school buildings and the stilt-type corridors. Damage was also observed at the base of columns.
- Gymnasium was retrofitted with braces and no buckling appears to have happened. However, cracking in the concrete foundation of the braces was observed.

Inclination of the school building

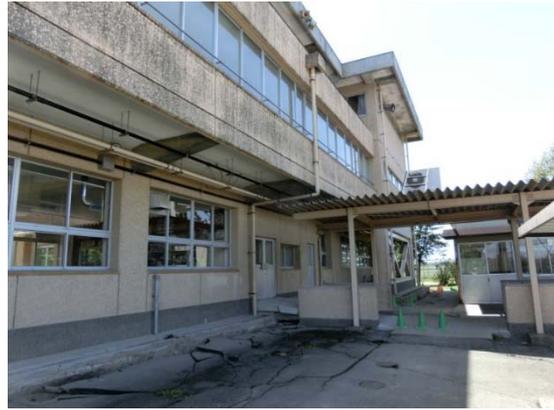
Damage outline: Inclination of a part of the school building due to ground deformation

Ground displacement around the school building

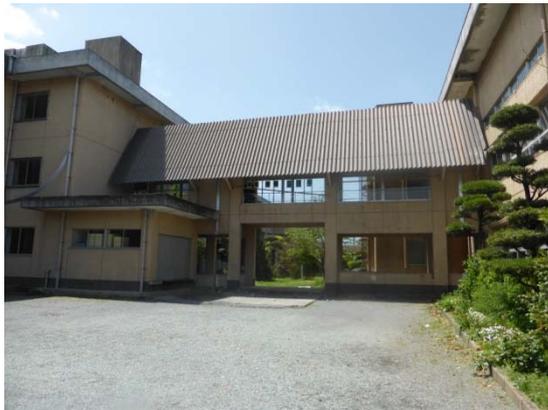
Corridor connecting the school buildings

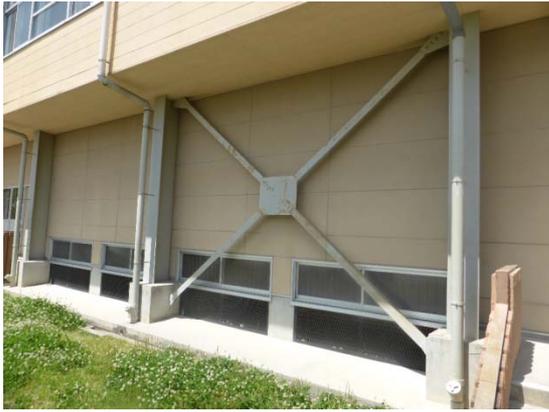
Steel braces in the first story of the gymnasium

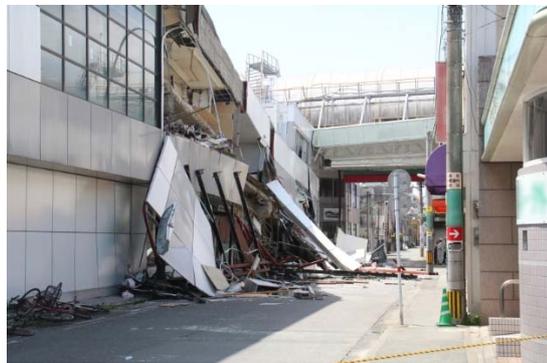
Damage outline: Total collapse

Overall view from the northeast

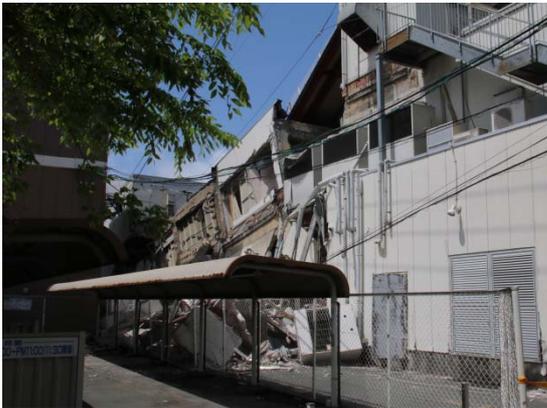
Overall view from the south

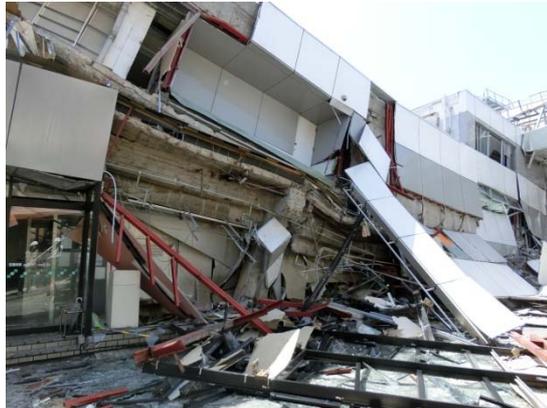
- Building separated by an expansion joint.
- West part of the building collapsed due to failure of the columns at the entrance hall with open ceiling.
- Main reinforcement bars in the columns were round bars.

Collapsed first story

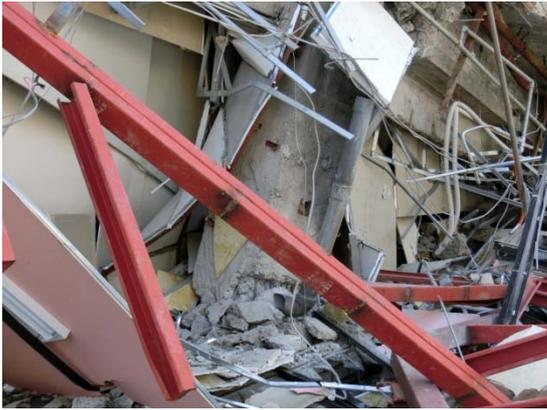
Collapsed column in the first story

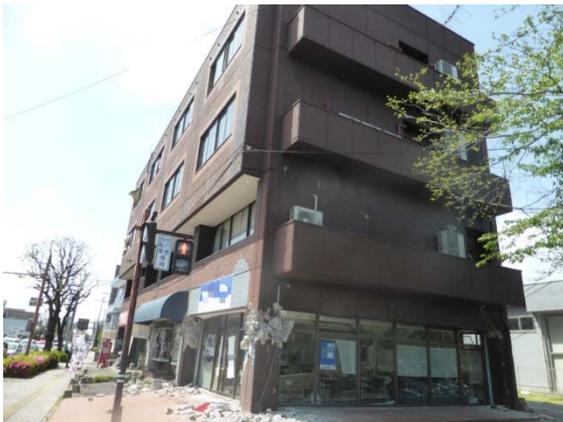
Damage outline: Shear failure of the stilt first story columns

Overview of the building

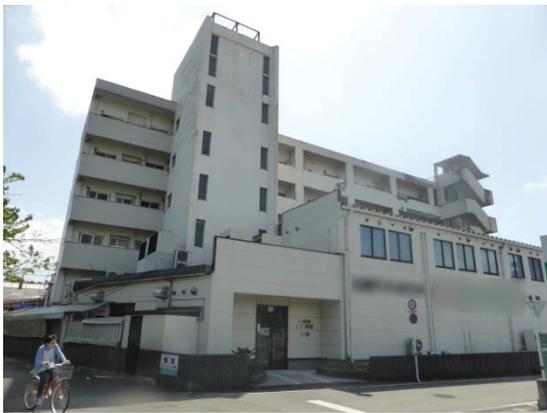
Damage outline: Story collapse at the first or the second floor

- Building is a 6-story building, but appeared to be a 5-story building because of the story collapse of one of the lower stories. It appeared as if the collapse happened on the first floor in the east side and the second floor in the west side.
- Main shock on April 16 caused the building collapse.
- No one lived in this building ahead of the impending demolition and reconstruction.

South view

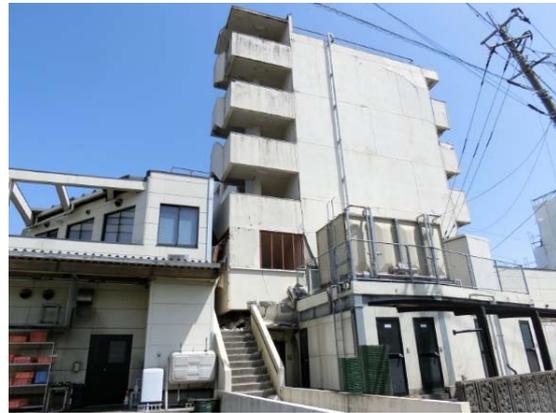
East view

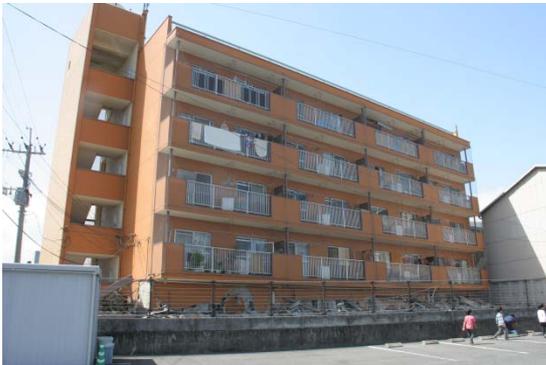
Damage outline: Collapse at the first story

Overall view from the east

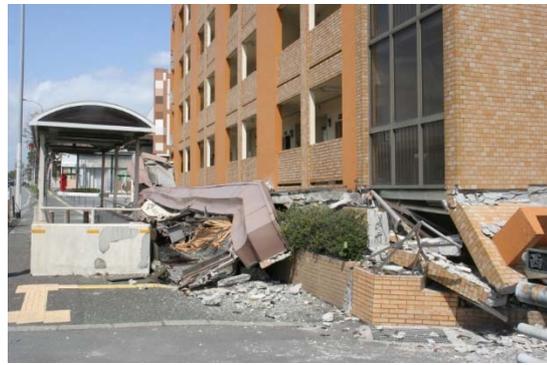
- First floor of the building is for office use and above floors are for residential use.
- Frame consists of four bays in the longitudinal direction. Outside staircases are located at the both gable ends of the building.
- Main shock of April 16th caused the collapse.

Collapsed first story

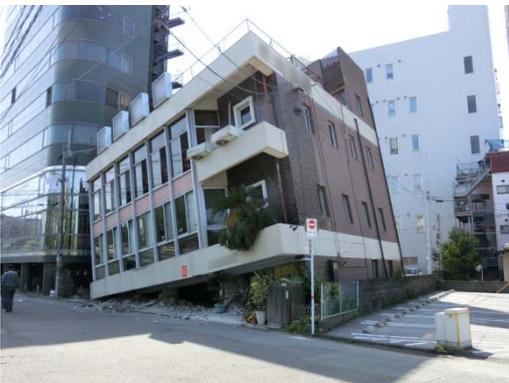
Damage outline: Collapse of the stilt first floor

North-east view

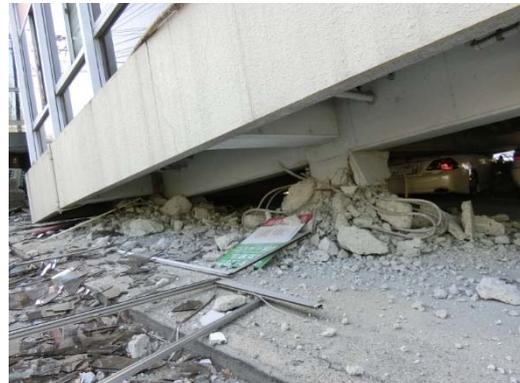
- Building is supported on stilts, having a parking area and an entrance hall at the first floor.
- Walls are arranged at an angle from the span direction.
- Walls at the first floor are located on the north side eccentrically.
- South side of the first floor collapsed completely resulting in an inclined building.
- Quick inspection had already been conducted and it resulted in a red tag.

Axially crushed south columns

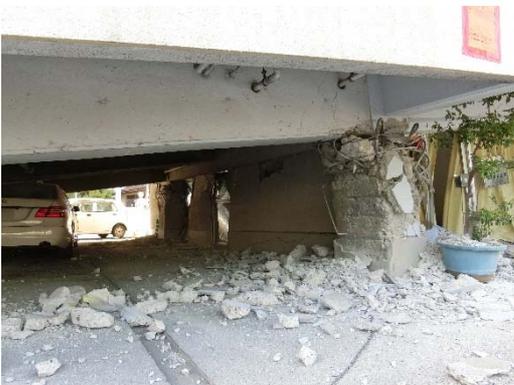
Axially crushed north columns

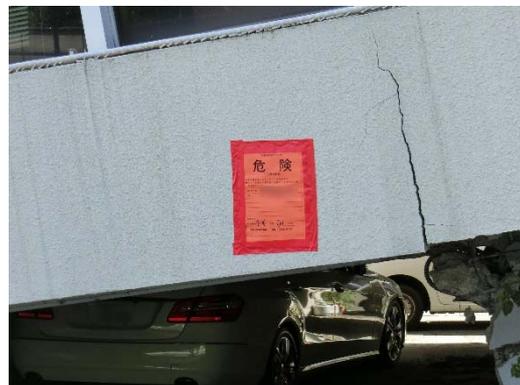
Quick inspection result (Red tag)

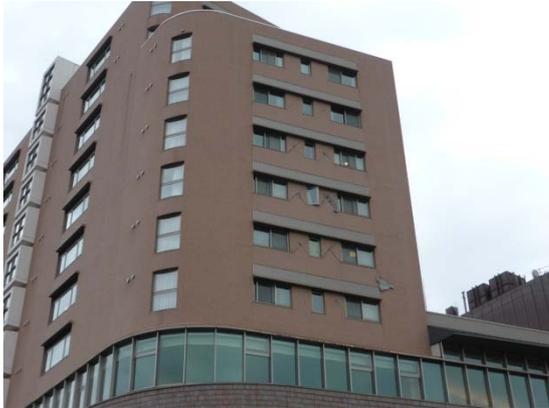
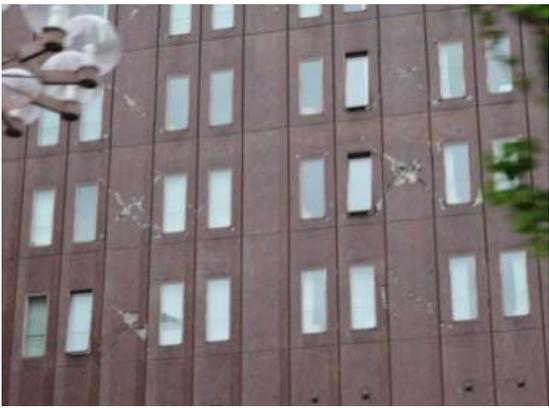
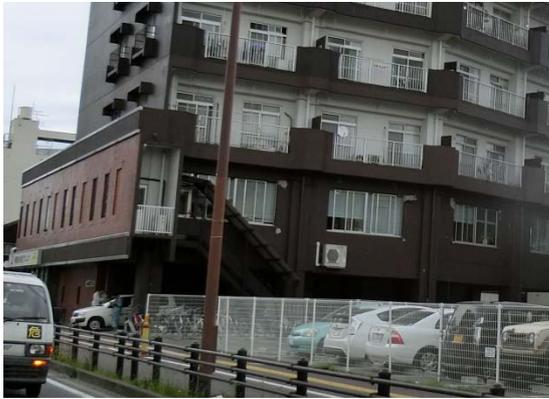
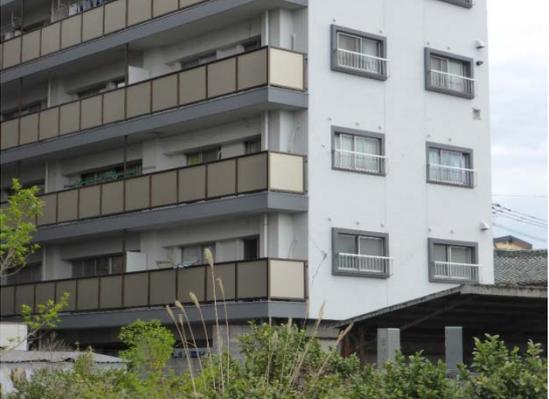
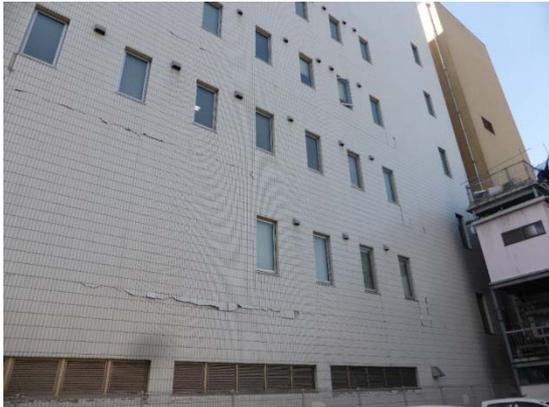
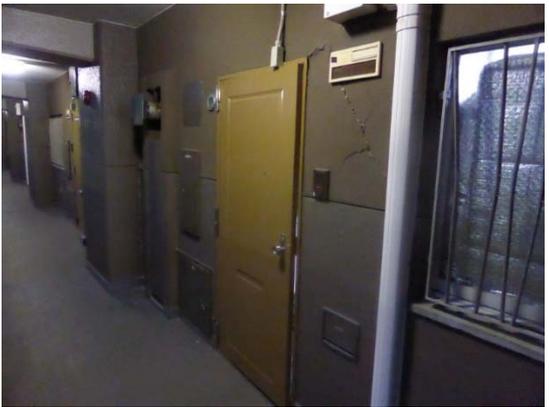
(1) Damage to non-structural members in reinforced concrete buildings

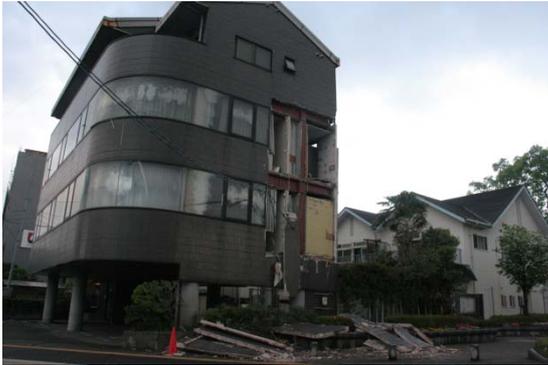
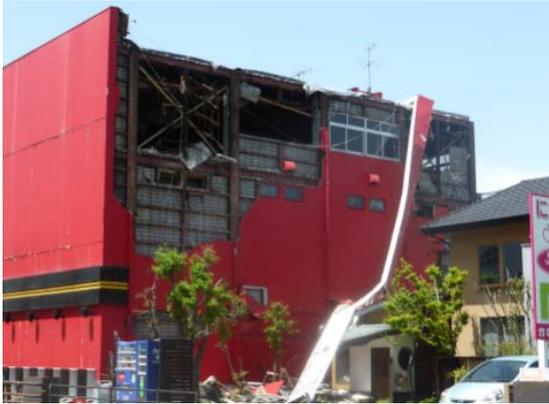
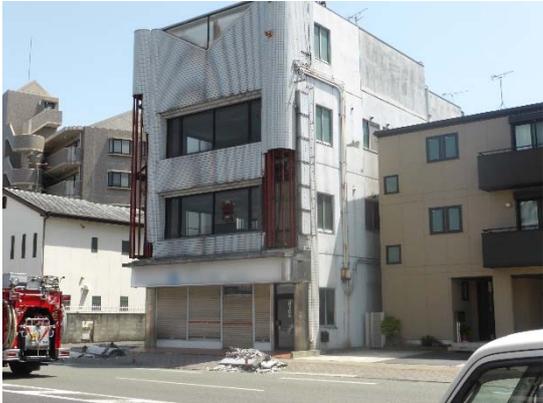
(2) Falling off of exterior panels in steel structures

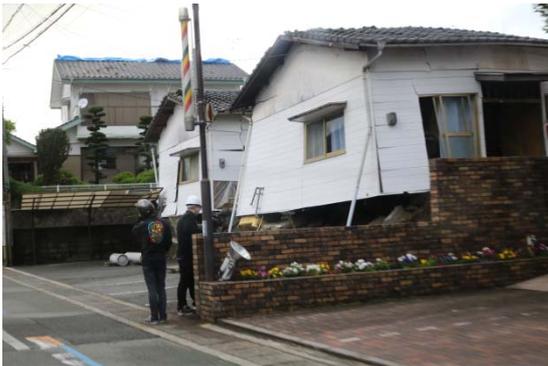
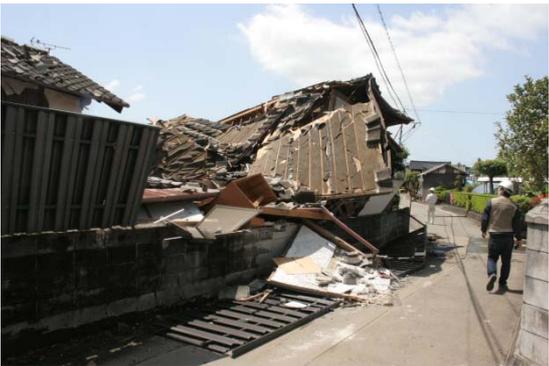
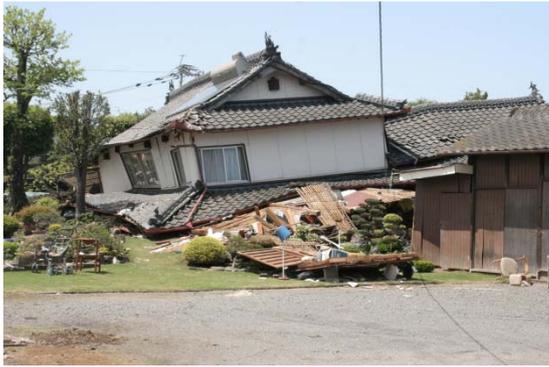
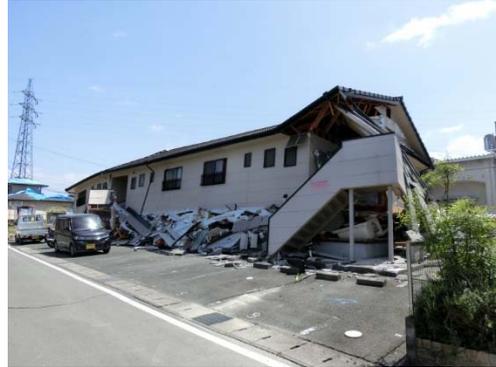
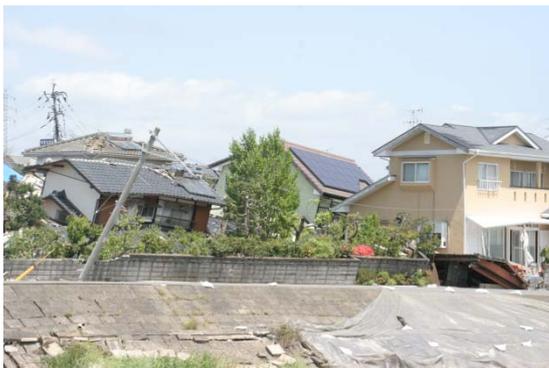
(3) Collapse of wooden houses

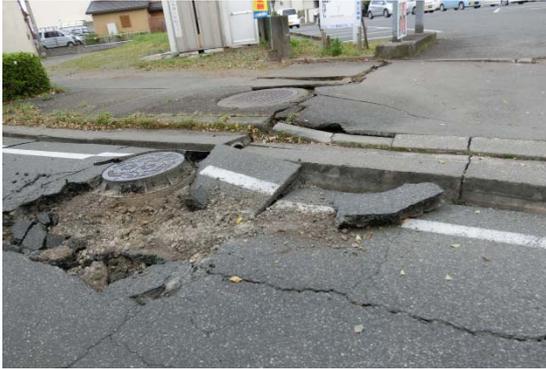
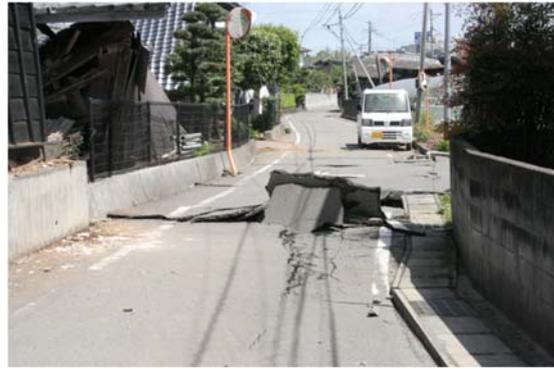
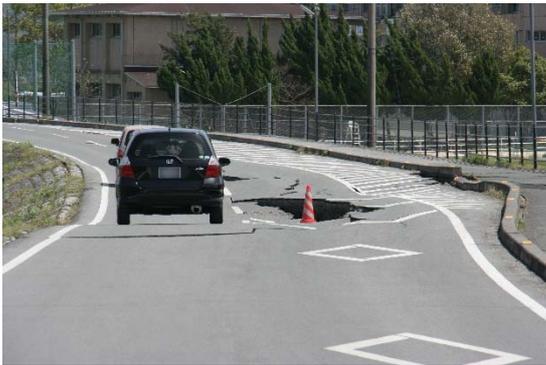
(5) Damage to the road
