# **Preliminary update - Mw7.8 Kaikoura Earthquake (15 November 2015)**

## **Upper Part of South Island**

**By Dmytro Dizhur and Marta Giaretton**

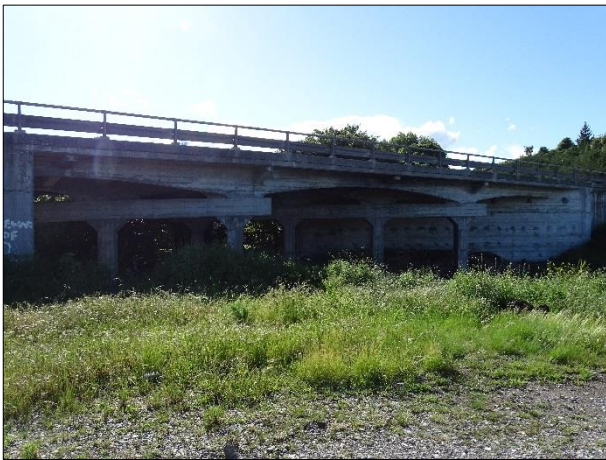
No damage observed

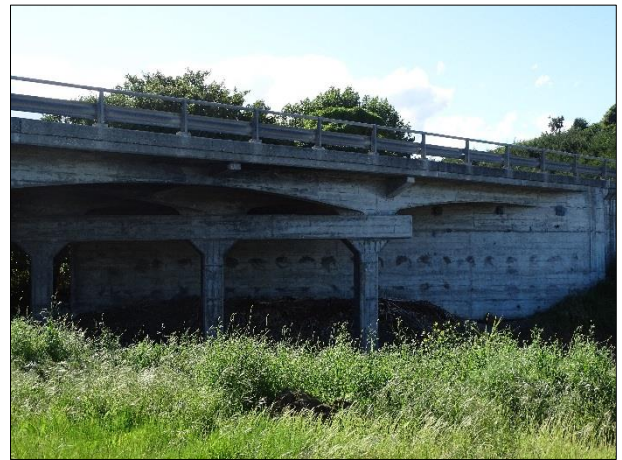
No damage observed

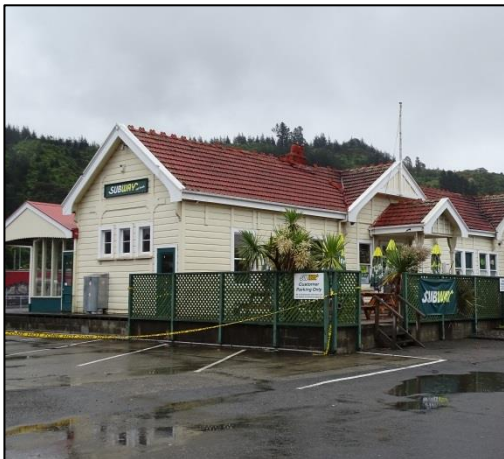
Picton Railway Station

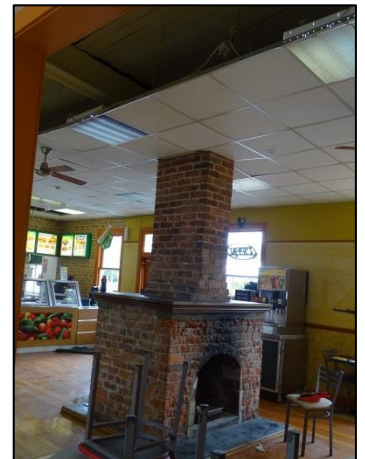
Chimney internal stack, torsional damage

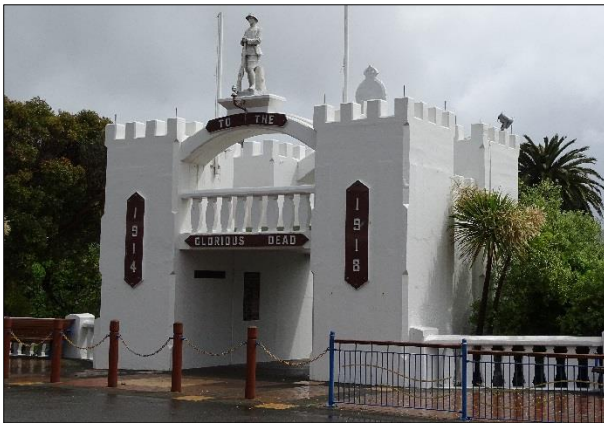
Historical monument – no observed damage to free-standing appendages

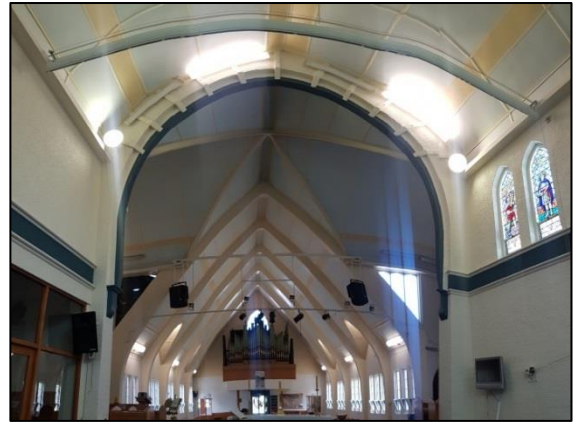
The Church of Nativity, internal view

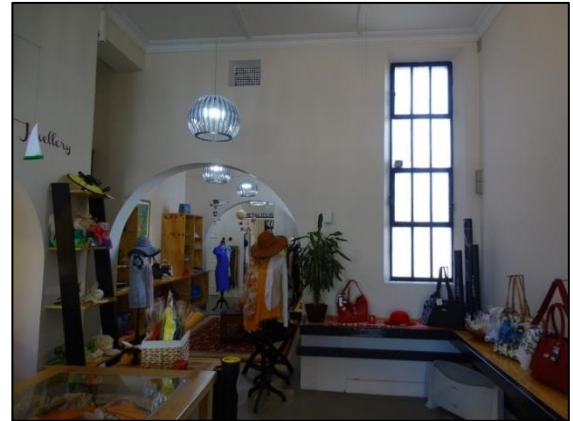
Bank of Australasia, internal view

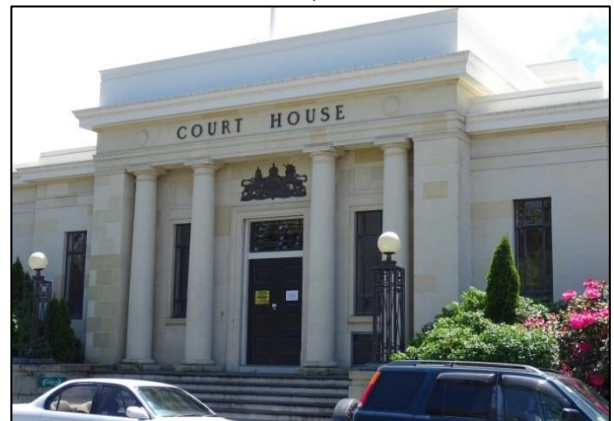
Court House, stone and concrete
