# **Preliminary update - Mw7.8 Kaikoura Earthquake (15 November 2015)**

## **Upper Part of South Island**

**By Dmytro Dizhur and Marta Giaretton**

This is a preliminary set of notes from observations made on 15 November 2016, route taken is shown below.

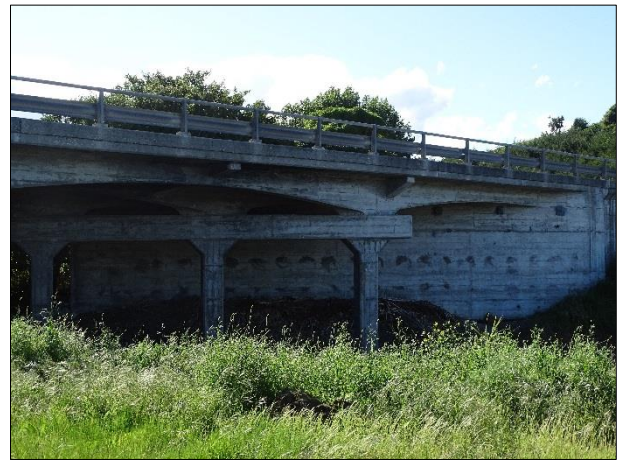
No damage observed

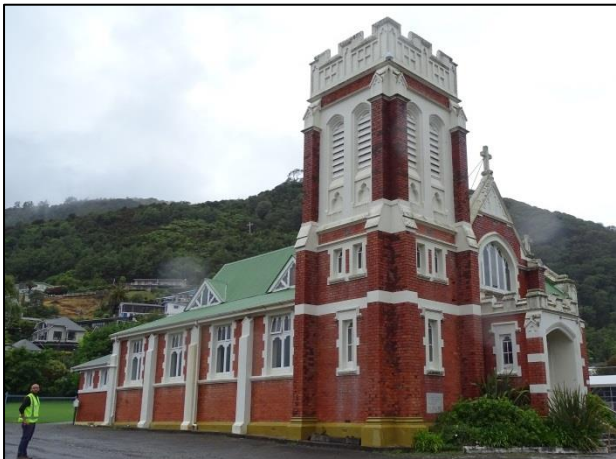
St Joseph's Church, clay brick masonry cavity-wall building (probably retrofitted)

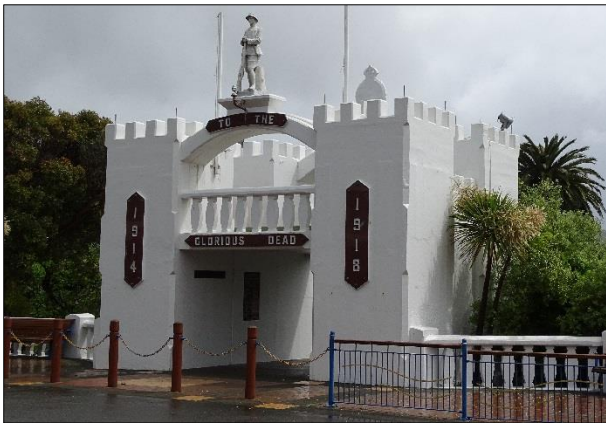
Historical monument – no observed damage to free-standing appendages

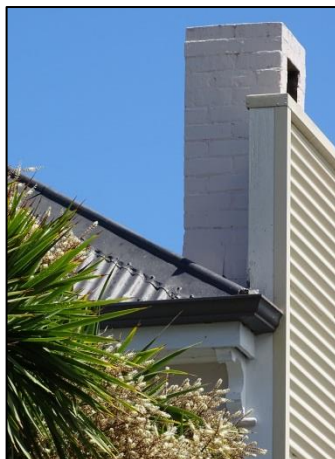
Standing chimney in the same building of the previous photo, Blenheim

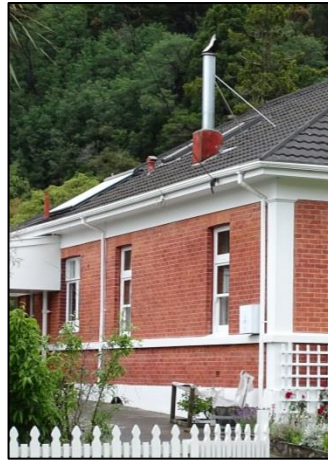
Example of removed chimney, Picton

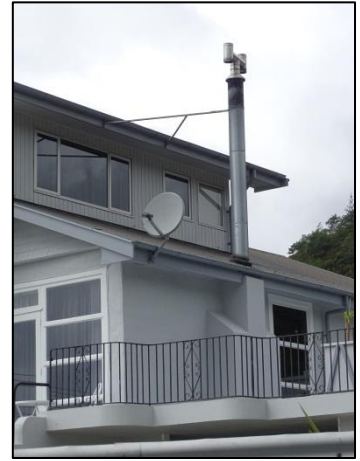
Example of removed chimney, Picton
