## Preliminary update - Mw7.8 Kaikoura Earthquake

**(16-17 November 2015, supplement to 15 November update)**

### Upper Part of South Island

# Preliminary update - Mw7.8 Kaikoura Earthquake (16-17 November 2015)

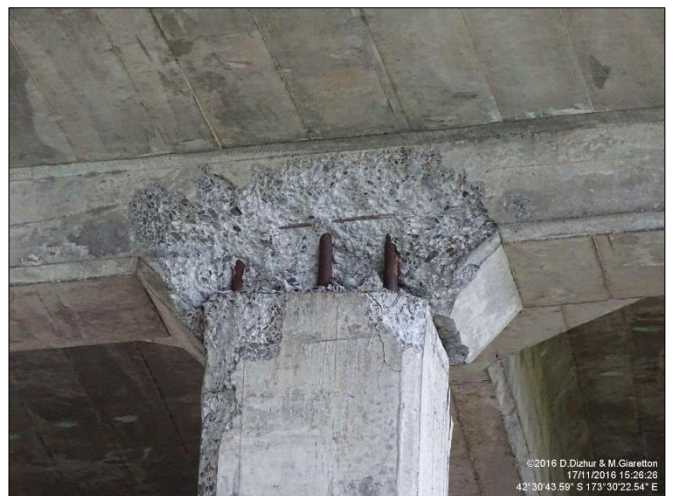
Hinging at the top of column

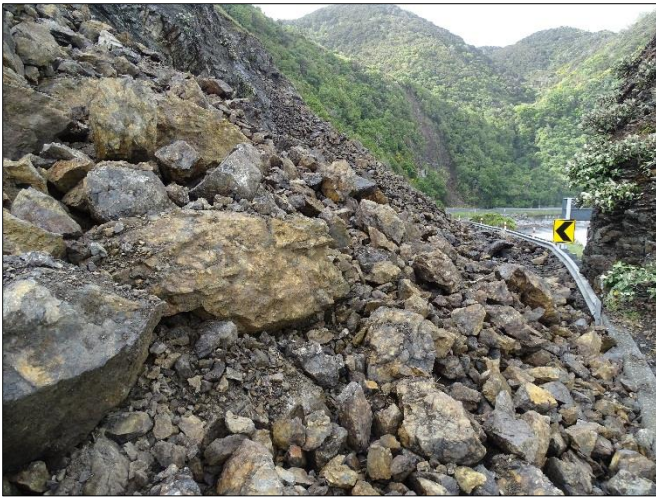
(a) Major rock fall over SH1

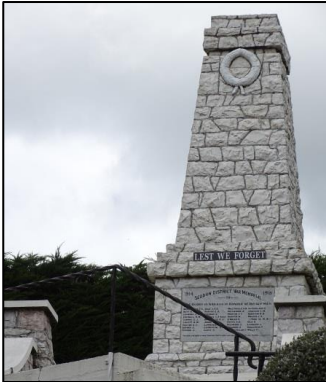
Seddon War Memorial (1926) – no visible damage

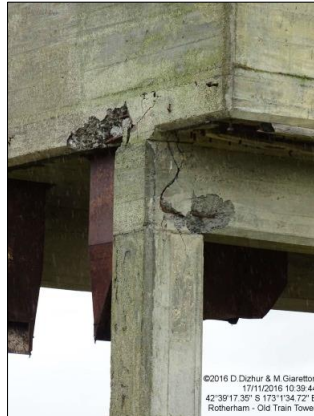
Hinging of the column-to-beam joints

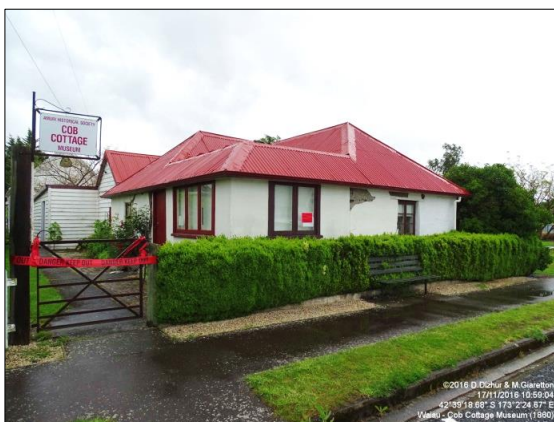
Cob Cottage museum (earth structure)

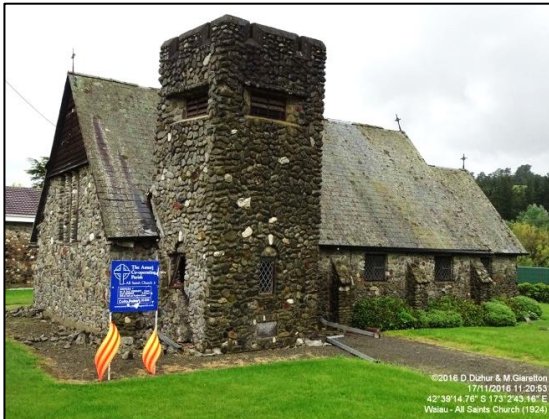
All Saints Church, stone and lightly reinforced concrete

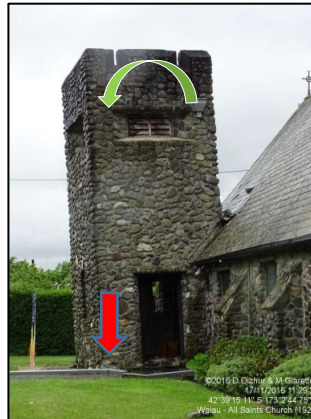
Tilting of the bell tower (note significant settlement of tower foundation)

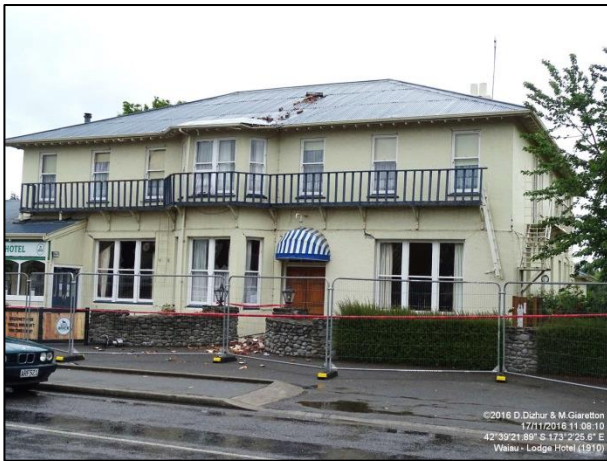
Waiau Lodge Hotel, vintage concrete structure

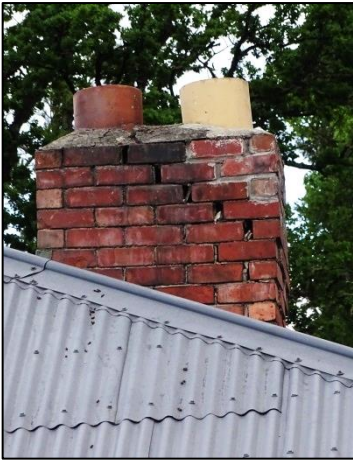
Dislodgment of the bricks,  
Hanmer Springs

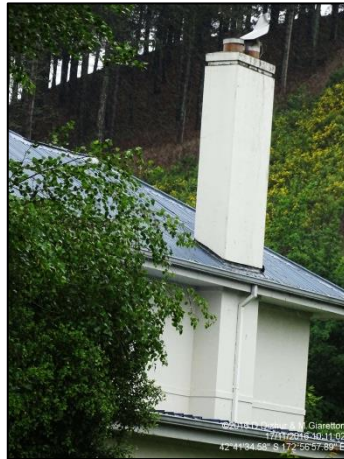
Non-damaged tall chimney,  
Rotherham

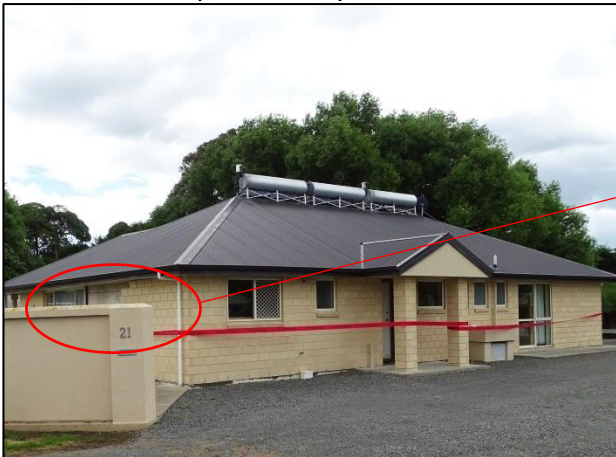
Recently constructed veneer building, Seddon

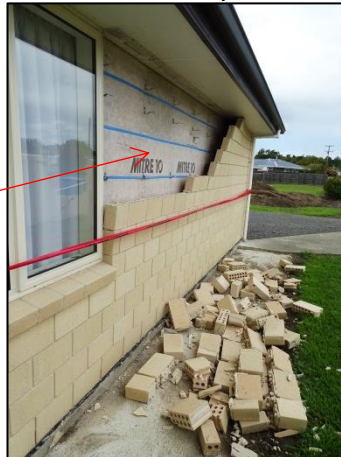
Out-of-plane collapse

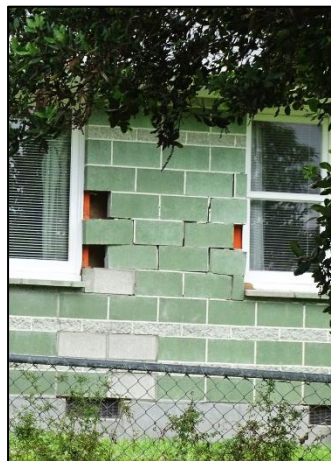
Dislodgement of the veneer blocks, Seddon
